PROJECT NO. I-5746C

DEPARTMENT OF TRANSPORTATION
RALEIGH
UNDERSIDE DECK
REPAIR

BEAM REPAIR LOCATIONS

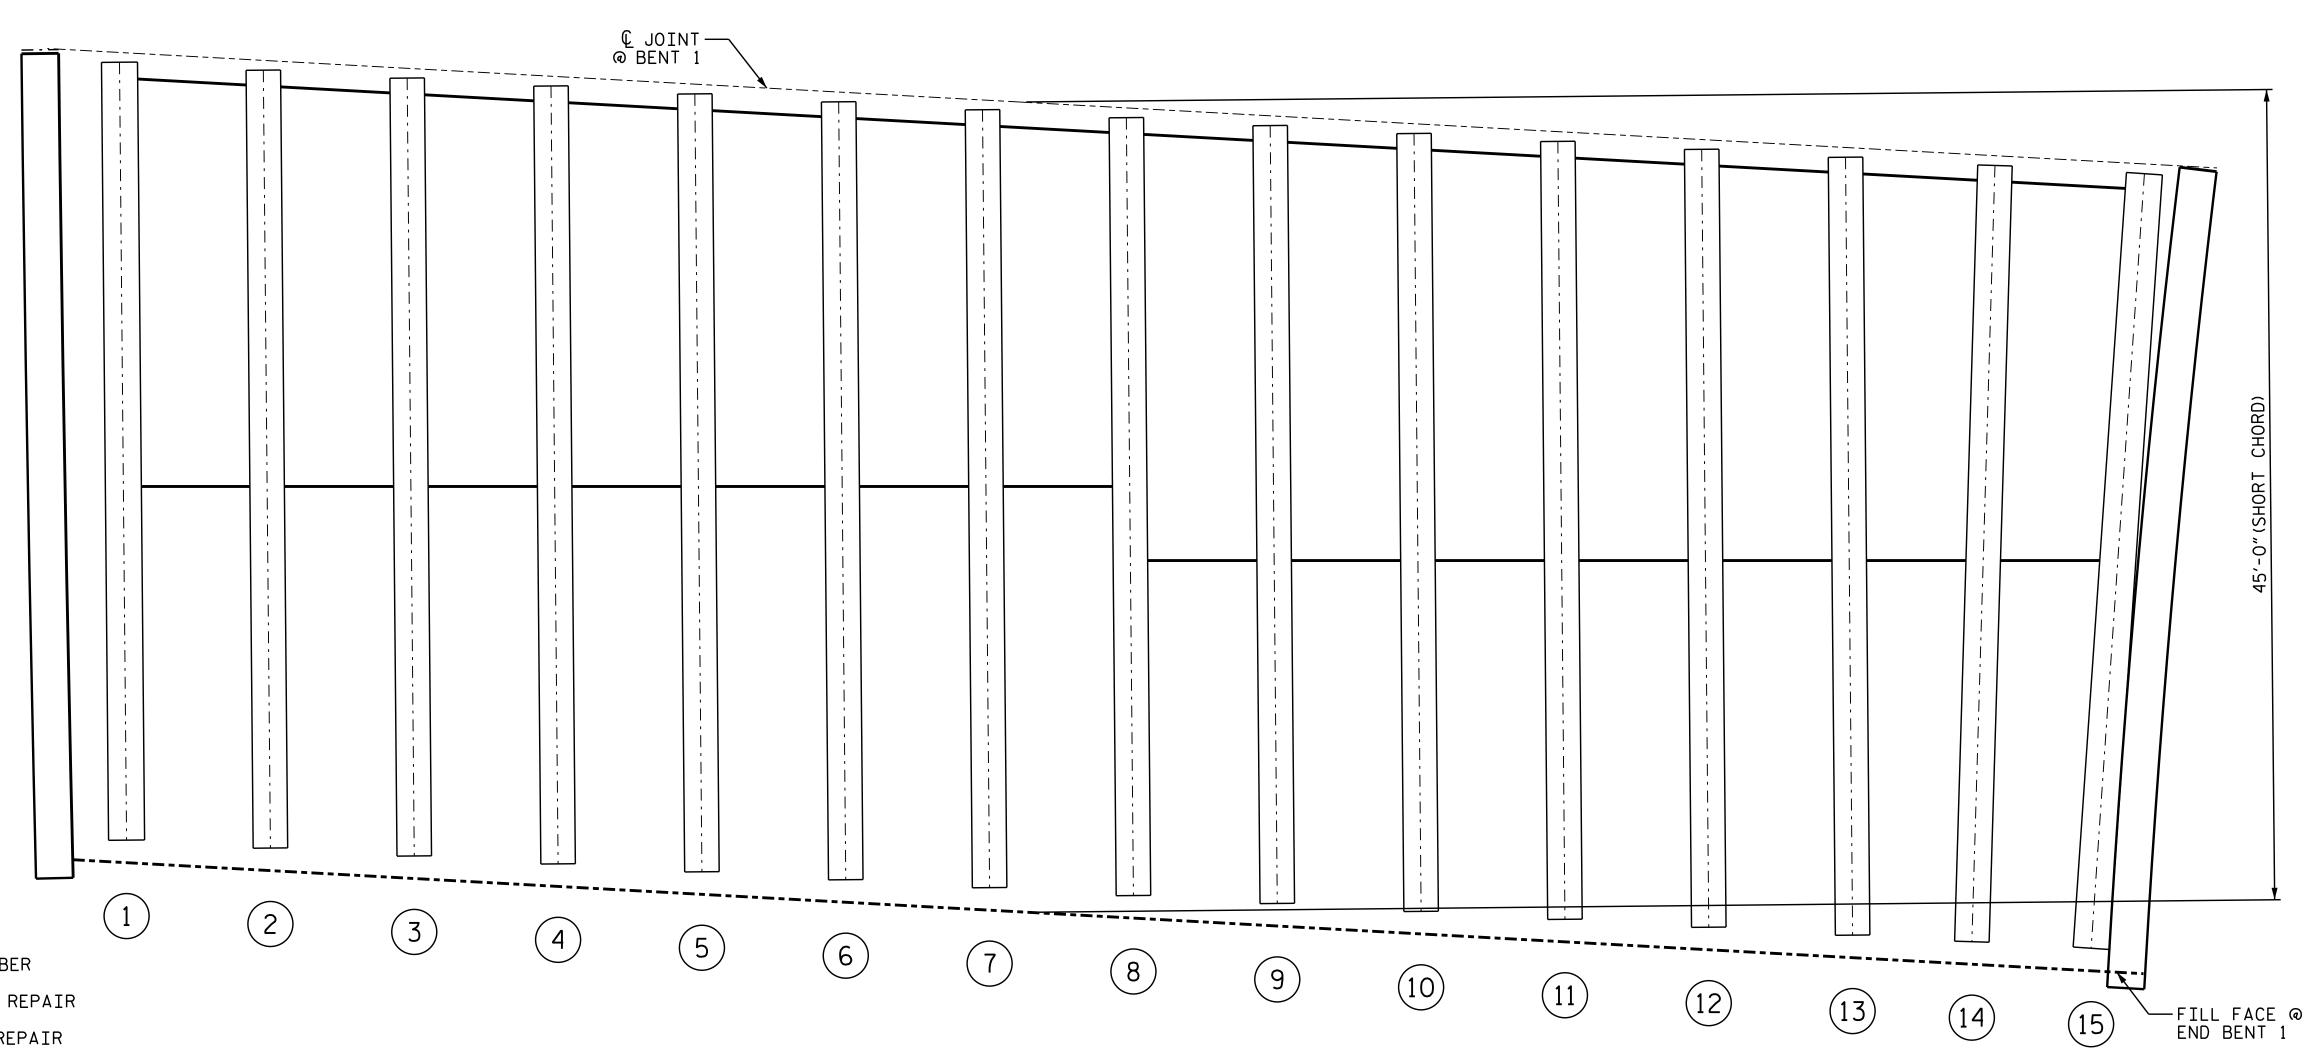
PLAN

- 1) BEAM NUMBER
- B BEAM END REPAIR
- P PLATING REPAIR
- S STIFFENER REPAIR
- (D) STEEL DIAPHRAGM REPAIR

· UNDERSIDE EPOXY COATING
UNDERSIDE REPAIR

DIAPHRAGM REPAIR

EPOXY RESIN INJECTION (ERI)

(OTHER LOCATIONS MAY EXIST, SEE NOTES)
