PROJECT NO. I-5746CMECKLENBURG COUNTY BRIDGE NO. 590327

STATE OF NORTH CAROLINA DEPARTMENT OF TRANSPORTATION BENT 2 SOUTHBOUND SPAN C FACE

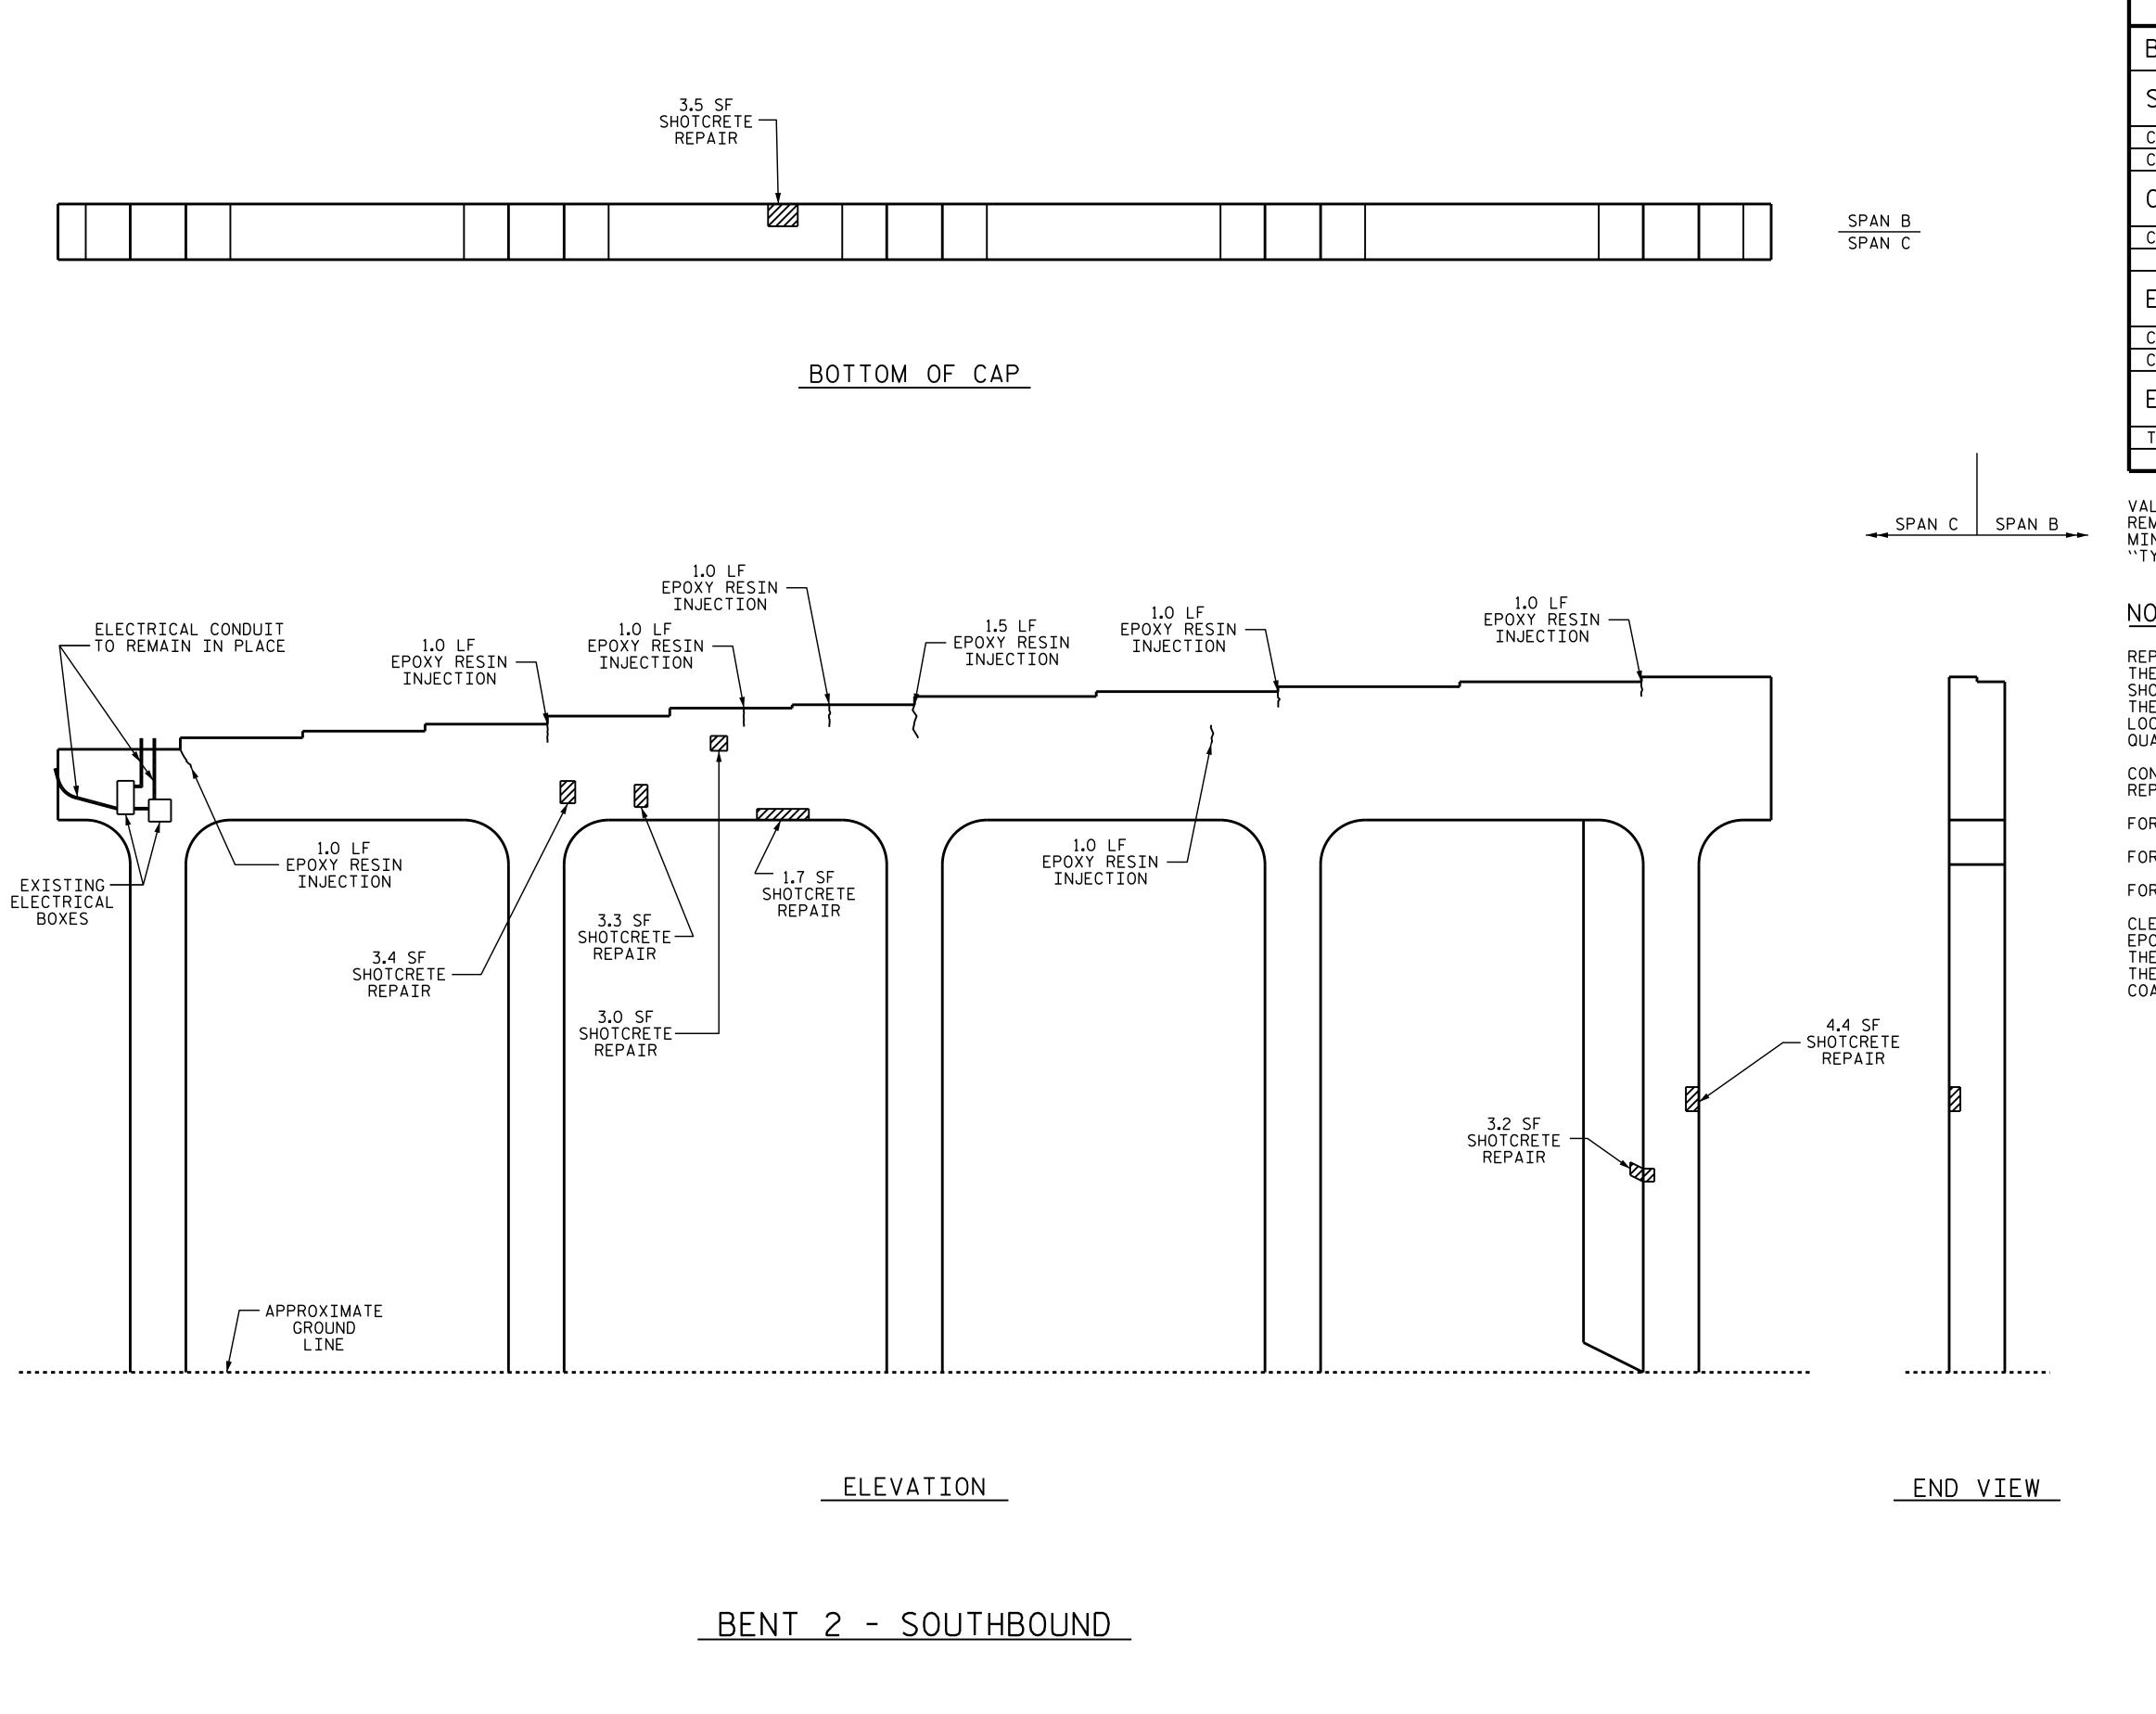
VALUES IN CHART REPRESENT ESTIMATED REPAIR TOTALS AFTER REMOVAL OF UNSOUND CONCRETE, MINIMUM OF 1"BEHIND REBAR AND MINIMUM 2"CLEARANCE TO SAWCUT. FOR REPAIR DETAILS, SEE "TYPICAL CAP AND COLUMN REPAIR DETAILS" SHEET.

CLEAN AND REMOVE DEBRIS FROM THE TOP OF THE CAP AND APPLY EPOXY PROTECTIVE COATING. EPOXY COATING SHALL BE APPLIED TO THE TOP SURFACE OF THE CAP. THE CONTRACTOR SHALL NOT COAT THE AREA OF THE CAP BENEATH THE MASONRY PLATES. FOR EPOXY COATING. SEE SPECIAL PROVISIONS.

SHOTCRETE REPAIR AREA

CONCRETE REPAIR AREA

EPOXY RESIN INJECTION (ERI)
