PROJECT NO. I-5939
ROBESON COUNTY
 BRIDGE NO. 770131

SLOPE PROTECTION REPAIRS

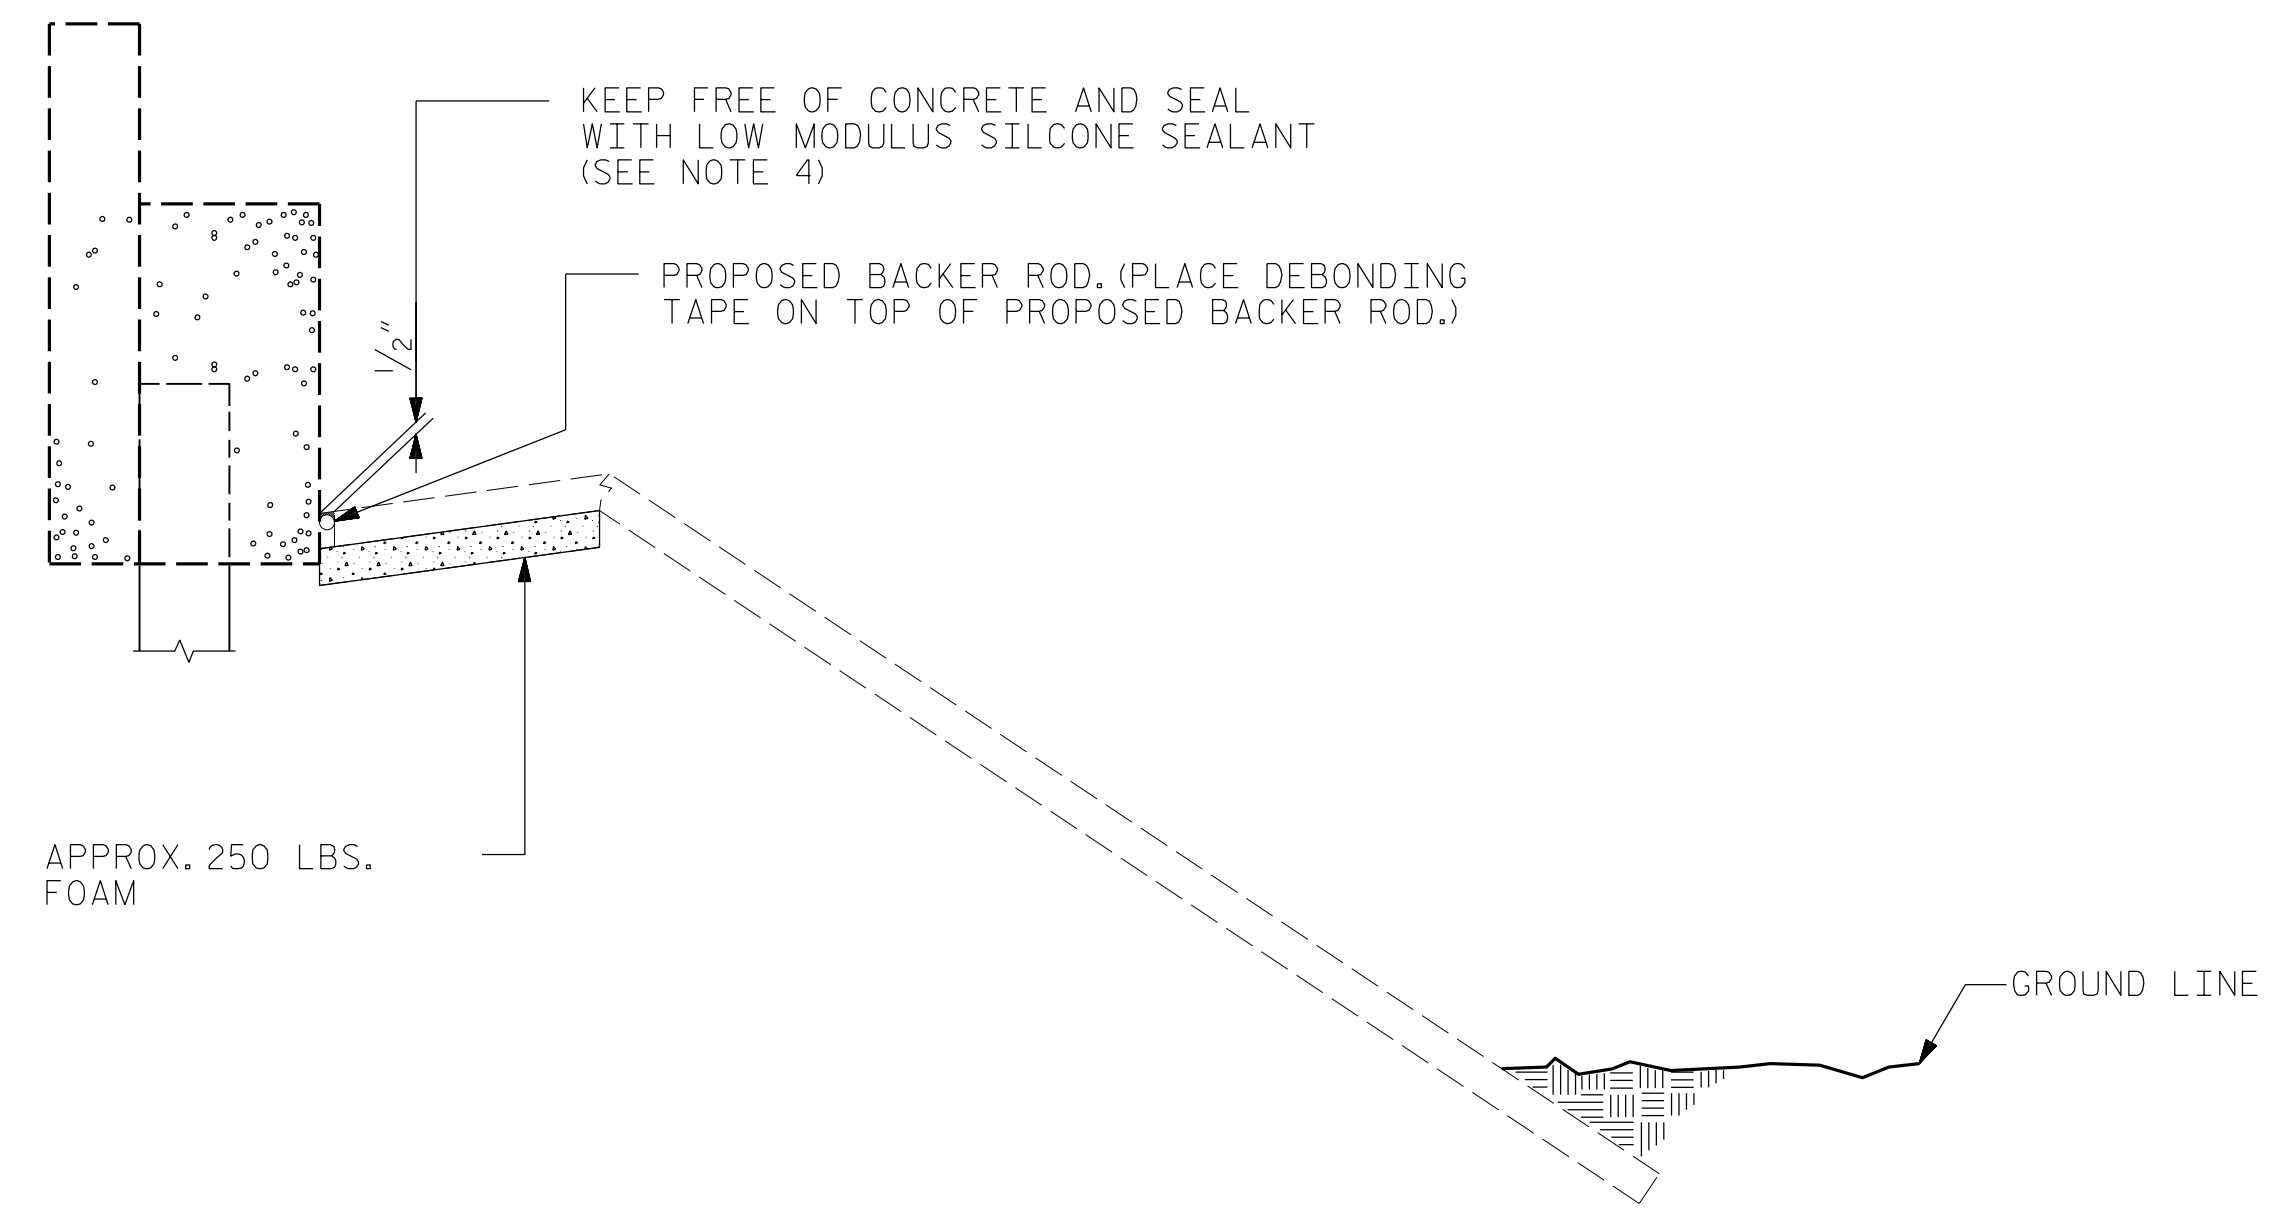
SECTION ALONG END BENT
(PROPOSED SLOPE REPAIR)

1. AFTER COMPLETION OF VOID FILLING, SEAL CRACKS IDENTIFIED WITH POURABLE SILICONE JOINT SEALANT AS DESCRIBED IN THE SPECIAL PROVISIONS FOR SILICONE JOINT SEALANT FOR SLOPE REPAIRS (BACKER RODS MAY BE OMITTED AS APPROVED BY THE ENGINEER)
2. FOR SLOPE PROTECTION VOID FILLING/ SILICONE JOINT SEAL LOCATIONS SEE, "GENERAL DRAWING" SHEET
3. FOR SLOPE PROTECTION VOID FILLING, SEE SPECIAL PROVISIONS
4. FOR SILICONE JOINT SEALANT FOR SLOPE PROTECTION REPAIR, SEE SPECIAL PROVISIONS
5. FOR SILICONE JOINT SEALANT FOR SLOPE PROTECTION REPAIR, SEE "JOINT SEAL REPAIR ELEVATION VIEW" DETAIL
