PROJECT NO. 15BPR.39
ROCKINGHAM COUNTY
 BRIDGE NO. 780132

STATE OF NORTH CAROLINA
 DEPARTMENT OF TRANSPORTATION
 RALEIGH

**TYPICAL CAP
AND COLUMN
REPAIR DETAILS**

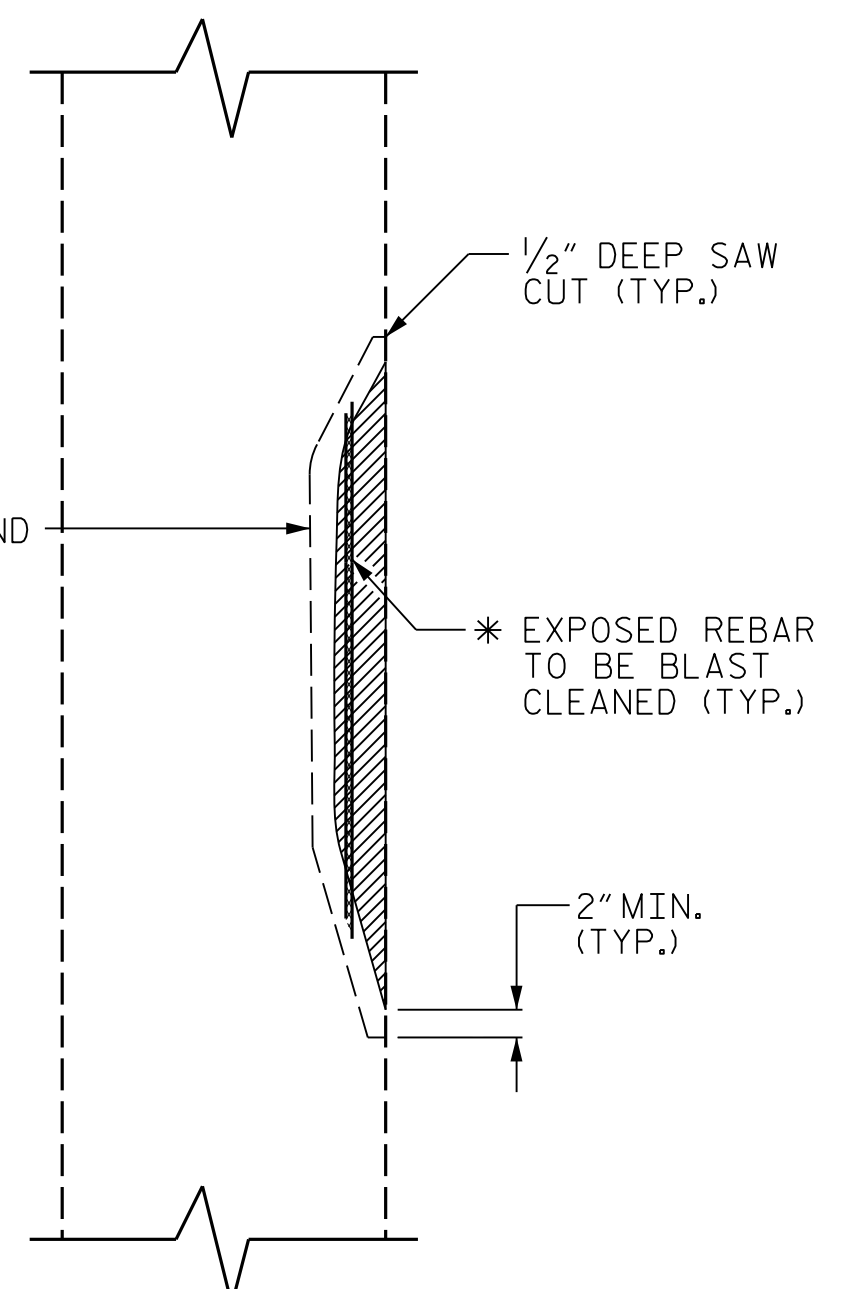
ELEVATION OF COLUMN
COLUMN REPAIR

* REPAIR LENGTH SHALL NOT EXCEED 10 FEET.

REMOVE UNSOUND CONCRETE TO THE EXTENT NECESSARY, MINIMUM OF 1" BEHIND REBAR AND MINIMUM OF 2" CLEARANCE TO SAWCUT.

NO MORE THAN ONE-THIRD OF THE CAP OR COLUMN CIRCUMFERENCE SHALL BE REMOVED AT ONE TIME. SHOULD IT BECOME NECESSARY TO REMOVE MORE THAN 30% OF A CAP OR COLUMN CROSS SECTIONAL AREA, NOTIFY THE ENGINEER PRIOR TO PROCEEDING.

SIMULTANEOUS REMOVAL OF UNSOUND CONCRETE MAY BE PERMITTED ON MORE THAN ONE FACE OF A CAP AND/OR COLUMN, BUT NO MORE 1/2 OF THE CIRCUMFERENCE SHALL BE REMOVED AT ONE TIME. IF REMOVAL EXTENDS MORE THAN 1 1/2" BEHIND THE MAIN REINFORCING BARS, NOTIFY THE ENGINEER PRIOR TO PROCEEDING. ON COLUMNS AND PILES, NO MORE THAN 10 VERTICAL FEET MAY BE EXPOSED AT ONE TIME BEFORE PLACEMENT OF REPAIR CONCRETE.
