BENT CAP REPAIRS

PROJECT NO. I-5997  
WAKE COUNTY  
 BRIDGE NO. 910242, 910260, 910263, 910264,  
910267, 910268 & 910278

STATE OF NORTH CAROLINA  
 DEPARTMENT OF TRANSPORTATION  
 RALEIGH  
 TYPICAL CAP  
 AND COLUMN  
 REPAIR DETAILS

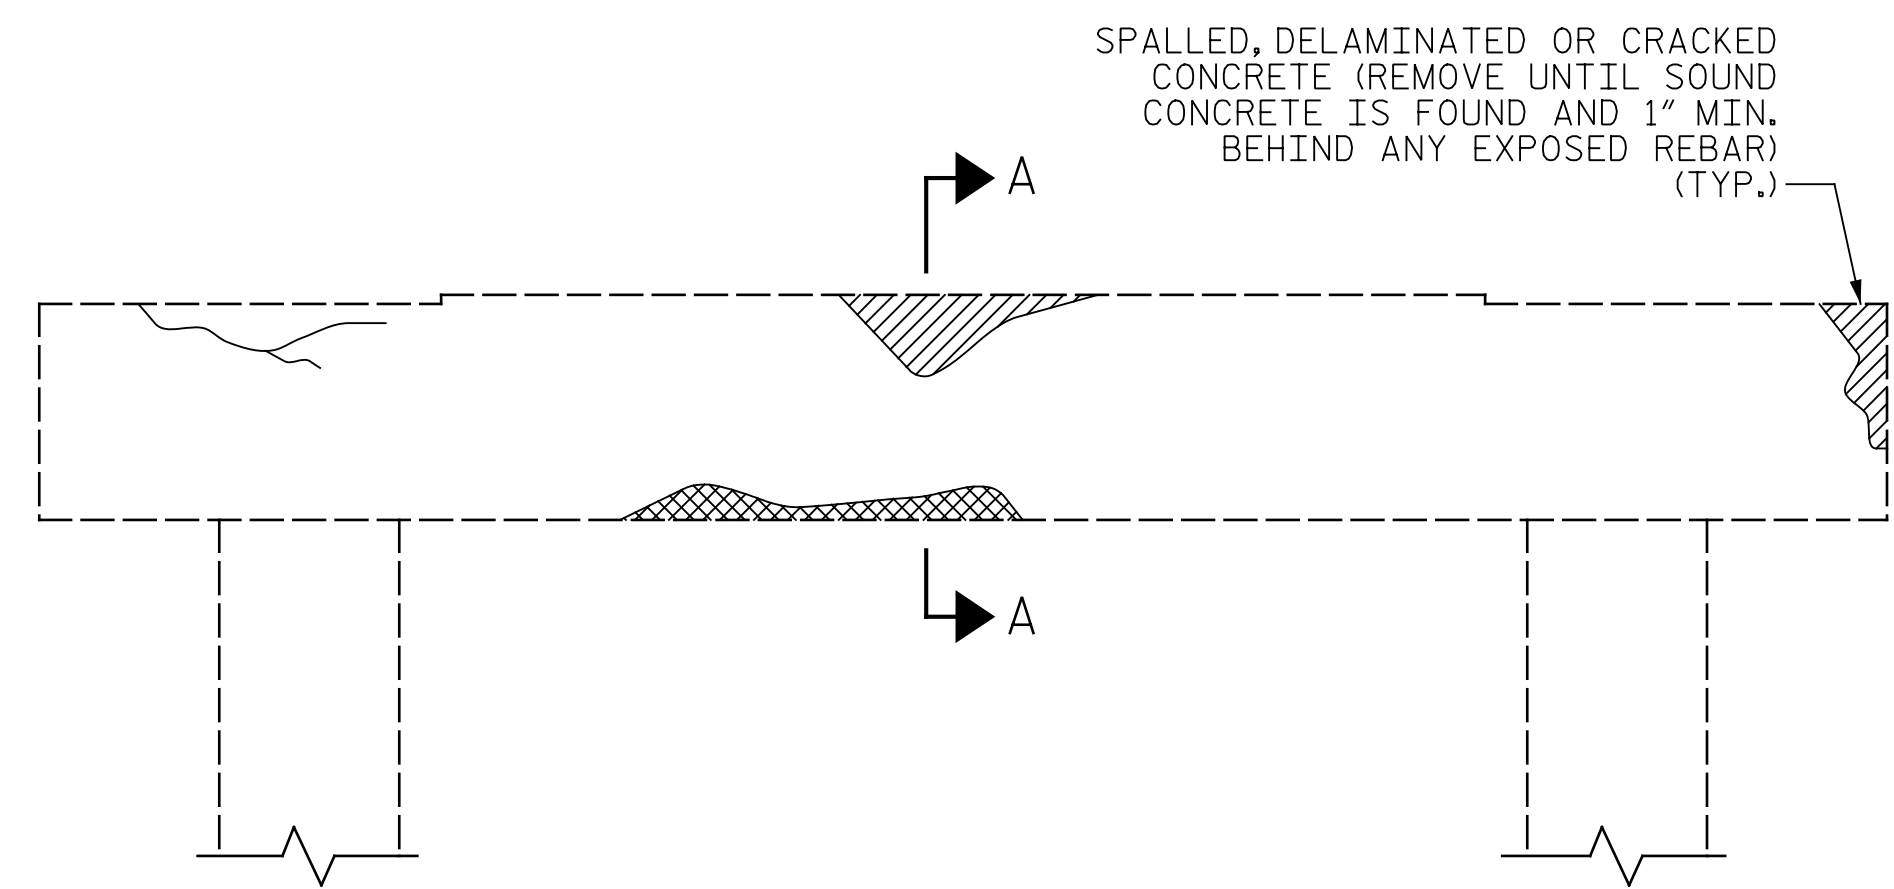
TYPICAL BENT CAP REPAIRS ARE SHOWN. REPAIR DETAILS SIMILAR FOR END BENT CAPS AND STRUTS.

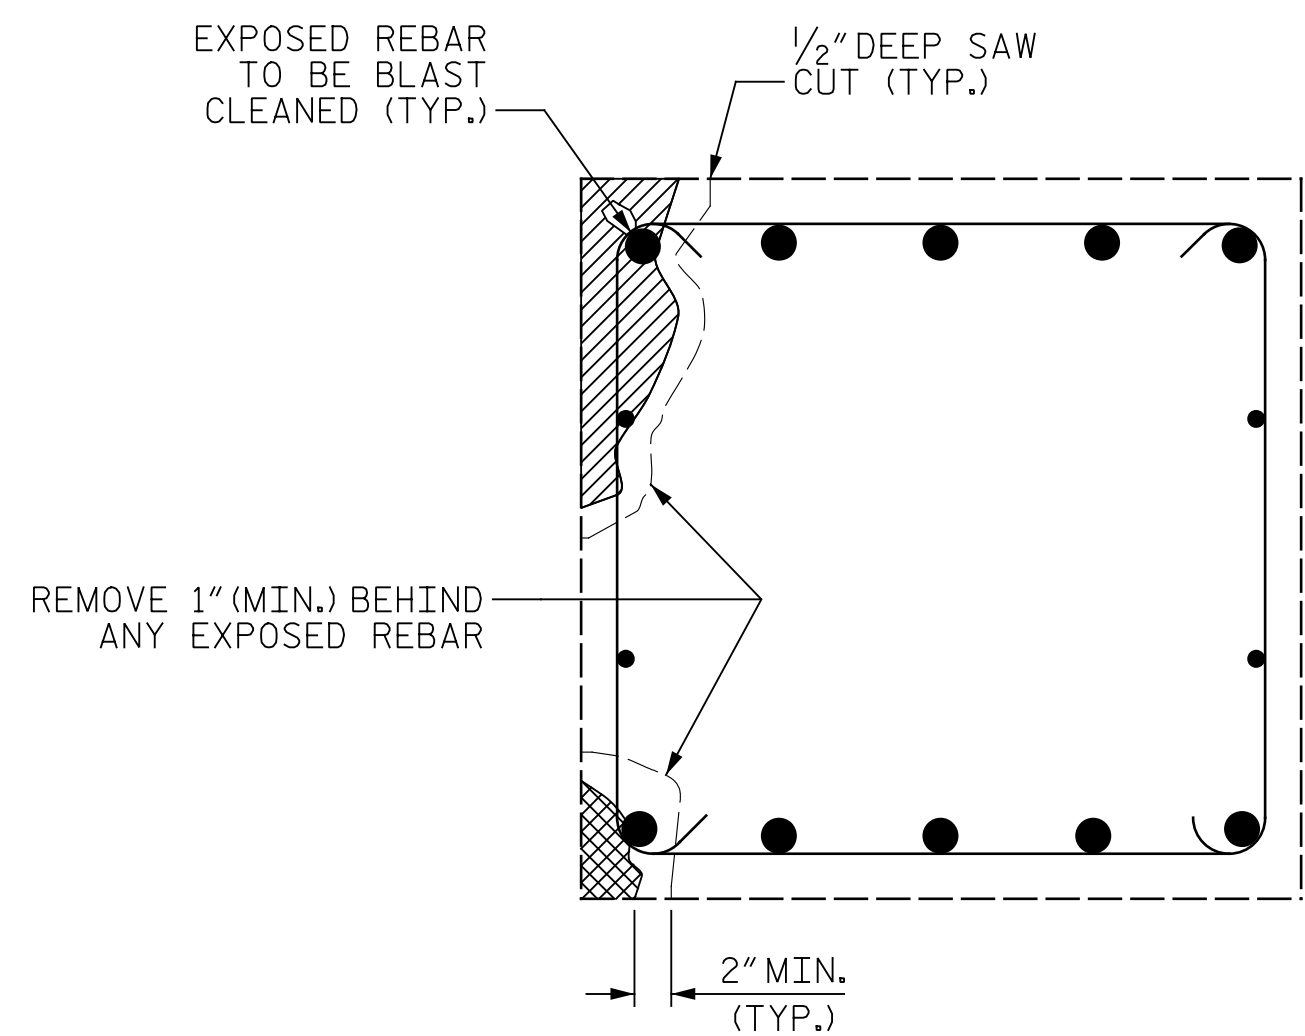
SECTION A-A

CAP REPAIR

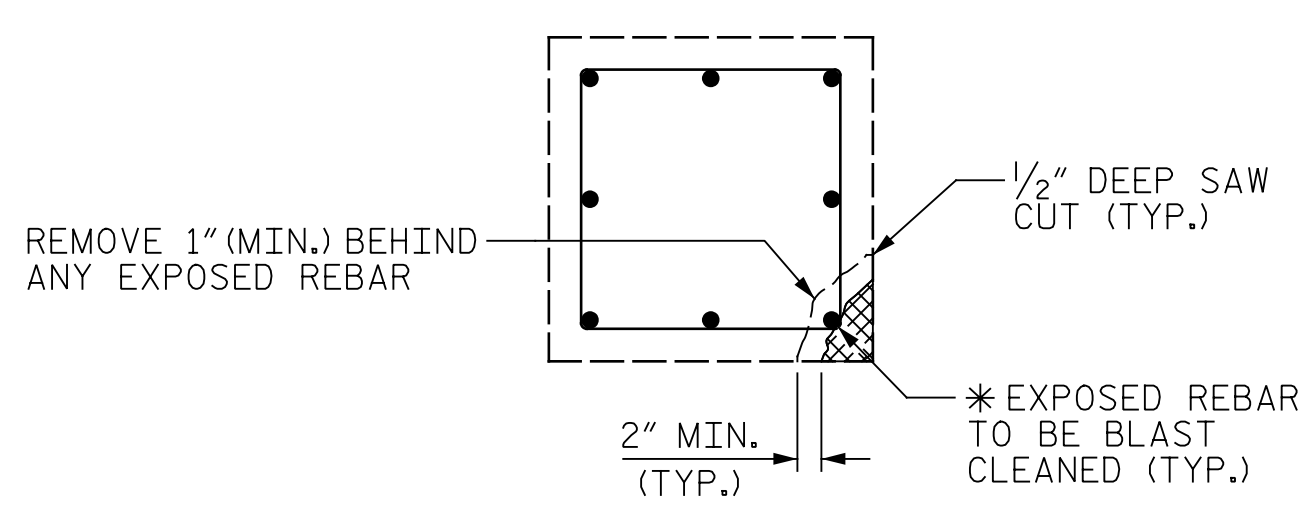
PLAN OF COLUMN

COLUMN REPAIR

REPAIR AT SQUARE COLUMN SHOWN  
REPAIR AT ROUND COLUMN SIMILAR

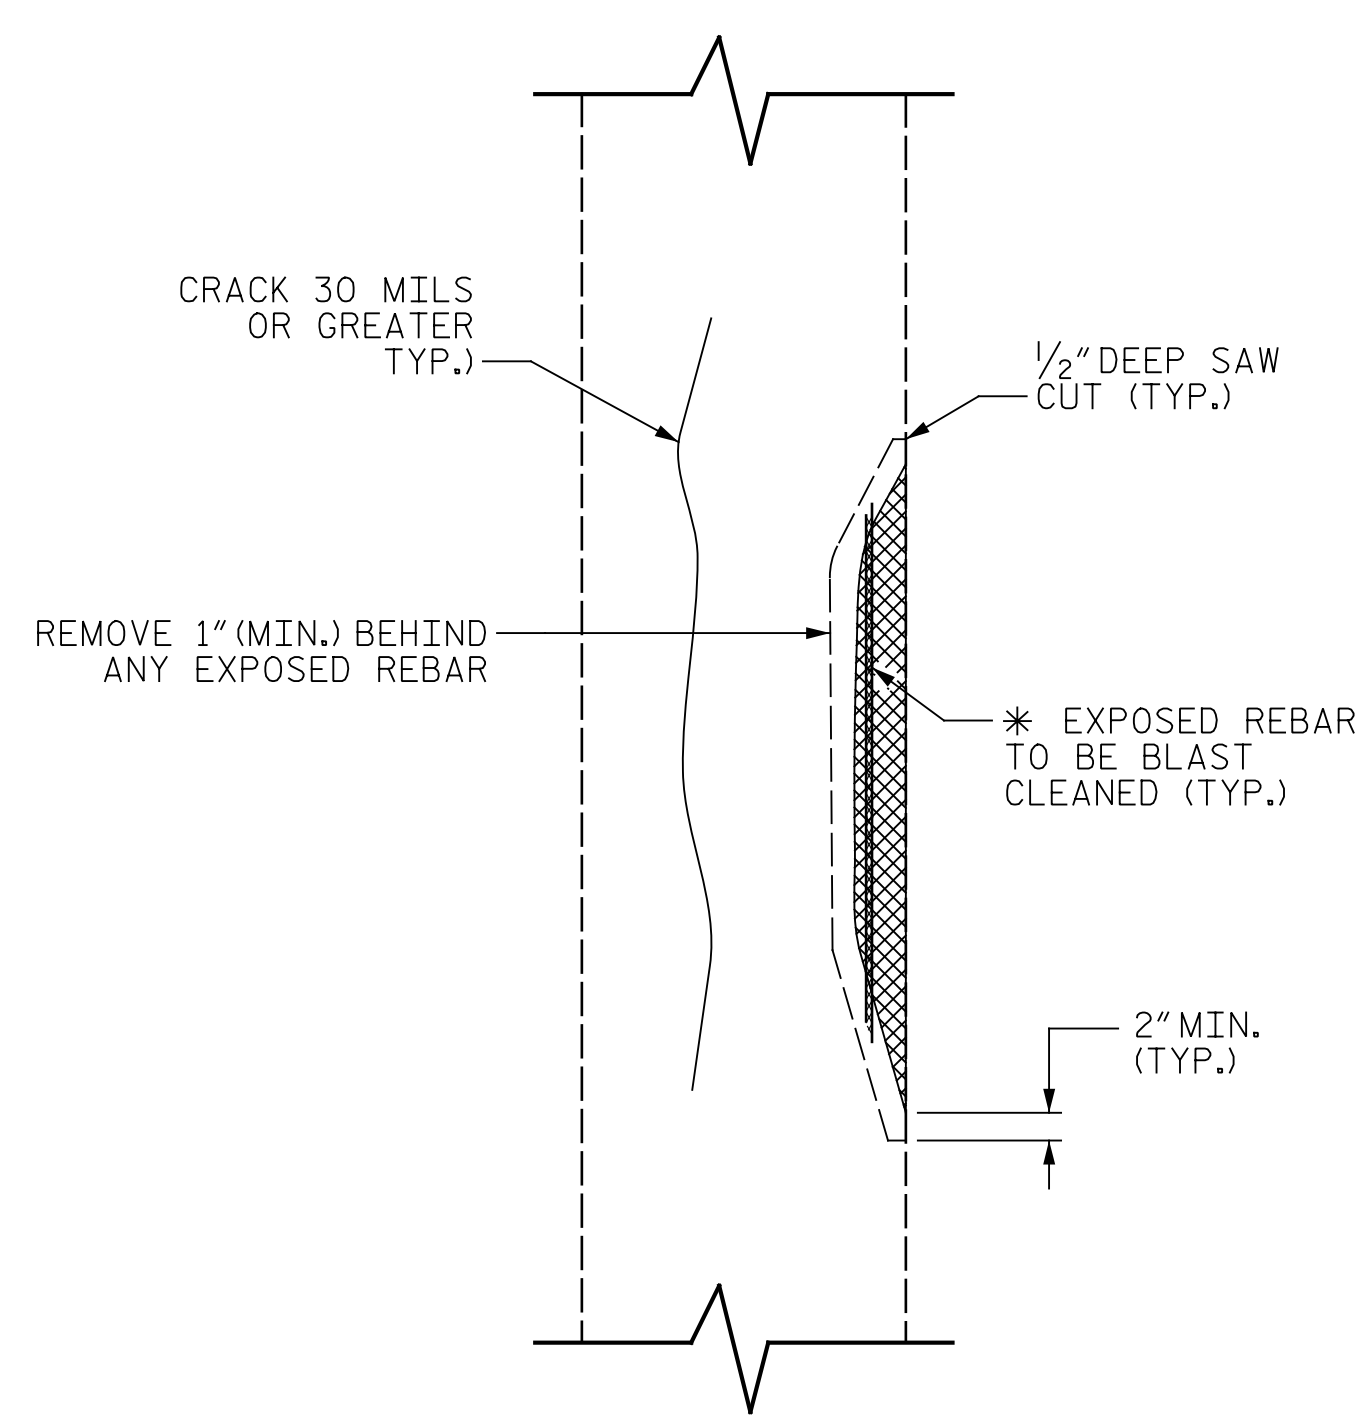
ELEVATION OF COLUMN

\* REPAIR LENGTH SHALL NOT EXCEED 10 FEET.

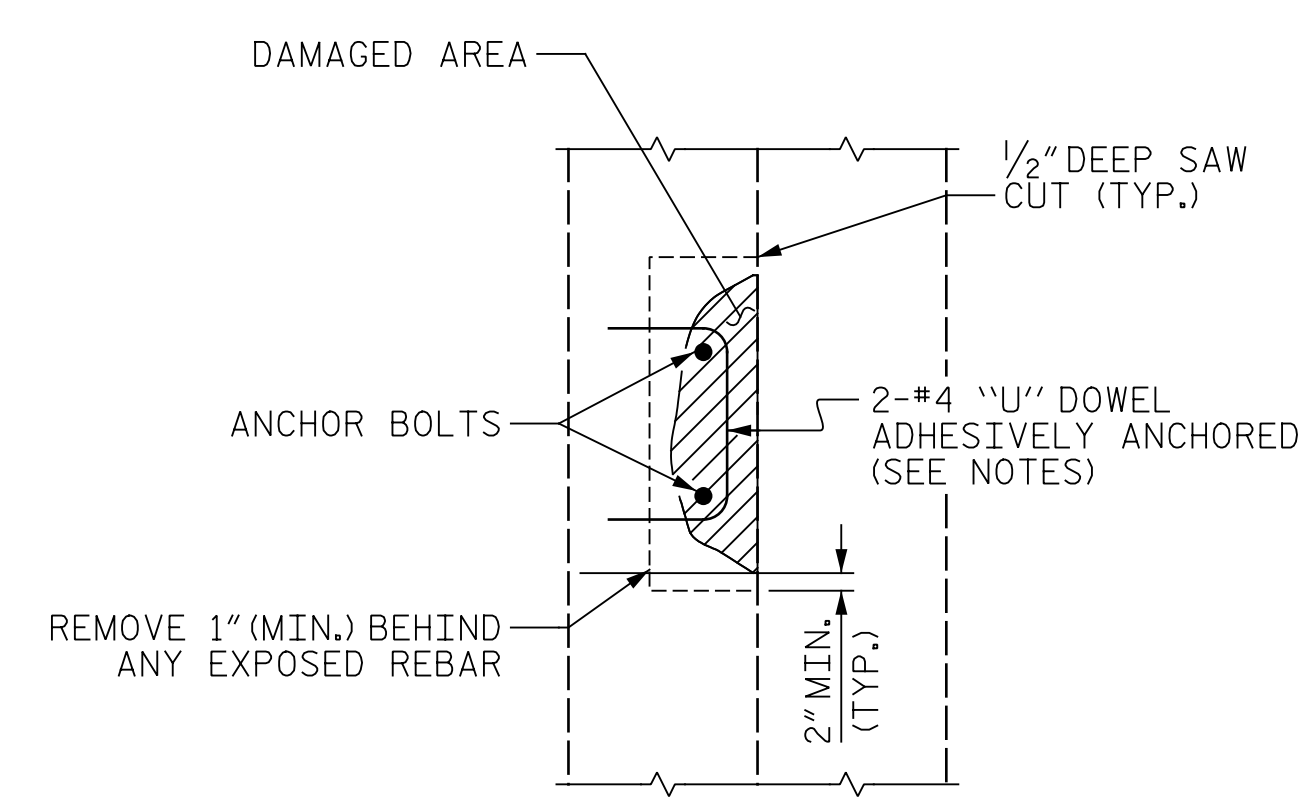
PLAN

PEDESTAL WALL REPAIR

THE #4 "U" DOWELS ARE REQUIRED ONLY AROUND THE ANCHOR BOLTS. THE EXISTING REINFORCING STEEL IN THE PEDESTAL WALL SHALL BE CLEANED, STRAIGHTENED AND REMAIN IN PLACE.
