AS-BUILT REPA	IR QU	JANTI	TY TA	BLE							
BENT 136											
CAP REPAIRS	ESTI	МАТЕ	ACTUAL								
SHOTCRETE REPAIRS	0.8 SF	0.4 CF	SF	CF							
EPOXY RESIN INJECTION	_	LF		LF							
COLUMN REPAIRS	ESTI	MATE	ACTUAL								
SHOTCRETE REPAIRS	46.0 SF	23.0 CF	SF	CF							
EPOXY RESIN INJECTION	5.3 LF		LF								
PILE REPAIRS	ESTI	MATE	ACTUAL								
FRP PROTECTIVE SYSTEM AWL	_	SF	SF								
FRP PROTECTIVE SYSTEM BWL		) SF	SF

STATE OF NORTH CAROLINA DEPARTMENT OF TRANSPORTATION

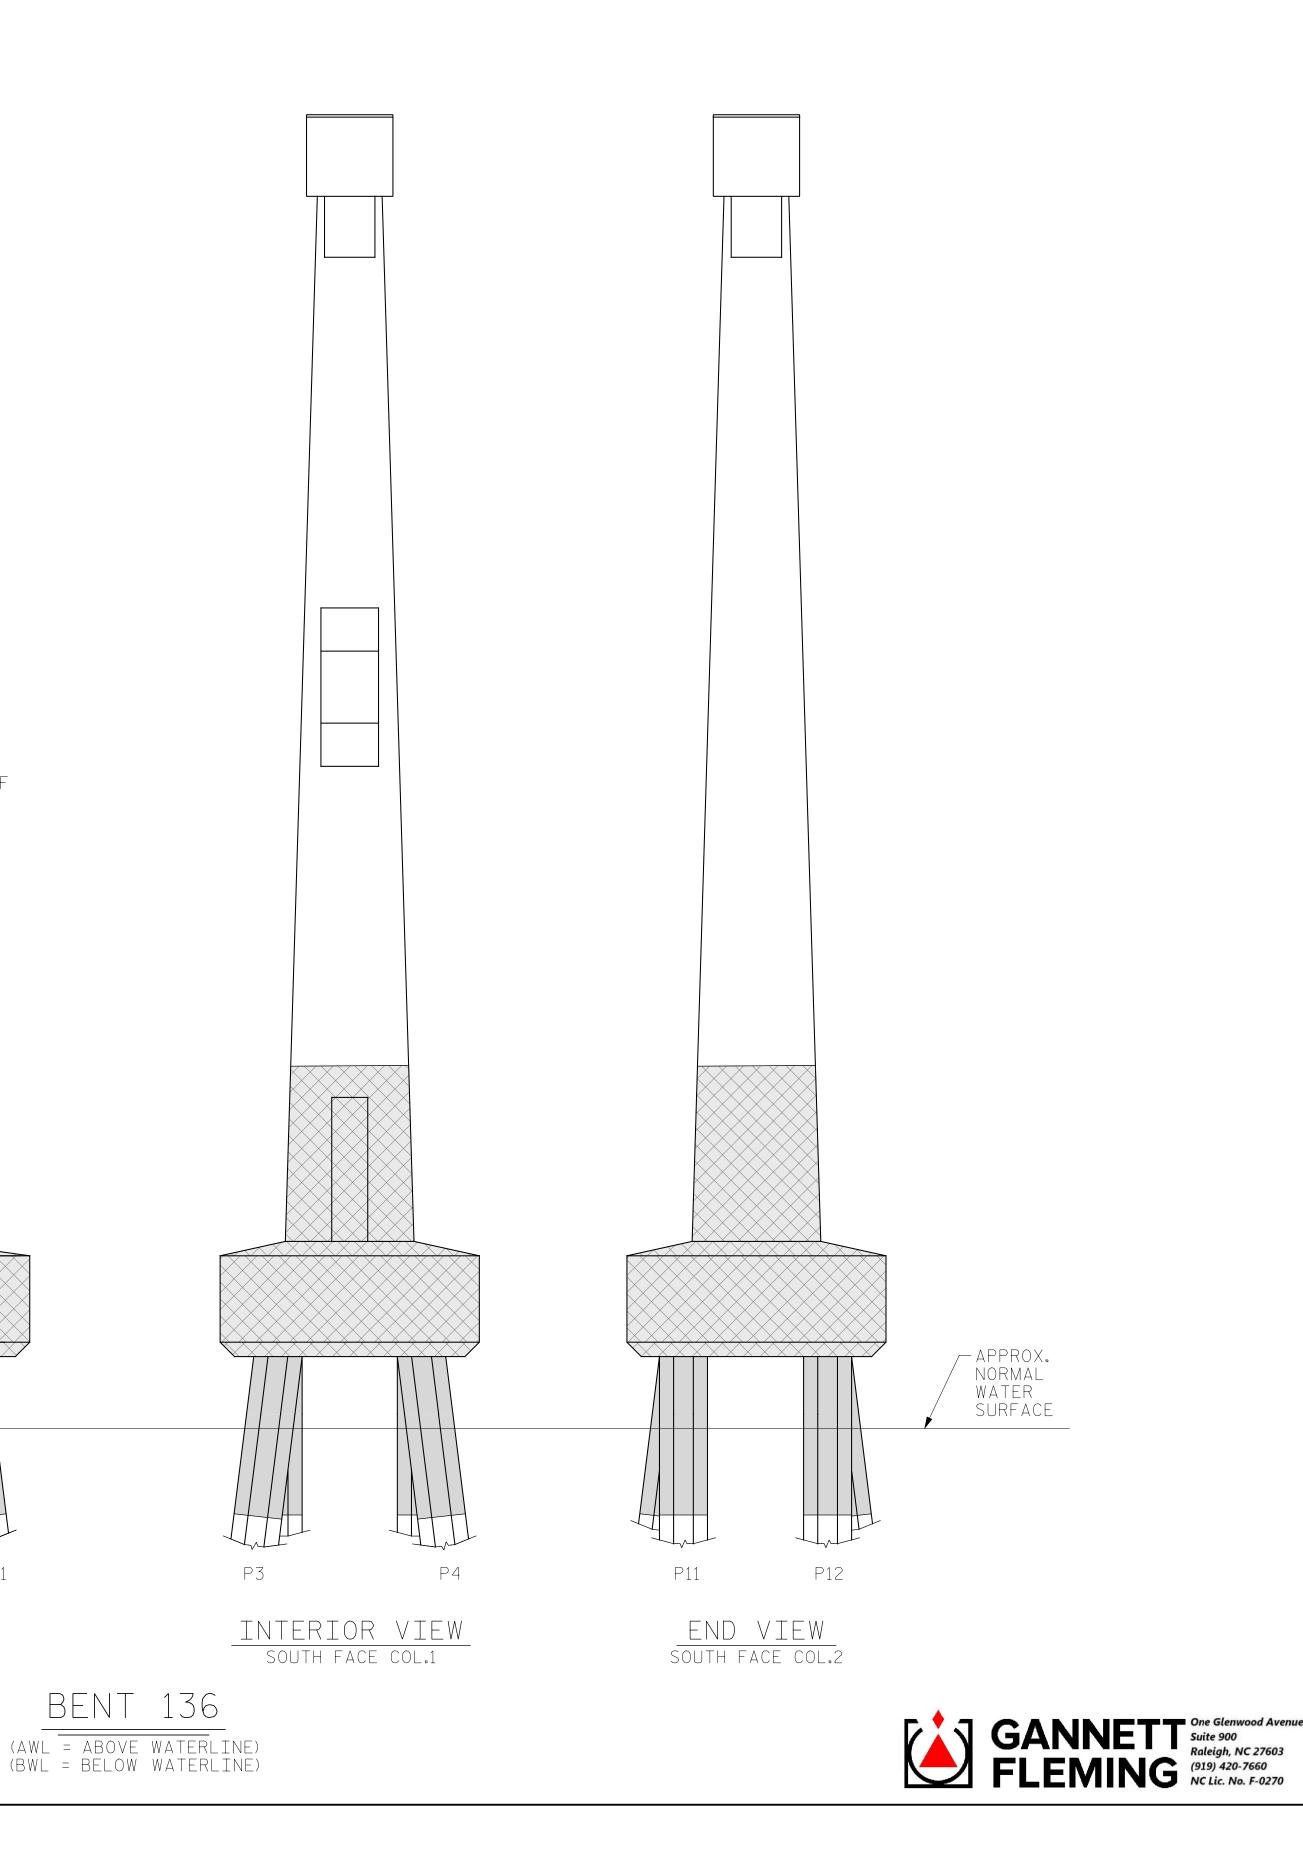
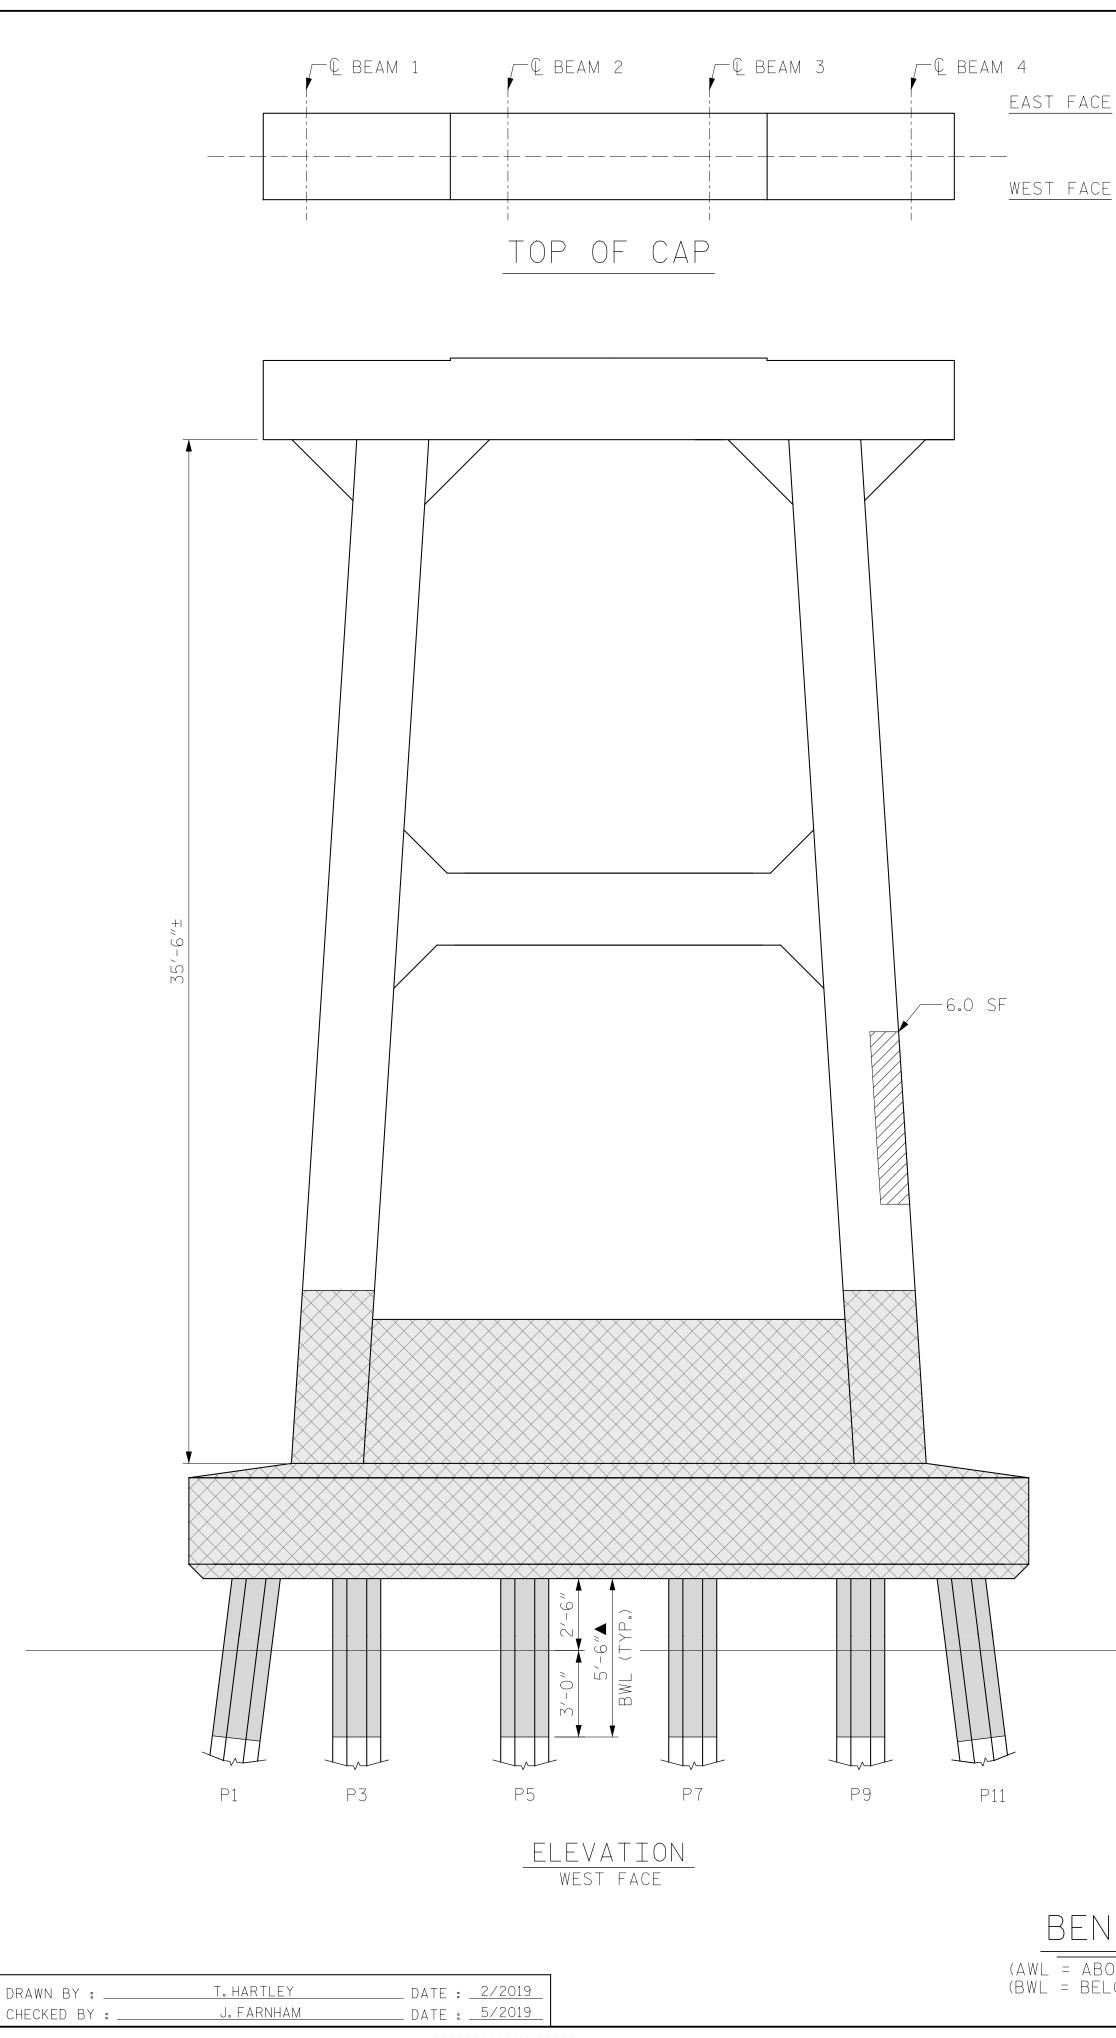
FOR CAP REPAIRS: VALUES IN CHART REPRESENT ESTIMATED REPAIR TOTALS AFTER REMOVAL OF UNSOUND CONCRETE, MIN. OF 1"BEHIND REBAR AND MIN. 2"CL TO SAWCUT. SEE REPAIR DETAILS.

▲ FRP PROTECTIVE SYSTEM BELOW WATERLINE MAY INCLUDE APPROVED UNDERWATER MORTAR REPAIRS
