BENT 274

AS-BUILT REPAIR QUANTITY TABLE BENT 273 CAP REPAIRS SF SHOTCRETE REPAIRS 11.6 SF | 5.8 CF EPOXY RESIN INJECTION - LF PILE REPAIRS SF PILE CONCRETE RESTORATION | 25.3 SF | 10.3 CF FRP PROTECTIVE SYSTEM AWL 192.5 SF FRP PROTECTIVE SYSTEM BWL 66.0 SF BENT 274 CAP REPAIRS SF SHOTCRETE REPAIRS 1.4 SF | 0.7 CF - LF EPOXY RESIN INJECTION

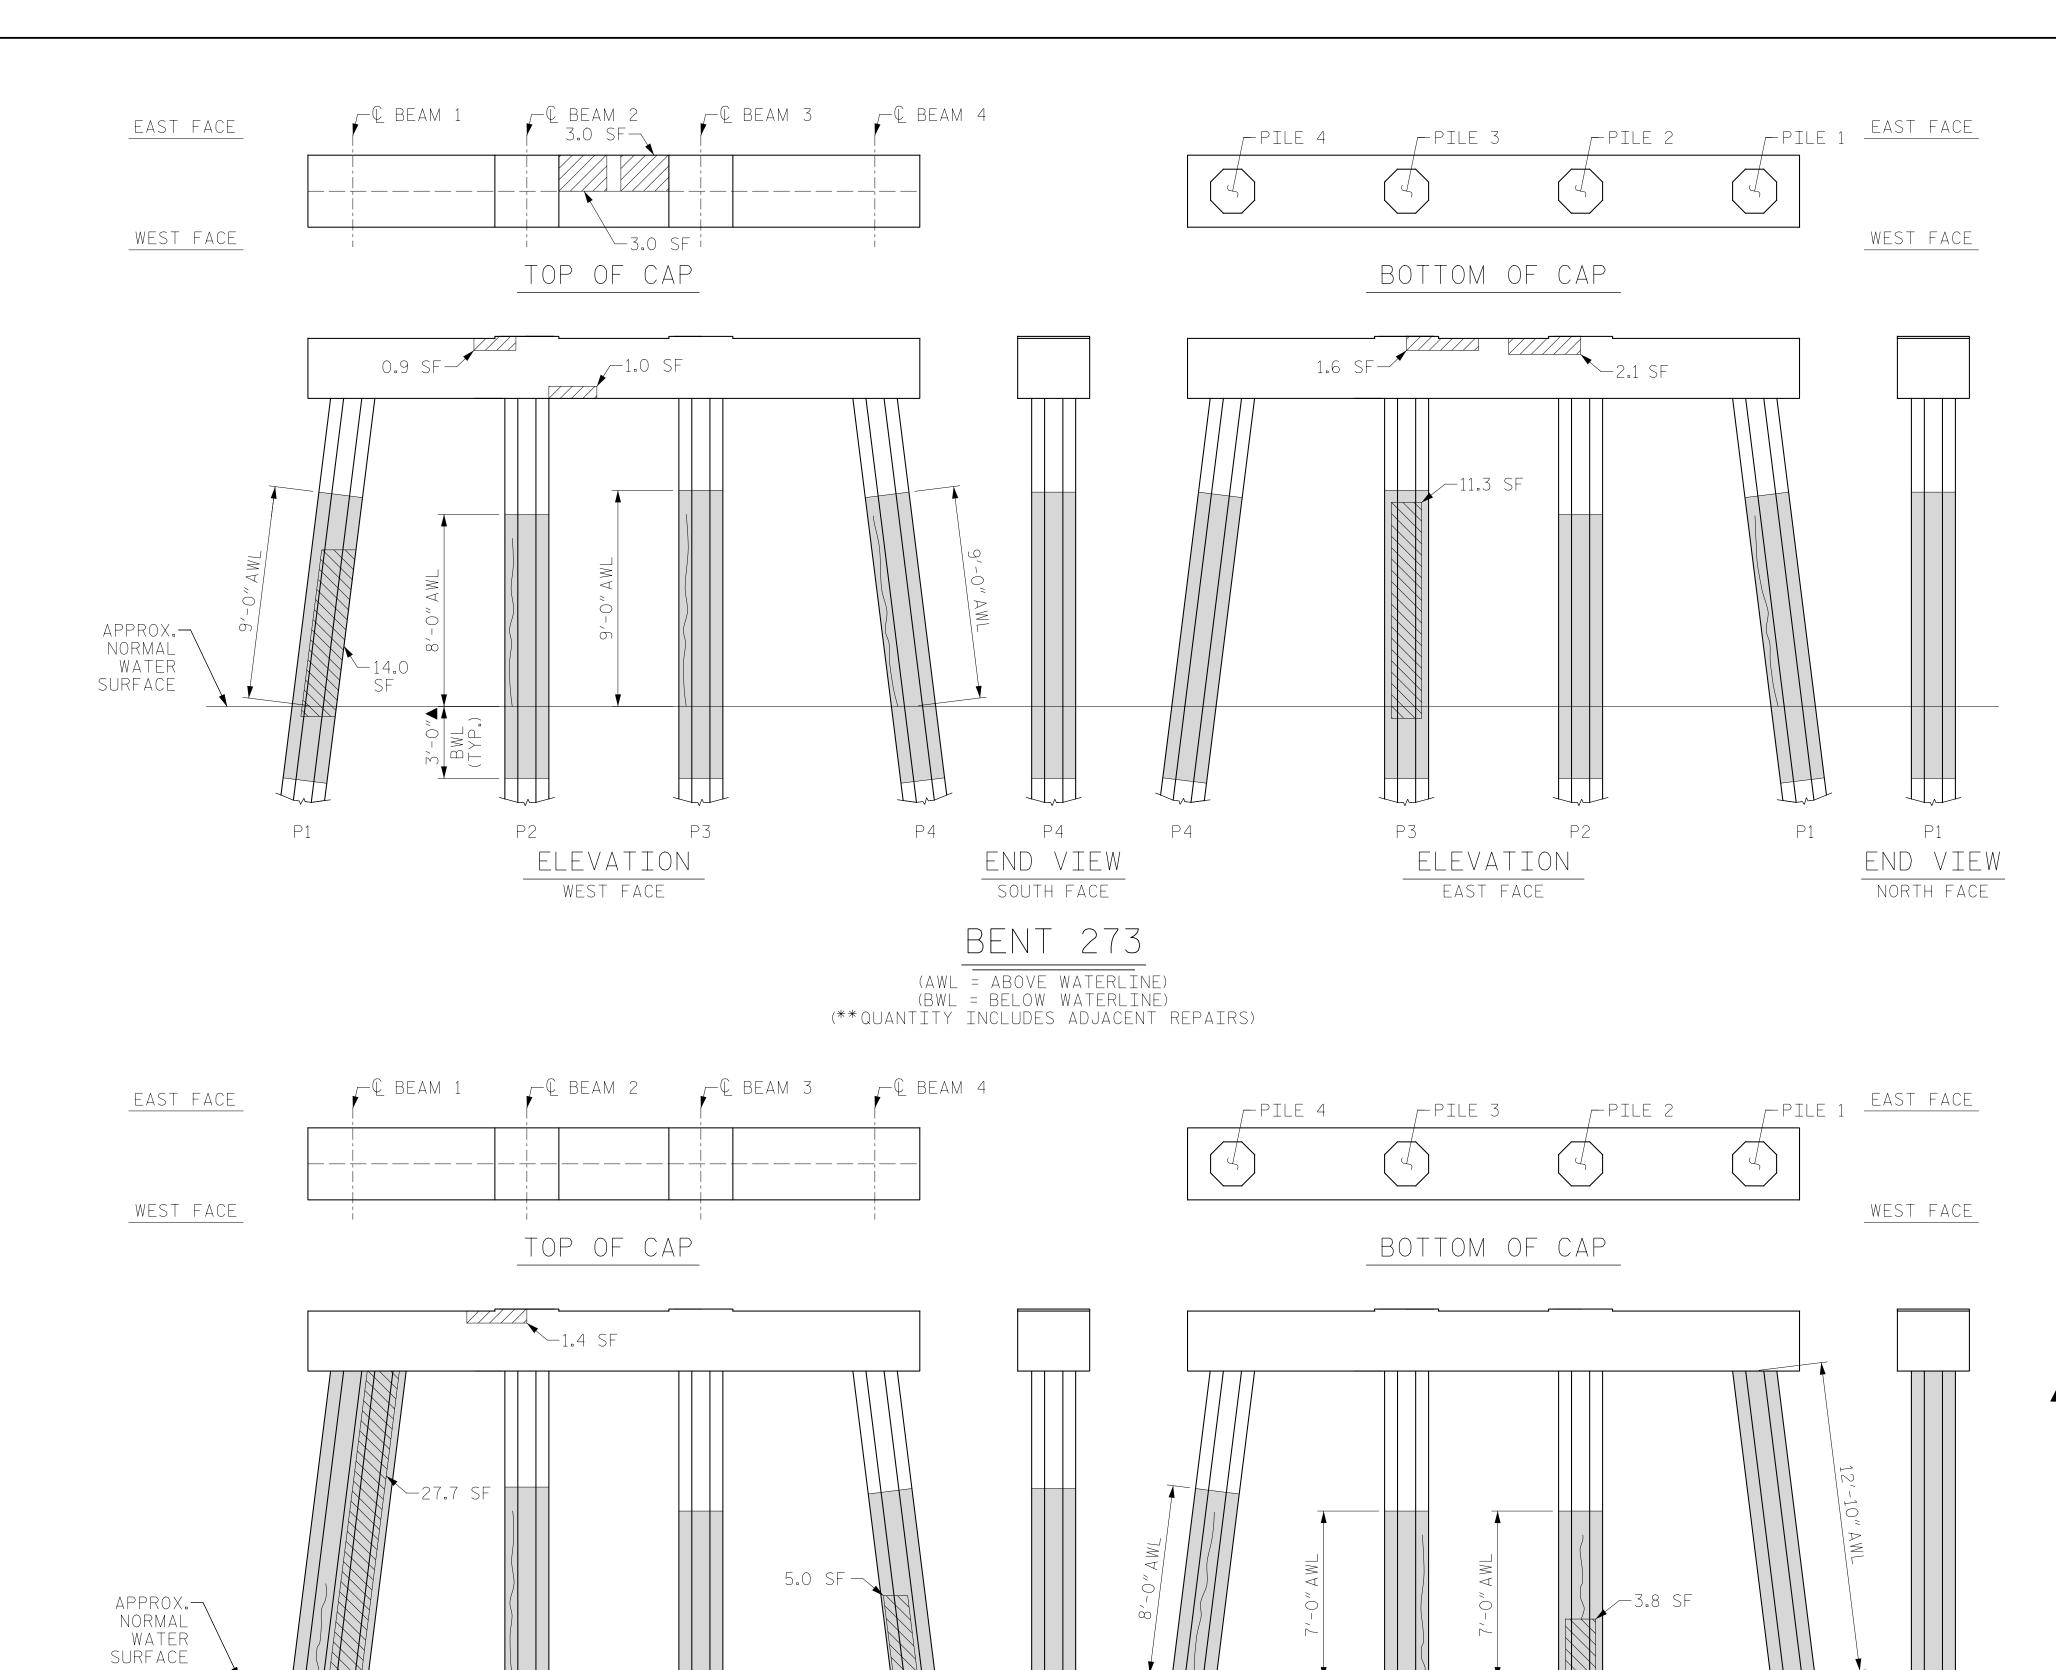
ELEVATION

EAST FACE

END VIEW

SOUTH FACE

UNWRAPPED VIEW (TYP.)

WEST FACE

FOR CAP REPAIRS: VALUES IN CHART REPRESENT ESTIMATED REPAIR TOTALS AFTER REMOVAL OF UNSOUND CONCRETE, MIN. OF 1"BEHIND REBAR AND MIN. 2 CL. TO SAWCUT. SEE REPAIR DETAILS.

FOR CONCRETE REPAIR DETAILS, SEE "TYPICAL CAP, COLUMN & UNDERDECK REPAIR DETAILS" & "PILE CONCRETE RESTORATION DETAILS" SHEETS.

FOR FRP PROTECTIVE SYSTEM DETAILS AND UNDERWATER MORTAR REPAIRS, SEE "PILE FRP PROTECTIVE SYSTEM DETAILS" SHEET.
