PROJECT NO. I-5950

DAVIDSON COUNTY

BRIDGE NO. 280170

DECK_UNDERSIDE REPAIR SPAN_B

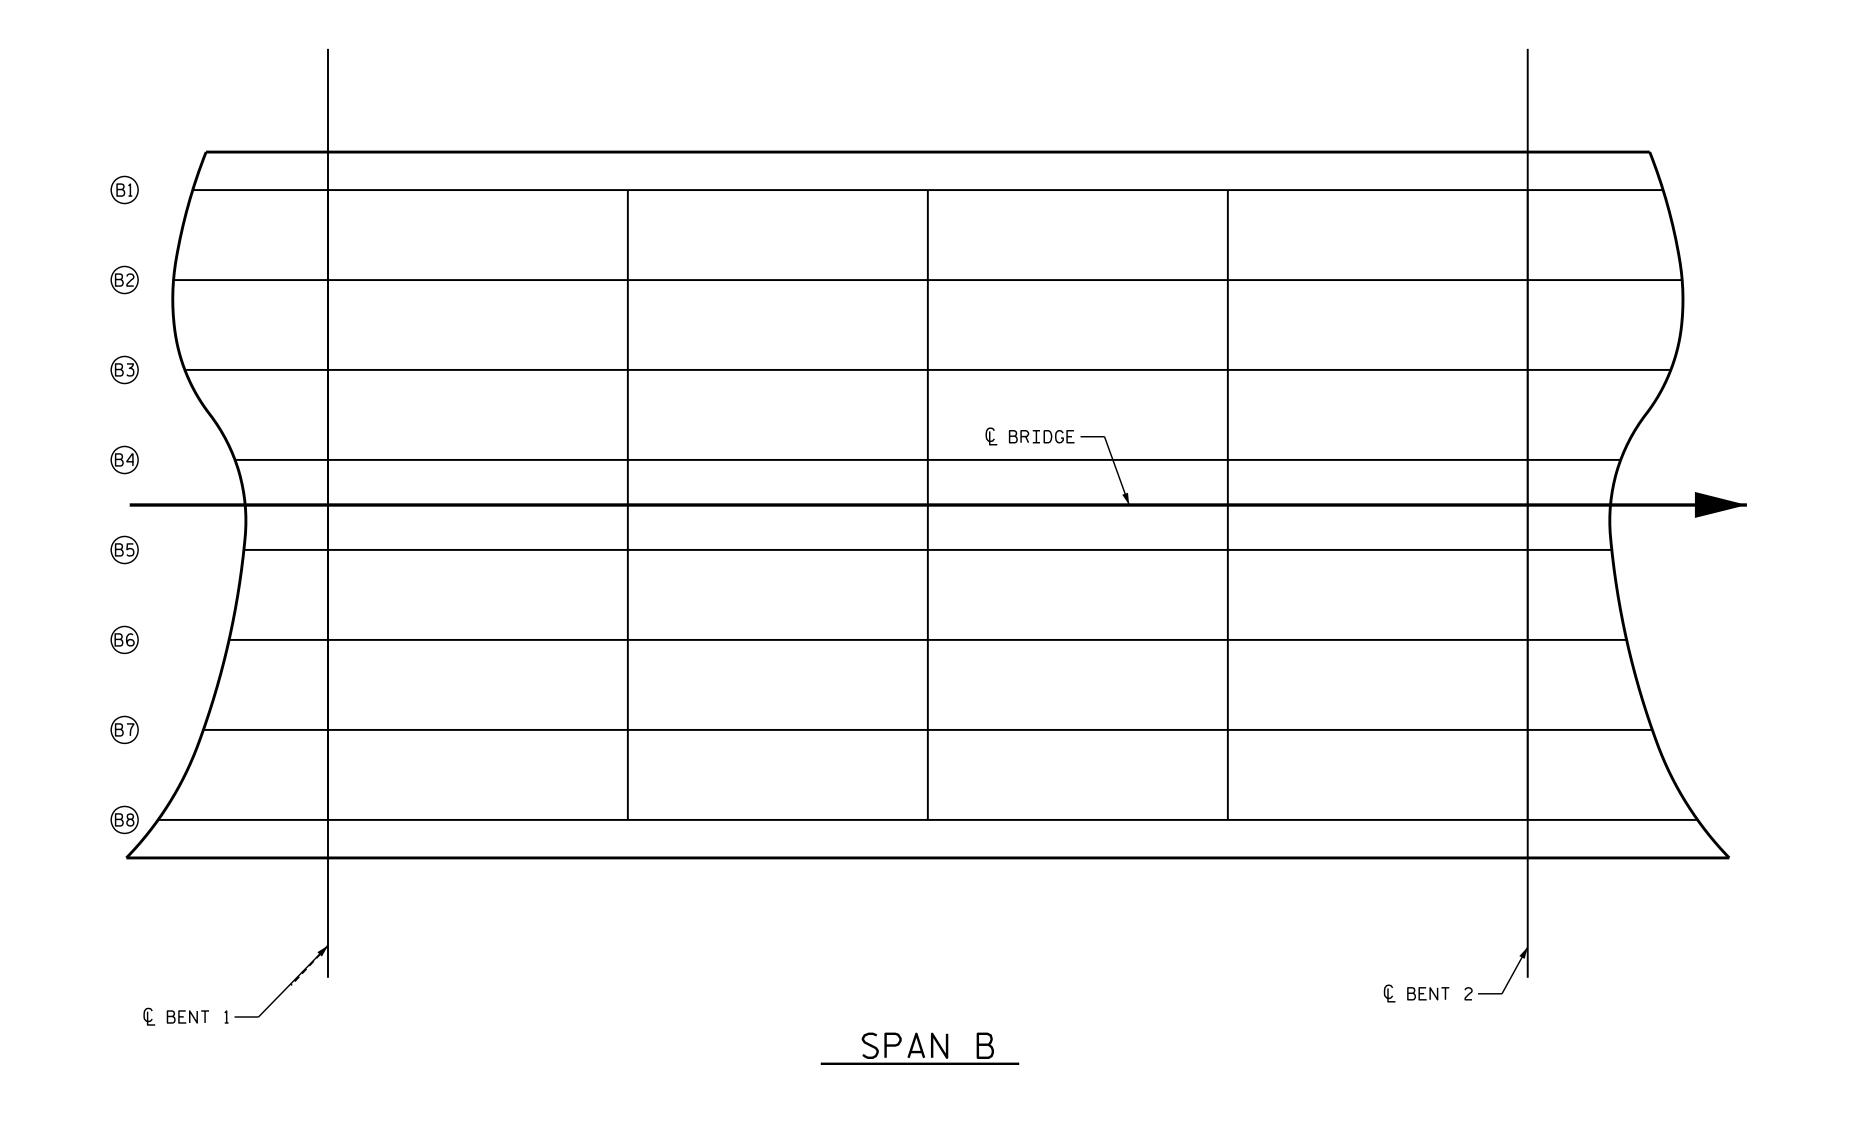
VALUES IN CHART REPRESENT ESTIMATED REPAIR TOTALS AFTER REMOVAL OF UNSOUND CONCRETE, MINIMUM OF 1"BEHIND REBAR AND MINIMUM 2"CLEARANCE TO SAWCUT. SEE "OVERHANG, DIAPHRAGM AND BRIDGE RAIL REPAIR DETAILS" SHEET.

THE CONTRACTOR SHALL SAW CUT TO A NOMINAL DEPTH OF 1/2"BUT REINFORCING STEEL SHALL NOT BE DAMAGED.

CONTRACTOR SHALL REMOVE SURFACE CONCRETE TO VERIFY THAT SAWCUT DEPTH WILL NOT DAMAGE EXISTING REINFORCING STEEL.

FOR UNDERSIDE DECK REPAIR, SEE "OVERHANG, DIAPHRAGM AND BRIDGE RAIL

REPAIR DETAILS" SHEET.
