## SUGGESTED REPAIR INSTALLATION PROCEDURE

PROJECT NO. 15BPR.59 WAKE COUNTY BRIDGE NO. 911039 SHEET 1 OF 2				
The CAROLINA SESSION CONTRACTOR C	STATE OF NORTH CAROLINA DEPARTMENT OF TRANSPORTATION RALEIGH STANDARD EXPANSION JOINT SEAL REPAIR DETAILS				
	REVISIONS SHEET NO.				
DOCUMENT NOT CONSIDERED	NO. BY:	DATE: NO		DATE:	S2-06
FINAL UNLESS ALL SIGNATURES COMPLETED	1	(2) (2)			total sheets 18

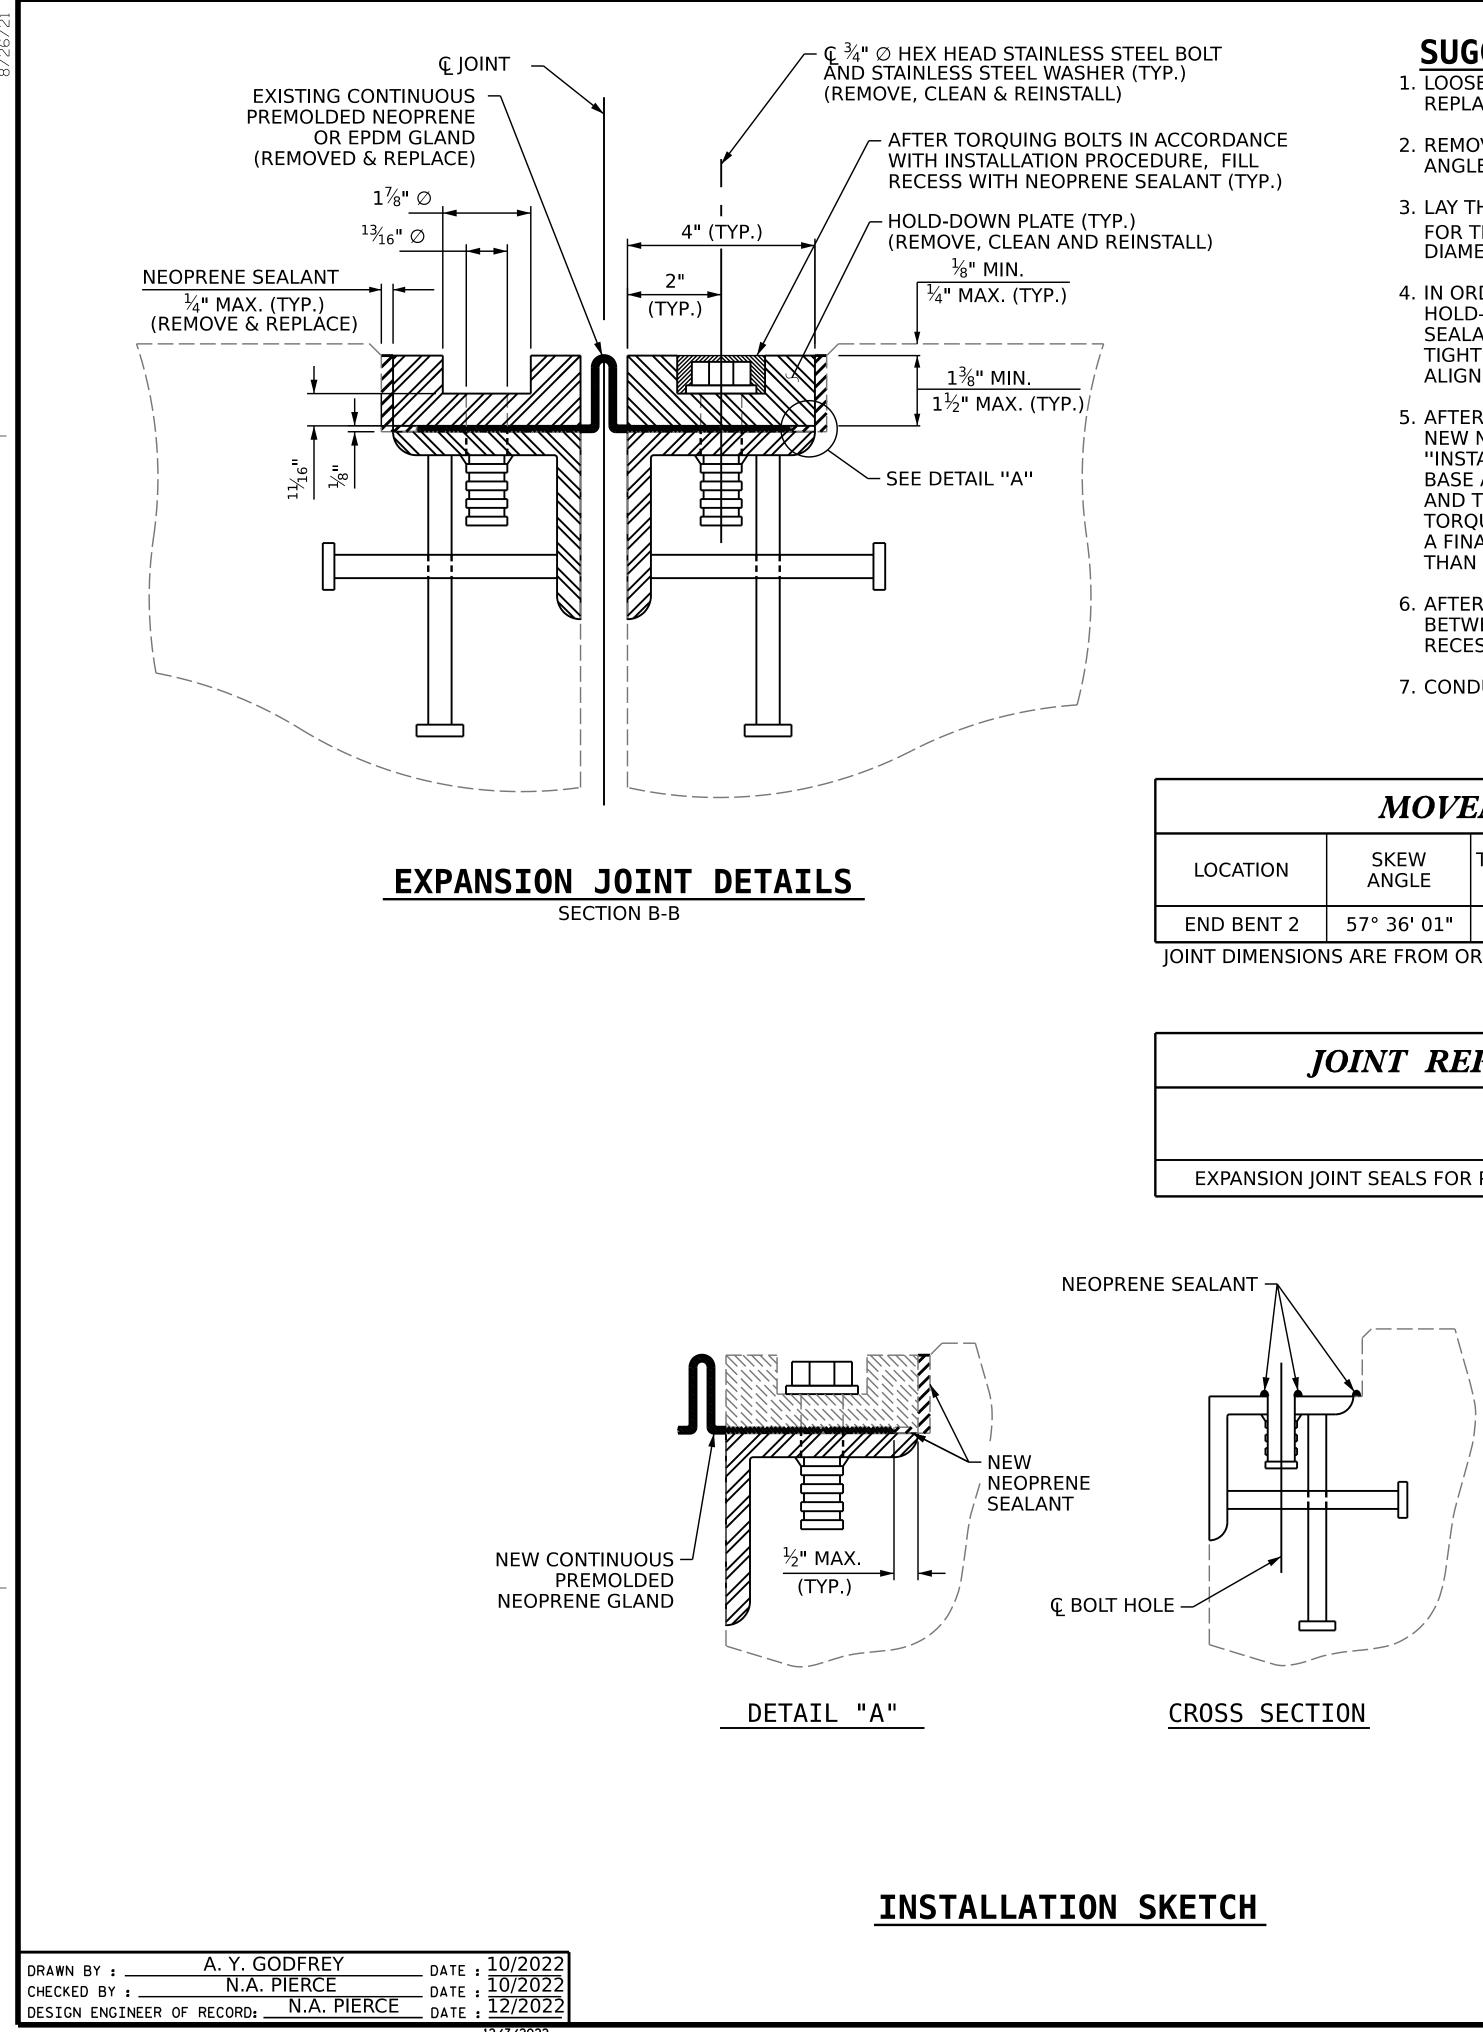
- 1. LOOSEN THE EXISTING BOLTS AND HOLD-DOWN PLATES TO REMOVE AND REPLACE THE EXISTING GLAND.
- 2. REMOVE THE EXISTING NEOPRENE SEALANT AND CLEAN THE EXISTING BASE ANGLE AND BOLT HOLES OF OIL, GREASE AND OTHER LATENTS.

- 3. LAY THE NEW GLAND ON THE BASE ANGLE AND FIELD MARK THE NEW GLAND For the bolt holes. Holes in the New Gland shall be punched  $\frac{7}{8}$ " in DIAMETER WITH A HAND PUNCH.

- 4. IN ORDER TO CHECK FOR PROPER ALIGNMENT, PLACE THE NEW GLAND AND HOLD-DOWN PLATES ON THE BASE ANGLE. DO NOT APPLY NEW NEOPRENE SEALANT. BOLT THE HOLD-DOWN PLATES TO THE BASE ANGLE, BUT DO NOT TIGHTEN. THE ENGINEER WILL INSPECT THE JOINT SEAL DEVICE FOR PROPER ALIGNMENT.

- 5. AFTER INSPECTION, REMOVE THE HOLD-DOWN PLATES AND NEW GLAND. APPLY NEW NEOPRENE SEALANT TO THE BASE ANGLE IN ACCORDANCE WITH THE "INSTALLATION SKETCH". PLACE NEW GLAND AND HOLD-DOWN PLATES ON THE BASE ANGLE. BOLT THE HOLD-DOWN PLATES TO THE BASE ANGLE ASSEMBLY AND TORQUE THE BOLTS TO 88 FT-LBS WITH A TORQUE WRENCH. CHECK THE TORQUE AFTER THREE (3) HOURS AND, IF NECESSARY, RETIGHTEN TO 88 FT-LBS. A FINAL CHECK SHALL BE MADE AT SEVEN (7) DAYS. TORQUE SHALL NOT BE LESS THAN 80 FT-LBS AFTER SEVEN (7) DAYS.

- 6. AFTER PROPER TORQUING, CLEAN THE BOLT HOLE RECESSES AND THE RECESS BETWEEN THE JOINT SEAL DEVICE AND CONCRETE. COMPLETELY FILL THESE RECESSES WITH NEW NEOPRENE SEALANT.
