PROJECT NO. I-5889B  
BUNCOMBE COUNTY  
 BRIDGE NO. 100334, 100339, 100344,  
100347, 100352 & 100356

STATE OF NORTH CAROLINA  
 DEPARTMENT OF TRANSPORTATION  
 RALEIGH

**TYPICAL CAP AND COLUMN REPAIR DETAILS**

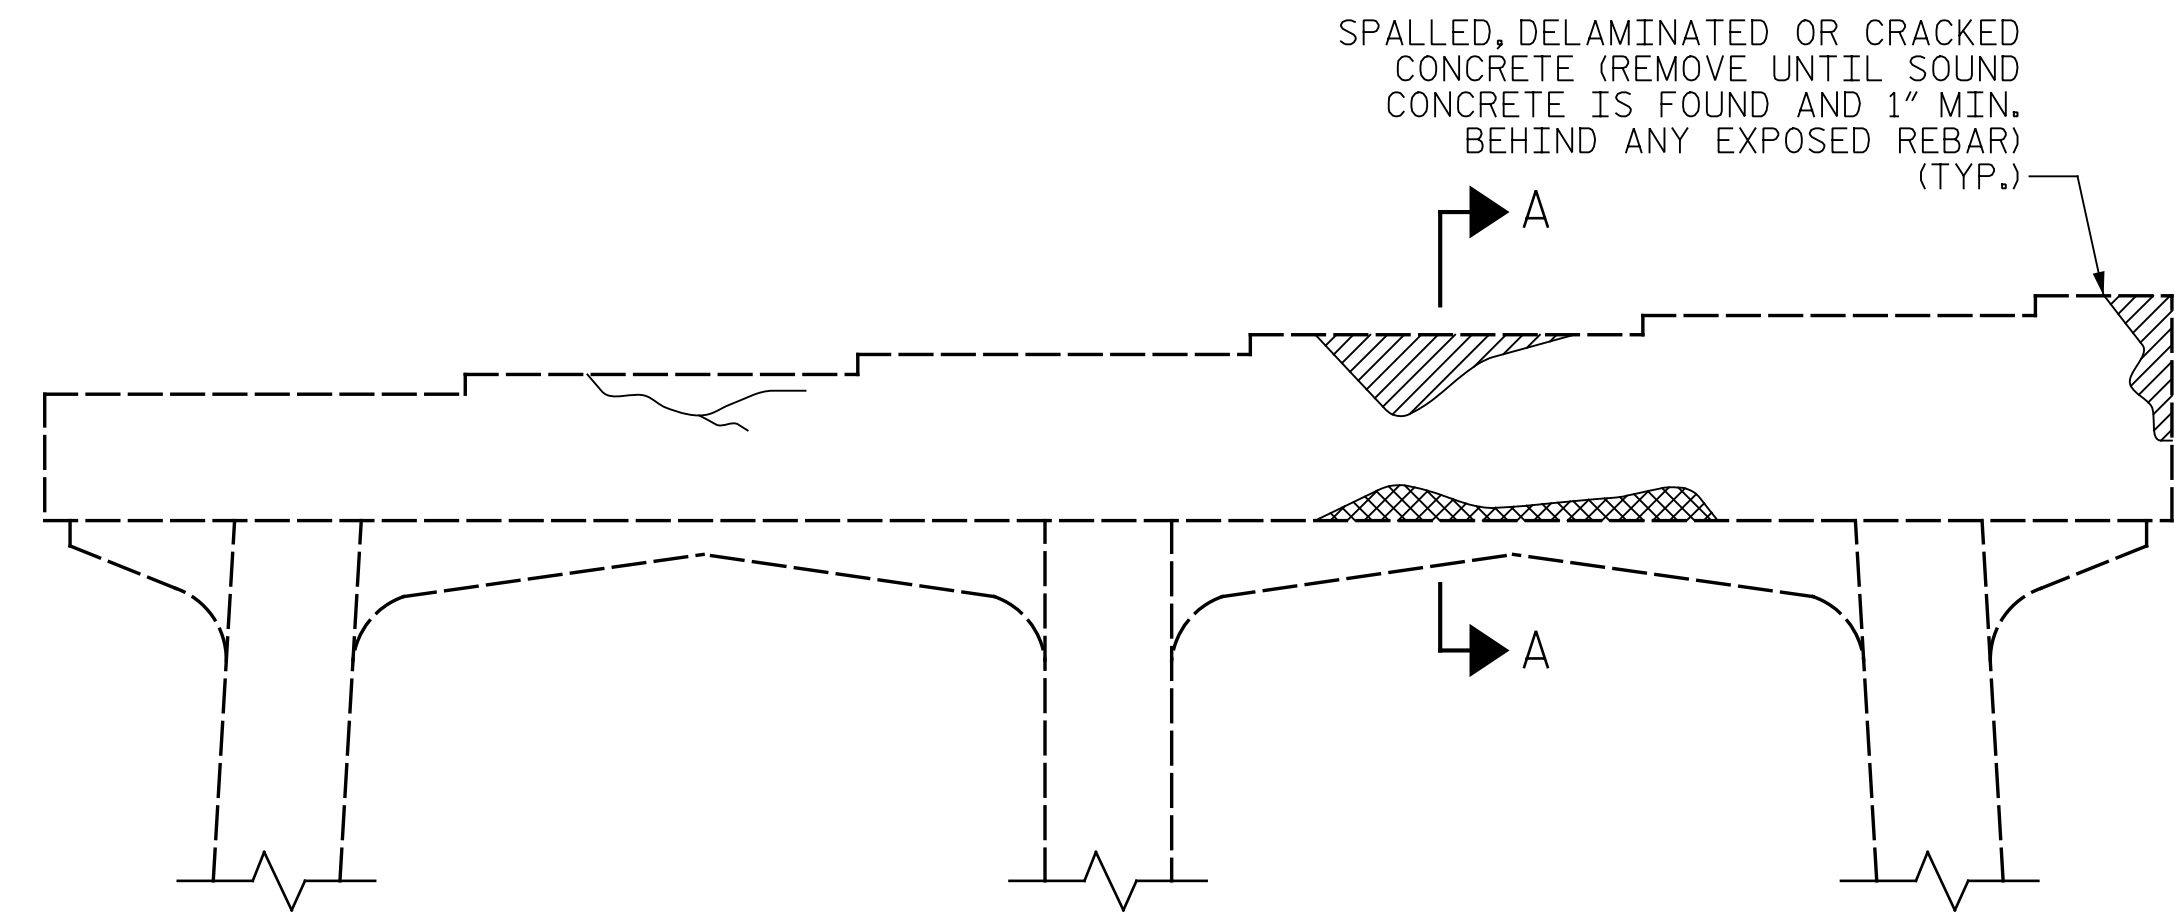
TYPICAL BENT CAP REPAIRS ARE SHOWN. REPAIR DETAILS SIMILAR FOR END BENT CAPS AND STRUTS.

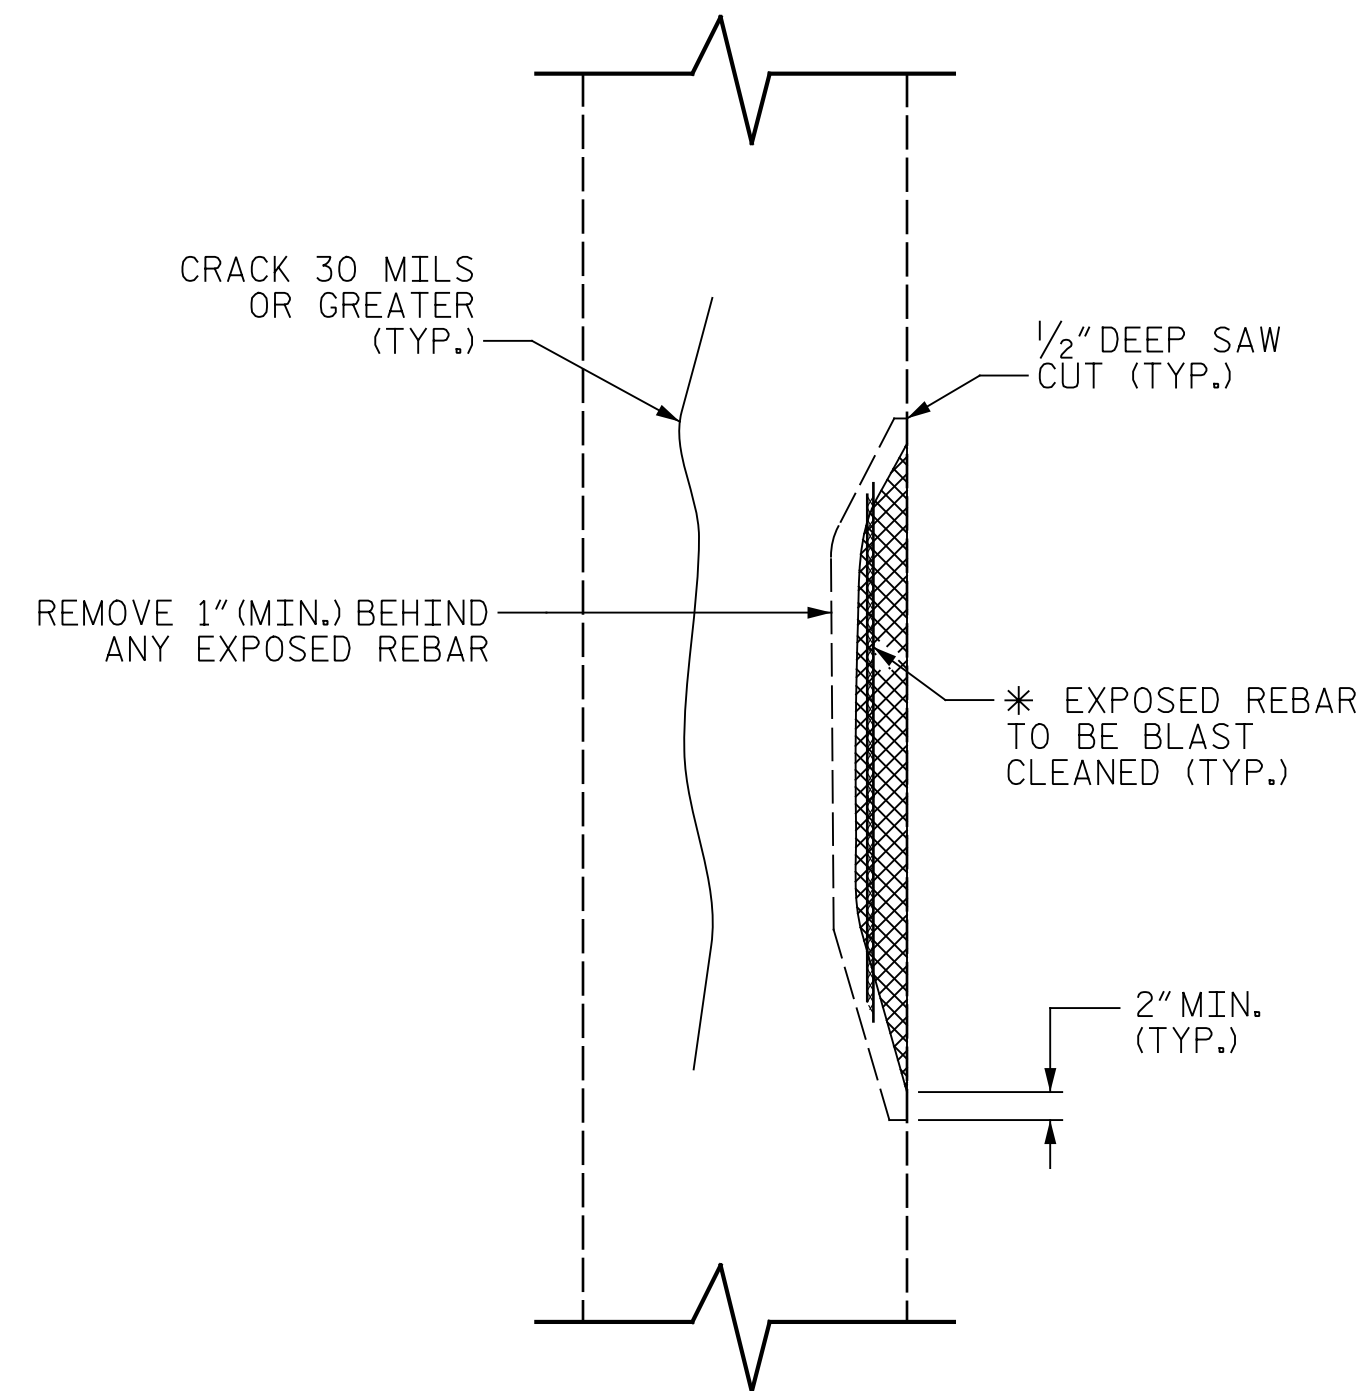
ELEVATION OF COLUMN  
COLUMN REPAIR

\* REPAIR LENGTH SHALL NOT EXCEED 10 FEET.
