**EXPANSION JOINT DETAILS**

I-6039 PROJECT NO. NEW HANOVER \_ COUNTY 640059 BRIDGE NO. SHEET 3 OF 3 STATE OF NORTH CAROLINA DEPARTMENT OF TRANSPORTATION

JOINT DETAILS

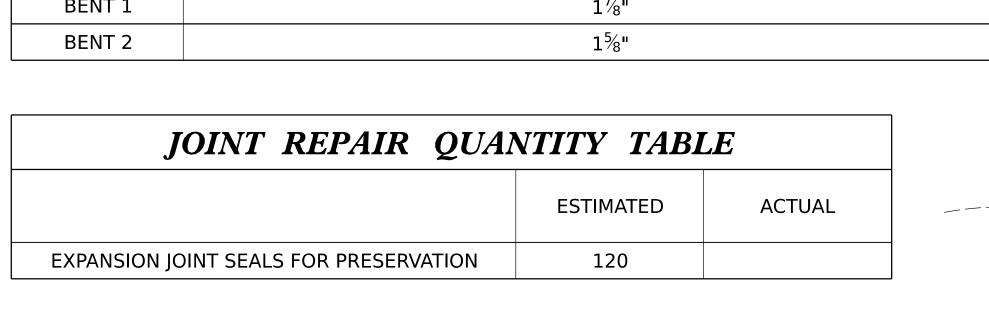
**INSTALLATION SKETCH**

**BOLT HOLE**

PLAN VIEW

- 5. AFTER INSPECTION, REMOVE THE HOLD-DOWN PLATES AND NEW GLAND. APPLY NEW NEOPRENE SEALANT TO THE BASE ANGLE IN ACCORDANCE WITH THE "INSTALLATION SKETCH". PLACE NEW GLAND AND HOLD-DOWN PLATES ON THE BASE ANGLE. BOLT THE HOLD-DOWN PLATES TO THE BASE ANGLE ASSEMBLY AND TORQUE THE SCREWS TO 88 FT-LBS WITH A TORQUE WRENCH. CHECK THE TORQUE AFTER THREE (3) HOURS AND, IF NECESSARY, RETIGHTEN TO 88 FT-LBS A FINAL CHECK SHALL BE MADE AT SEVEN (7) DAYS. TORQUE SHALL NOT BE LESS THAN 80 FT-LBS AFTER SEVEN (7) DAYS.

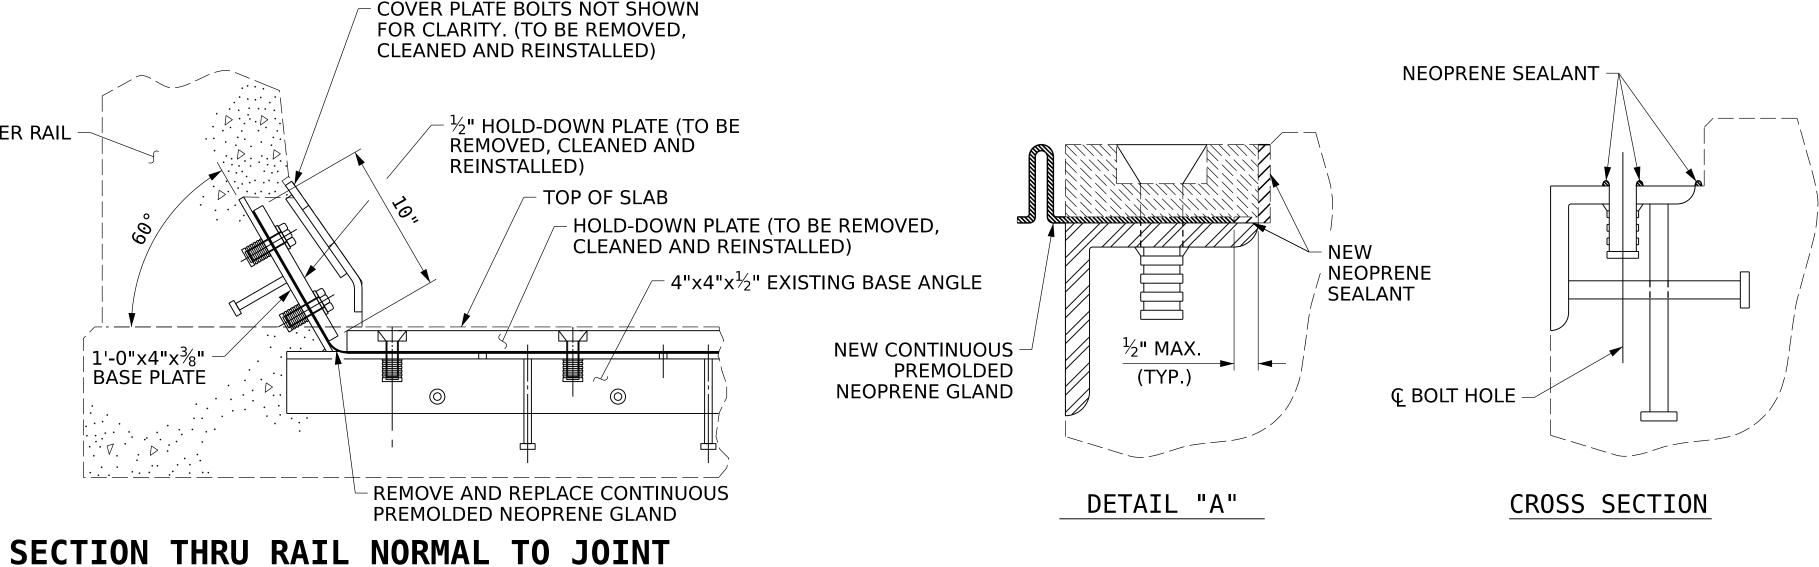
DIM 'A' MOVEMENT AT JOINT	
LOCATION	PERPENDICULAR JOINT OPENING AT 51°F	
BENT 1	1%"	
BENT 2	15/8"	
·

- 1. LOOSEN THE EXISTING SCREWS AND HOLD-DOWN PLATES TO REMOVE AND REPLACE THE EXISTING GLAND.
- 2. REMOVE THE EXISTING NEOPRENE SEALANT AND CLEAN THE EXISTING BASE ANGLE AND BOLT HOLES OF OIL, GREASE AND OTHER LATENTS.

- 3. LAY THE NEW GLAND ON THE BASE ANGLE AND FIELD MARK THE NEW GLAND FOR THE BOLT HOLES. HOLES IN THE NEW GLAND SHALL BE PUNCHED  $\frac{7}{8}$ " IN DIAMETER WITH A HAND PUNCH.

- 4. IN ORDER TO CHECK FOR PROPER ALIGNMENT, PLACE THE NEW GLAND AND HOLD-DOWN PLATES ON THE BASE ANGLE. DO NOT APPLY NEW NEOPRENE SEALANT. BOLT THE HOLD-DOWN PLATES TO THE BASE ANGLE, BUT DO NOT TIGHTEN. THE ENGINEER WILL INSPECT THE JOINT SEAL DEVICE FOR PROPER ALIGNMENT.

- 6. AFTER PROPER TORQUING, CLEAN THE BOLT HOLE RECESSES AND THE RECESS BETWEEN THE JOINT SEAL DEVICE AND CONCRETE. COMPLETELY FILL THESE RECESSES WITH NEW NEOPRENE SEALANT.
