STATE OF NORTH CAROLINA  
DEPARTMENT OF TRANSPORTATION

Subject: **Request for Modification to Nationwide Permit 27 Action Id. 200430806** for the Back Creek Stream Mitigation Site in Mecklenburg County for TIP No. R-967CA, State Project 6.689002T. \$200.00 to Work Order 6.689002T (WBS Element 34355.1.2)

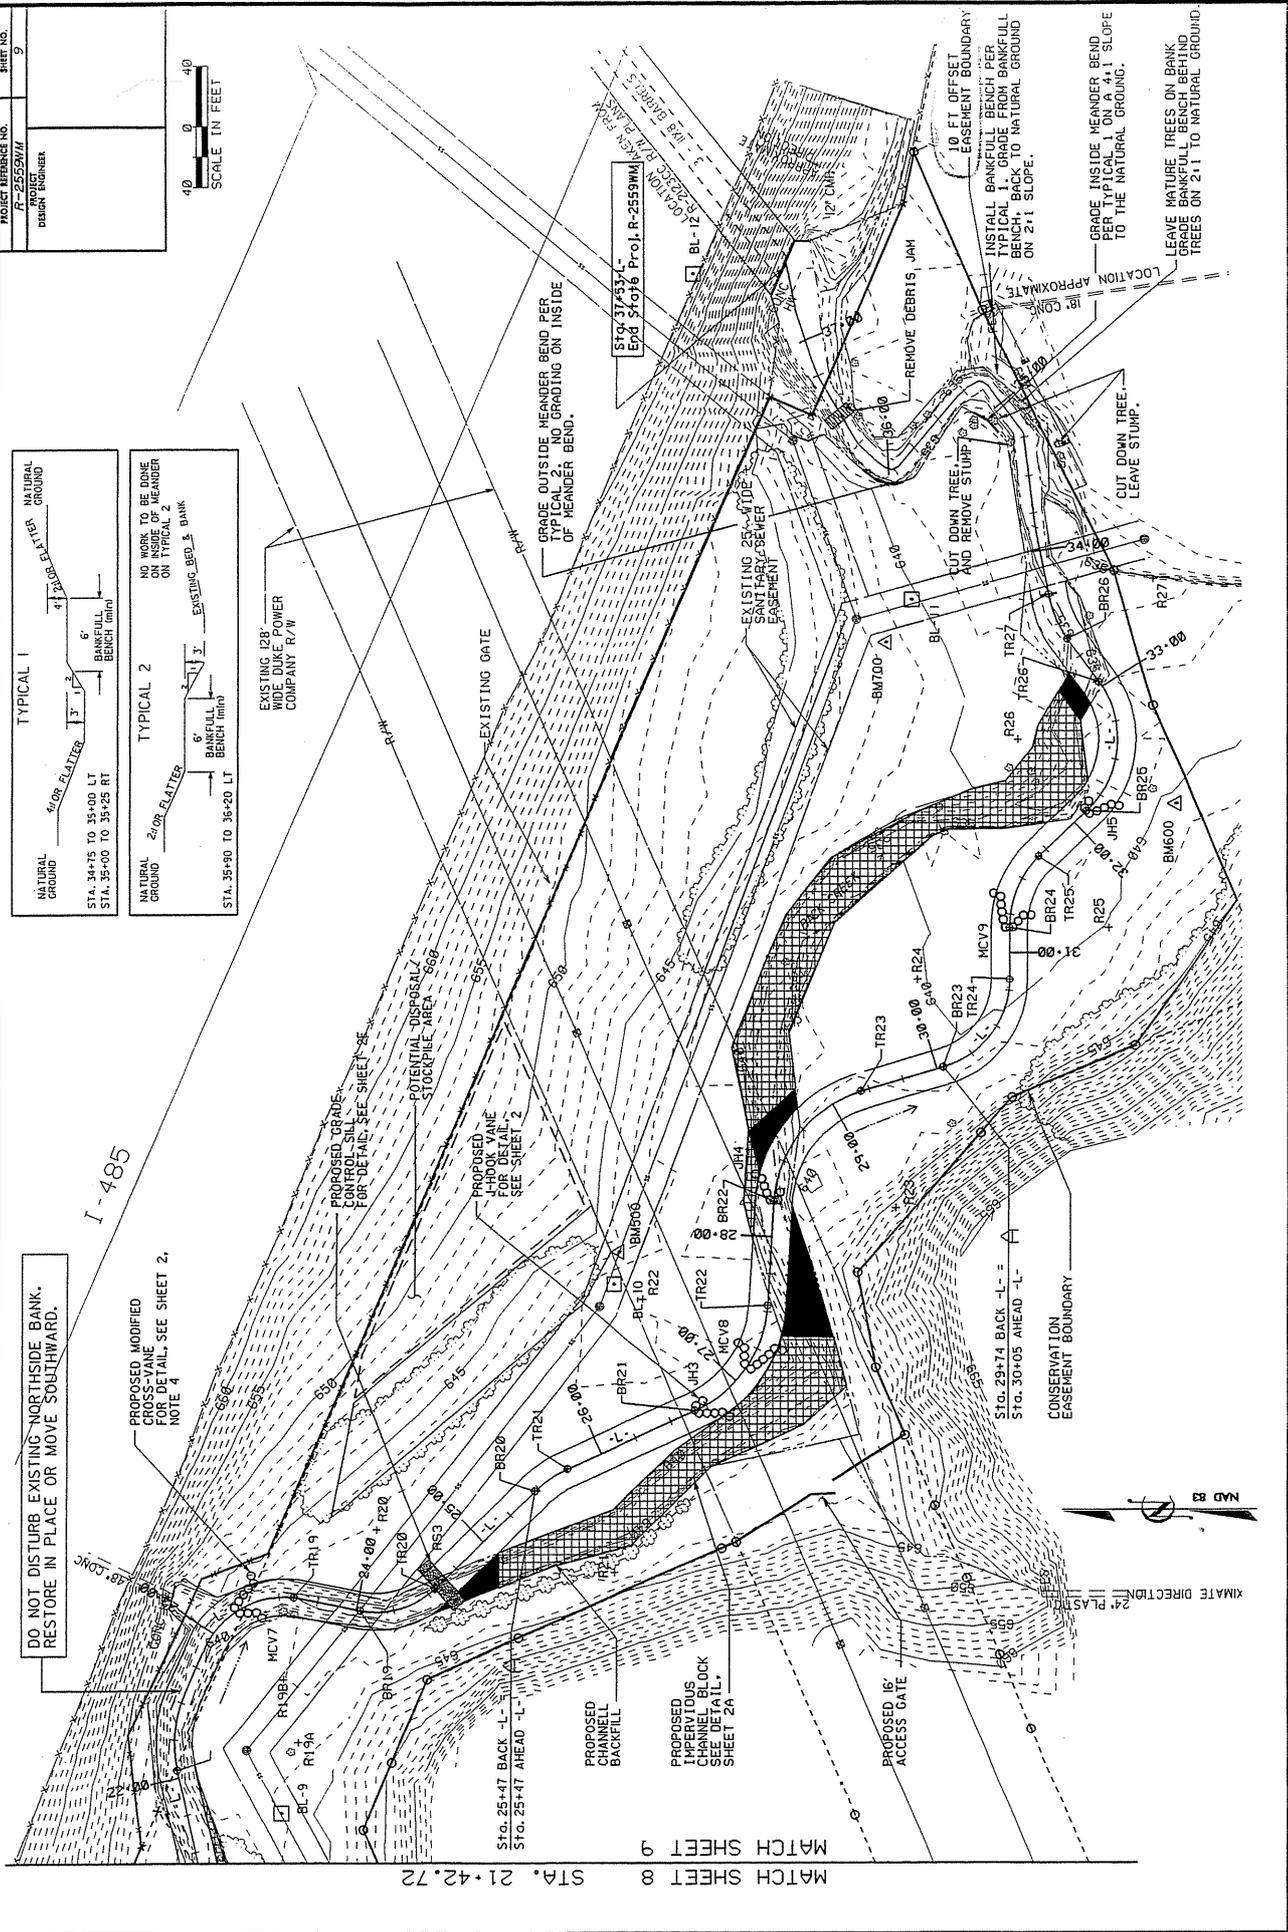
Please find enclosed a plan view of the proposed modifications to the Back Creek stream restoration plan. These modifications are proposed to address stream bank stability along Back Creek downstream of the existing design limits to the culvert crossing under I-485. The proposal consists of grading on approximately 80 linear feet of channel bank. This grading will consist of installing a 6-foot minimum bankfull bench per the typical sections shown on the plan sheet. The bankfull bench will be installed on the outside meander bends. Mature trees located on the outside meander bend from Sta. 34+75 to Sta. 35+00 will not be disturbed. On the inside meander bend at approximately Sta. 35+00, the existing bank will be graded on a 4:1 or flatter slope from existing toe to natural ground. This would tie in with the existing point bar. The grading would require removal of one tree and stump located at Sta. 34+75 Left. Two other trees (Sta. 34+70 Right and 34+90 Left) will be cut, but the stumps will remain. Installing the bankfull bench and grading the inside meander bend from Sta. 34+75 to 35+25 will help reduce the stress that is currently on the outside bank.

The section located between Sta. 35+90 to 36+20 would only consist of installing a bankfull bench on the outside bend. The inside bend is stable and requires no work. Installing the bankfull bench on the outside will help reduce the stress on this bank. The Department would also remove a debris jam that is located at Sta. 36+50 that is contributing to some of the instability noted upstream.
