CROSS SECTION DIAGRAM AT BENT-2 CONCRETE SPAN

Bridge No. 13 on I-77 SBL Over Yadkin River, Yadkin Valley RR, and NC 268

Yadkin/ Surry County, North Carolina

| Project No. 34209.1.1 | TIP No. I-4025A |

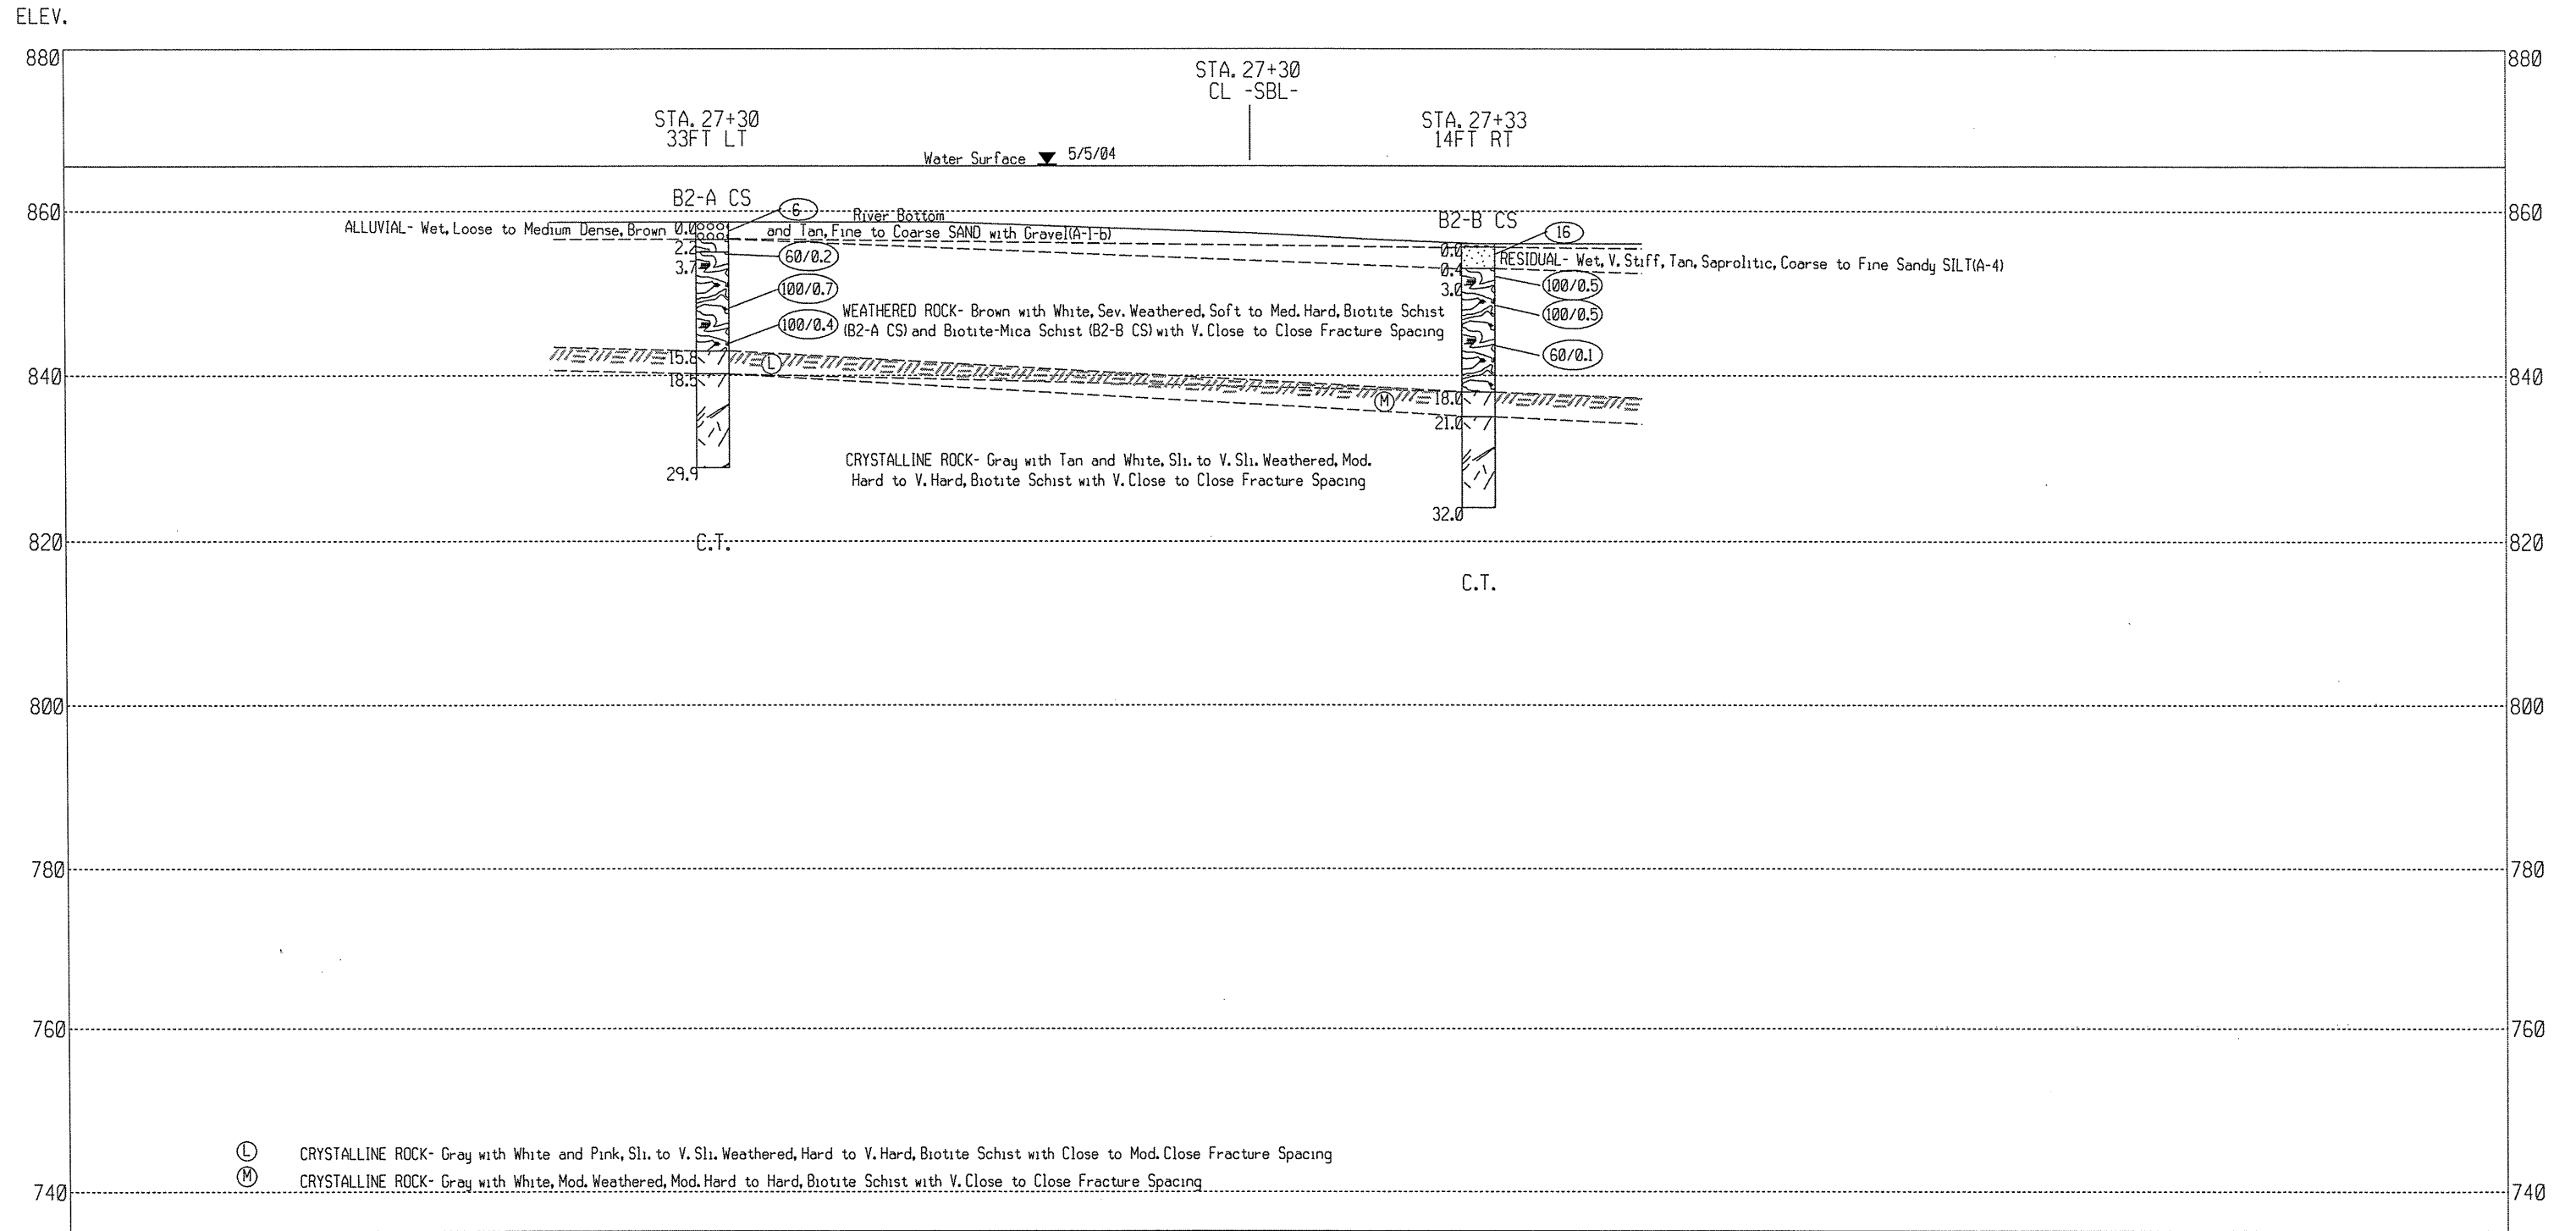
| Drawn by DRK | Drawing No. 7 |

- (L) CRYSTALLINE ROCK- Gray with White and Pink, Sl. to V. Sl. Weathered, Hard to V. Hard, Biotite Schist with Close to Mod. Close Fracture Spacing
- (M) CRYSTALLINE ROCK- Gray with White, Mod. Weathered, Mod. Hard to Hard, Biotite Schist with V. Close to Close Fracture Spacing
