# SOIL PROFILE ALONG SR 1001 (-L-) OVER DOG BRANCH

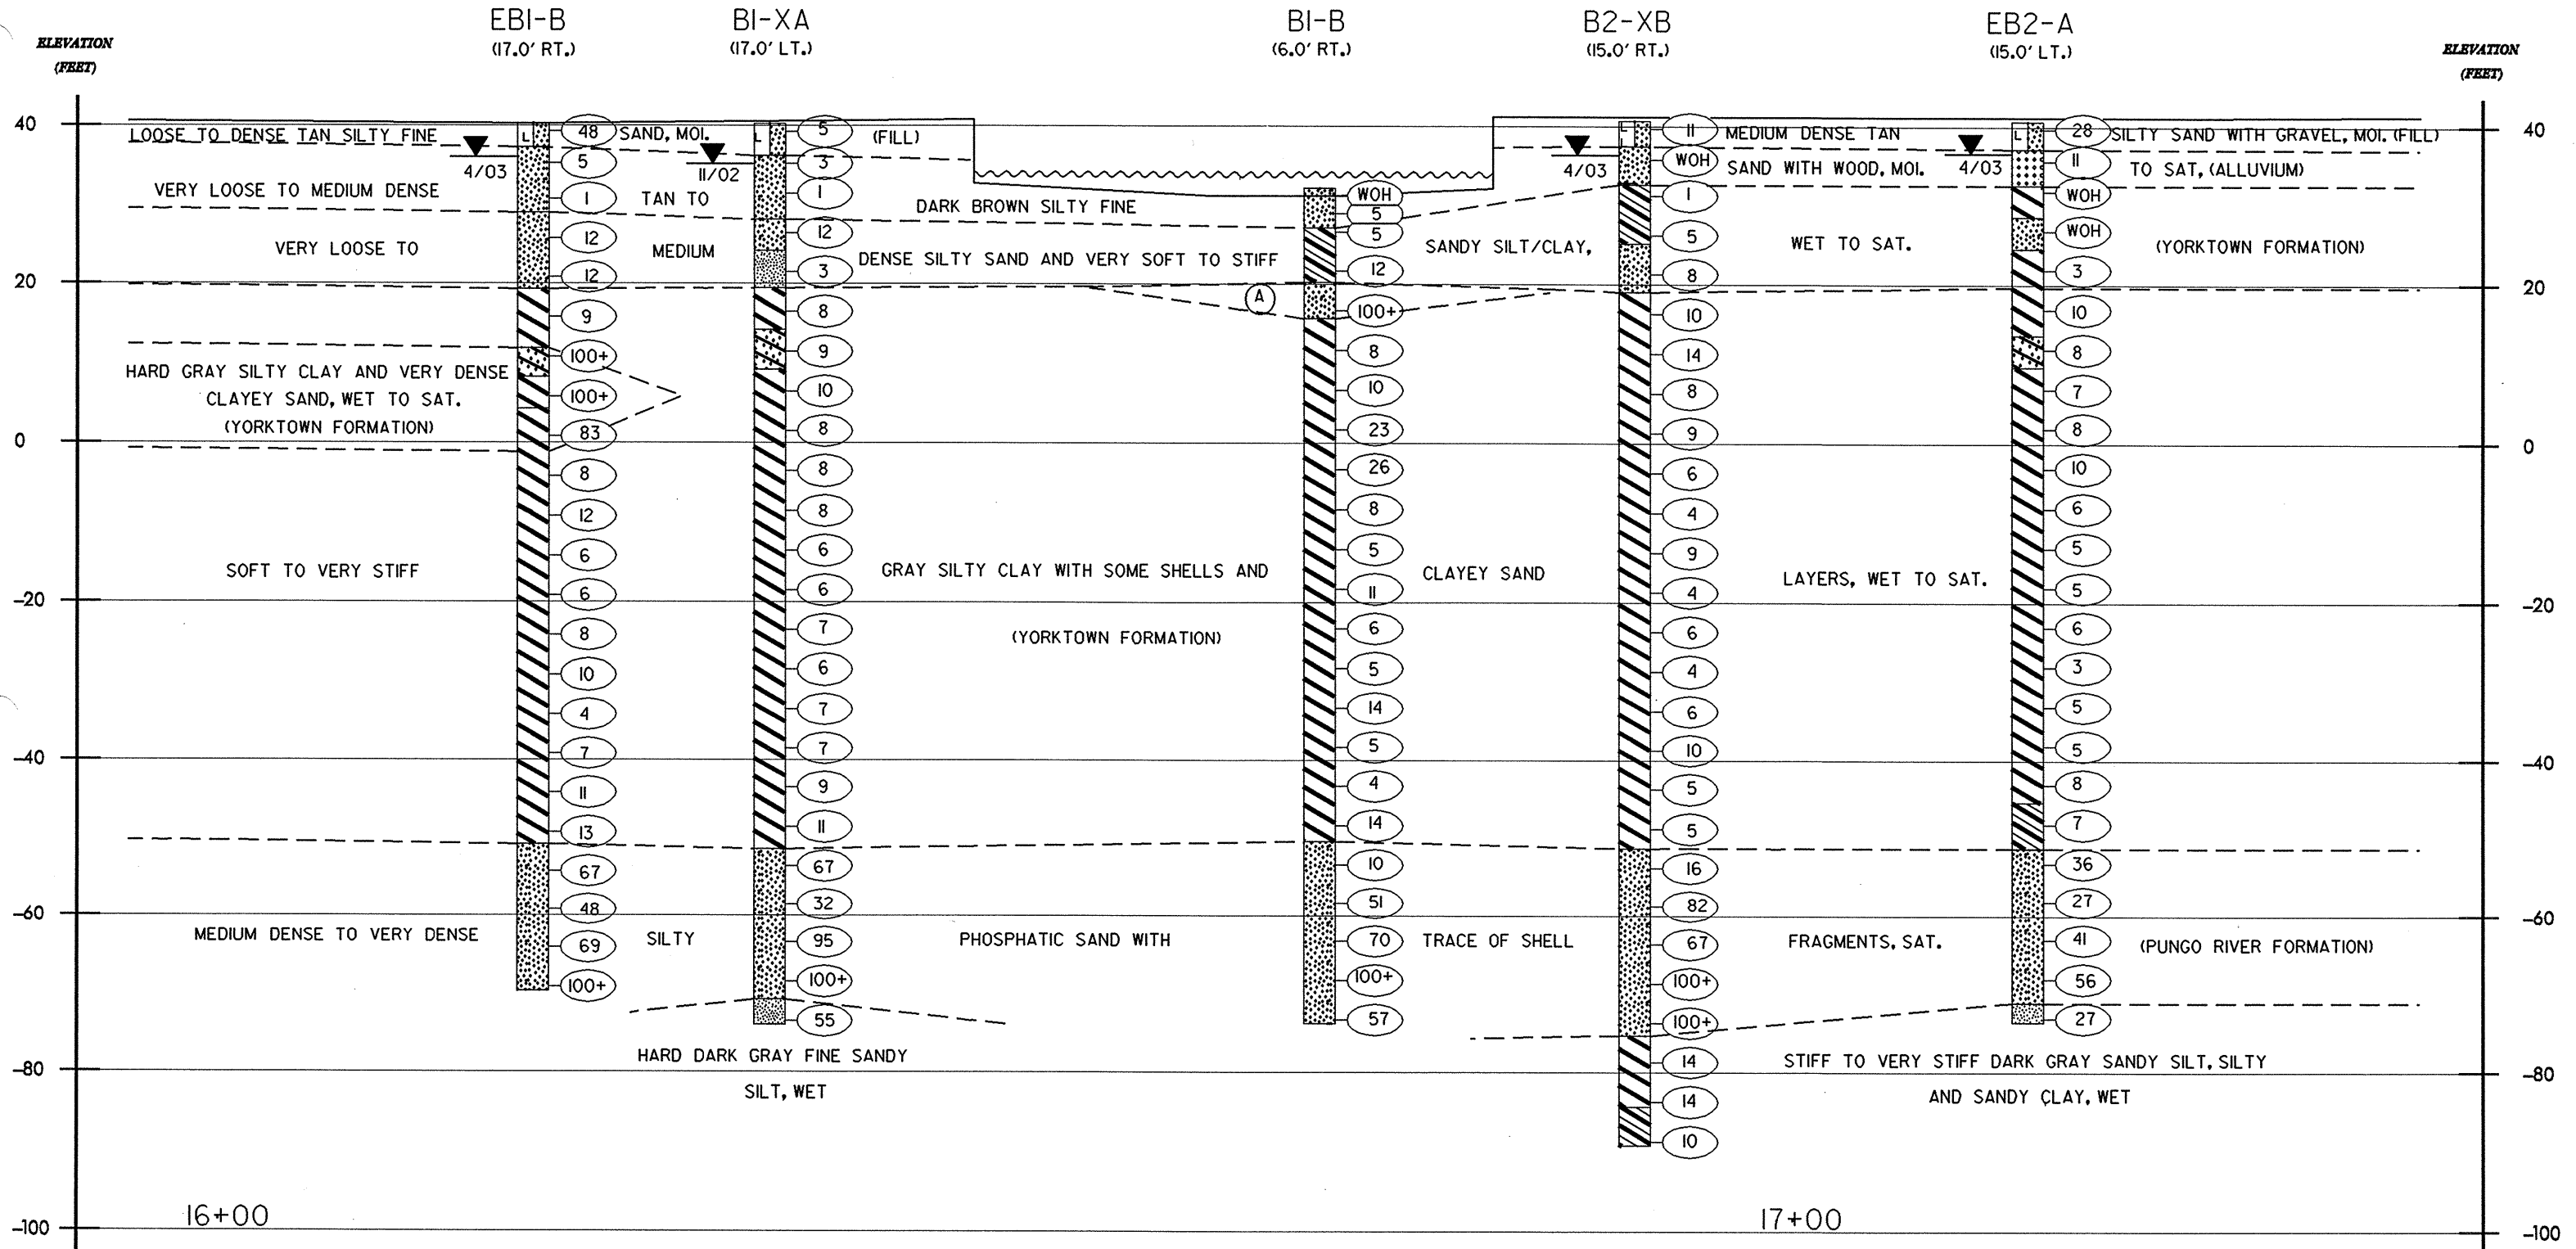
(A) VERY DENSE GRAY SILTY SAND WITH SHELL FRAGMENTS, SAT. (YORKTOWN FORMATION)
