STATE	STATE PROJECT REFERENCE NO.	SHEET NO.	TOTAL SHEETS
N.C.	33351.1.1 (B-3917)	1	23
STATE PROJ. NO.	F.A. PROJ. NO.	DESCRIPTION	
33351.1.1	BRZ-1379(1)	P.E.	
		CONST.

## STRUCTURE SUBSURFACE INVESTIGATION

STATE PROJECT 33351.1.1 I.D. NO. B-3917  
 F.A. PROJECT BRZ-1379(1)  
 COUNTY WAKE  
 PROJECT DESCRIPTION BRIDGE NO. 311  
ON -L- (SR 1379, PENNY RD.) OVER  
LAKE WHEELER (SWIFT CREEK)  
AT STA. 16+96.5

STATE PROJECT: 33351.1.1 (B-3917)  
F.A. PROJECT: BRZ-1379(1)  
COUNTY: Wake  
DESCRIPTION: Bridge No. 311 on -L- (SR 1379, Penny Rd.) over Lake Wheeler (Swift Creek) at Station 16+96.5  
SUBJECT: Geotechnical Report – Inventory

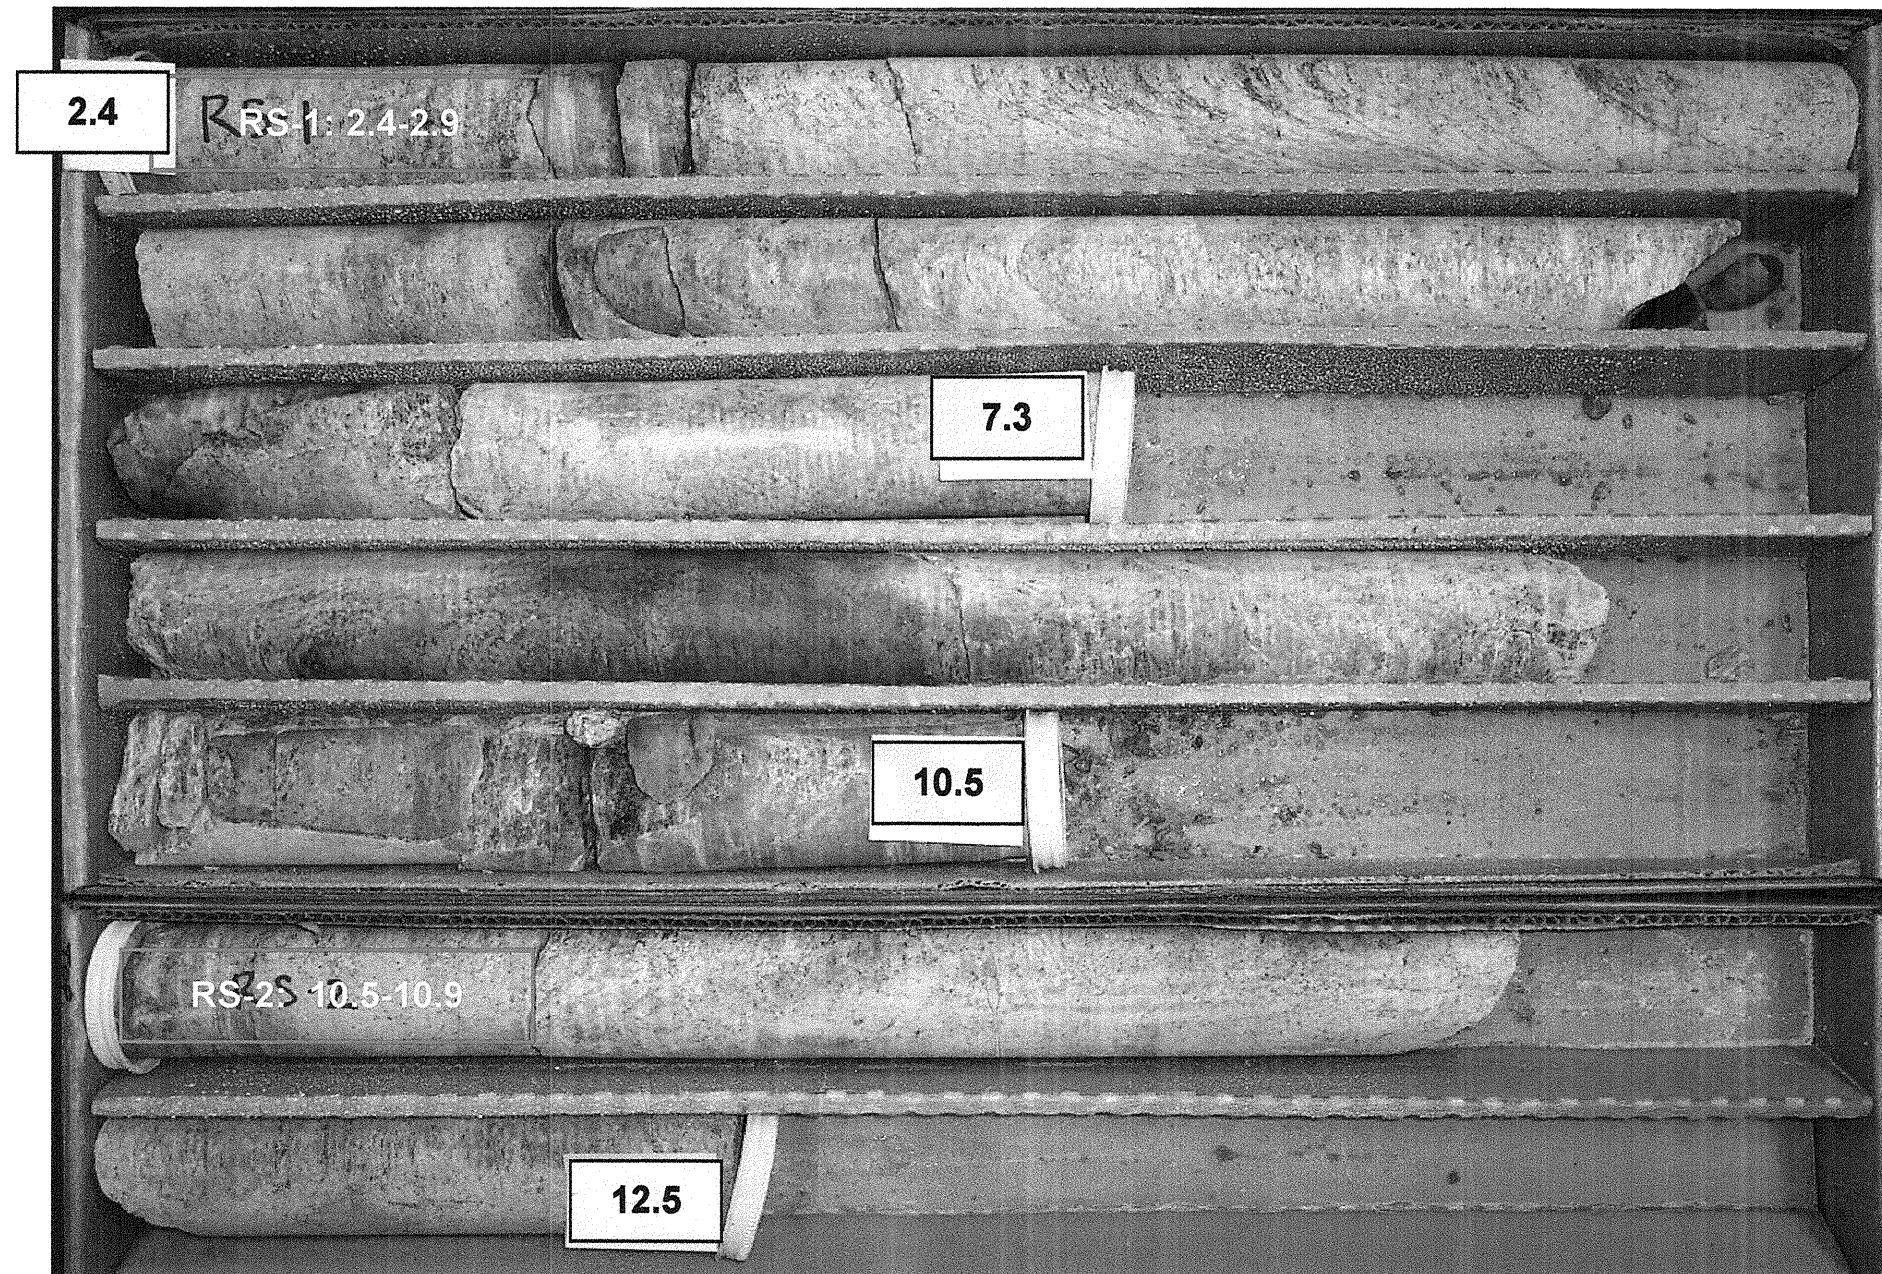
## EB1-A

0.5'	0.5'	0.5'	0	25	50	75			
288.5	2.4	60								RS-1	WEATHERED ROCK (GNEISS)
285.0										RS-2	CRYSTALLINE ROCK, GRAY, HARD TO VERY HARD, FRESH TO SLIGHTLY WEATHERED, CLOSELY TO MODERATELY CLOSELY FRACTURED, GNEISS REC=97% ROD=86%
CORING TERMINATED AT ELEVATION 276.0 FEET IN CRYSTALLINE ROCK (GNEISS)

BOXES 1 & 2: 2.4-12.5 FEET

Crystalline rock was encountered at each boring location. EB1-A was cored to confirm the presence of shallow rock in the area. Core Recovery (REC) ranged from 85% to 97%, with an average of 92%. Rock Quality Designation (RQD) ranges from 72% to 95%, with an average of 82%. Testing indicates the gneiss has a unit weight ranging from 156.9 lbf/ft<sup>3</sup> to 164.9 lbf/ft<sup>3</sup>. Compressive strength ranges from 4.28 ksi to 38.1 ksi. More detailed rock descriptions can be found in the Core Boring Report.

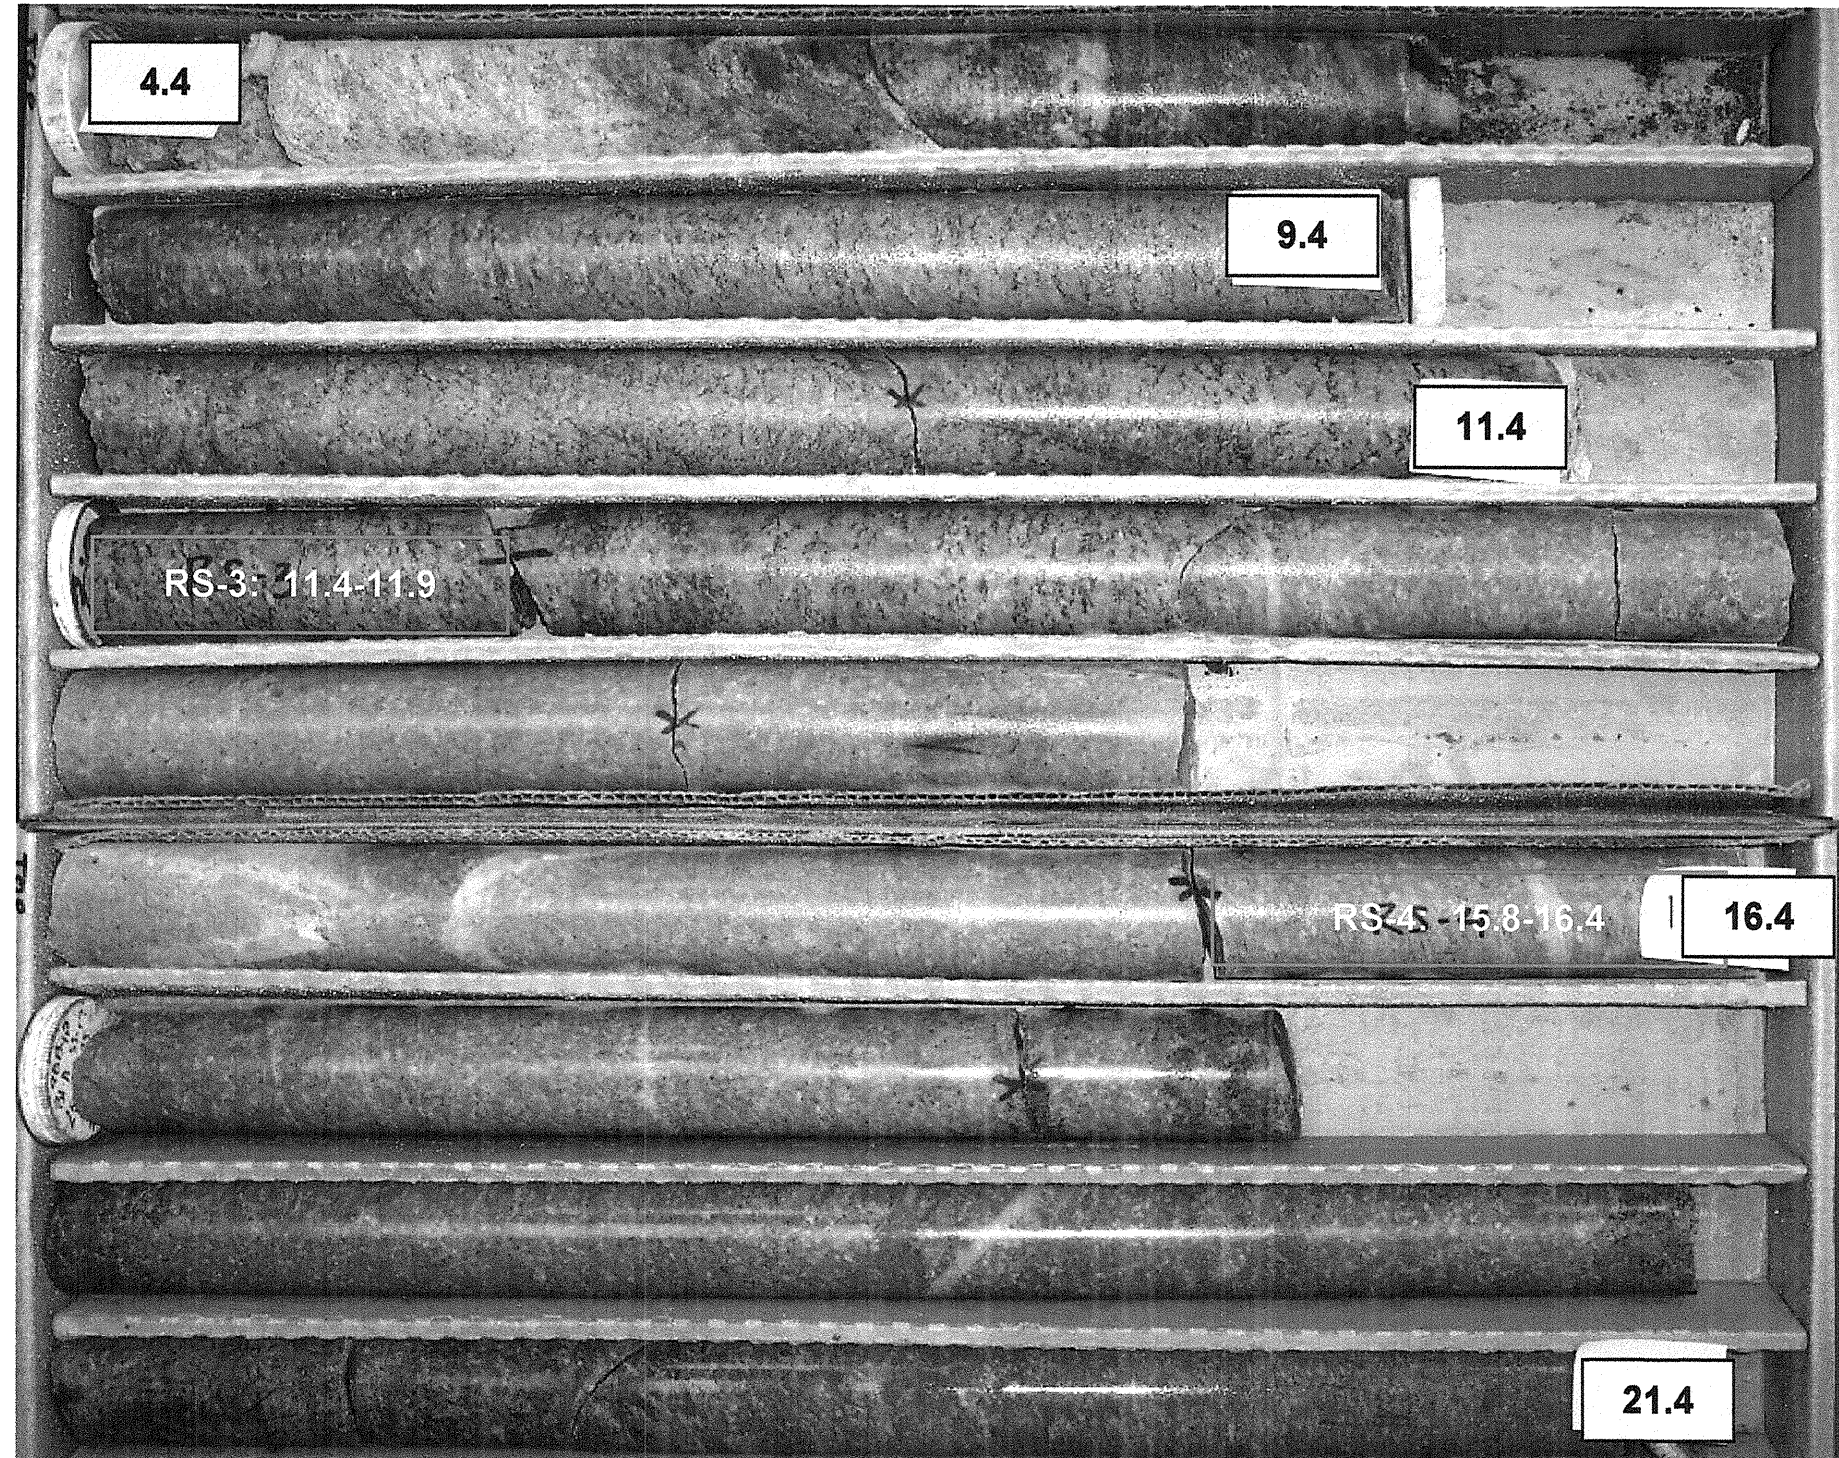
## B1-A

BOXES 1 & 2: 4.4-21.4 FEET

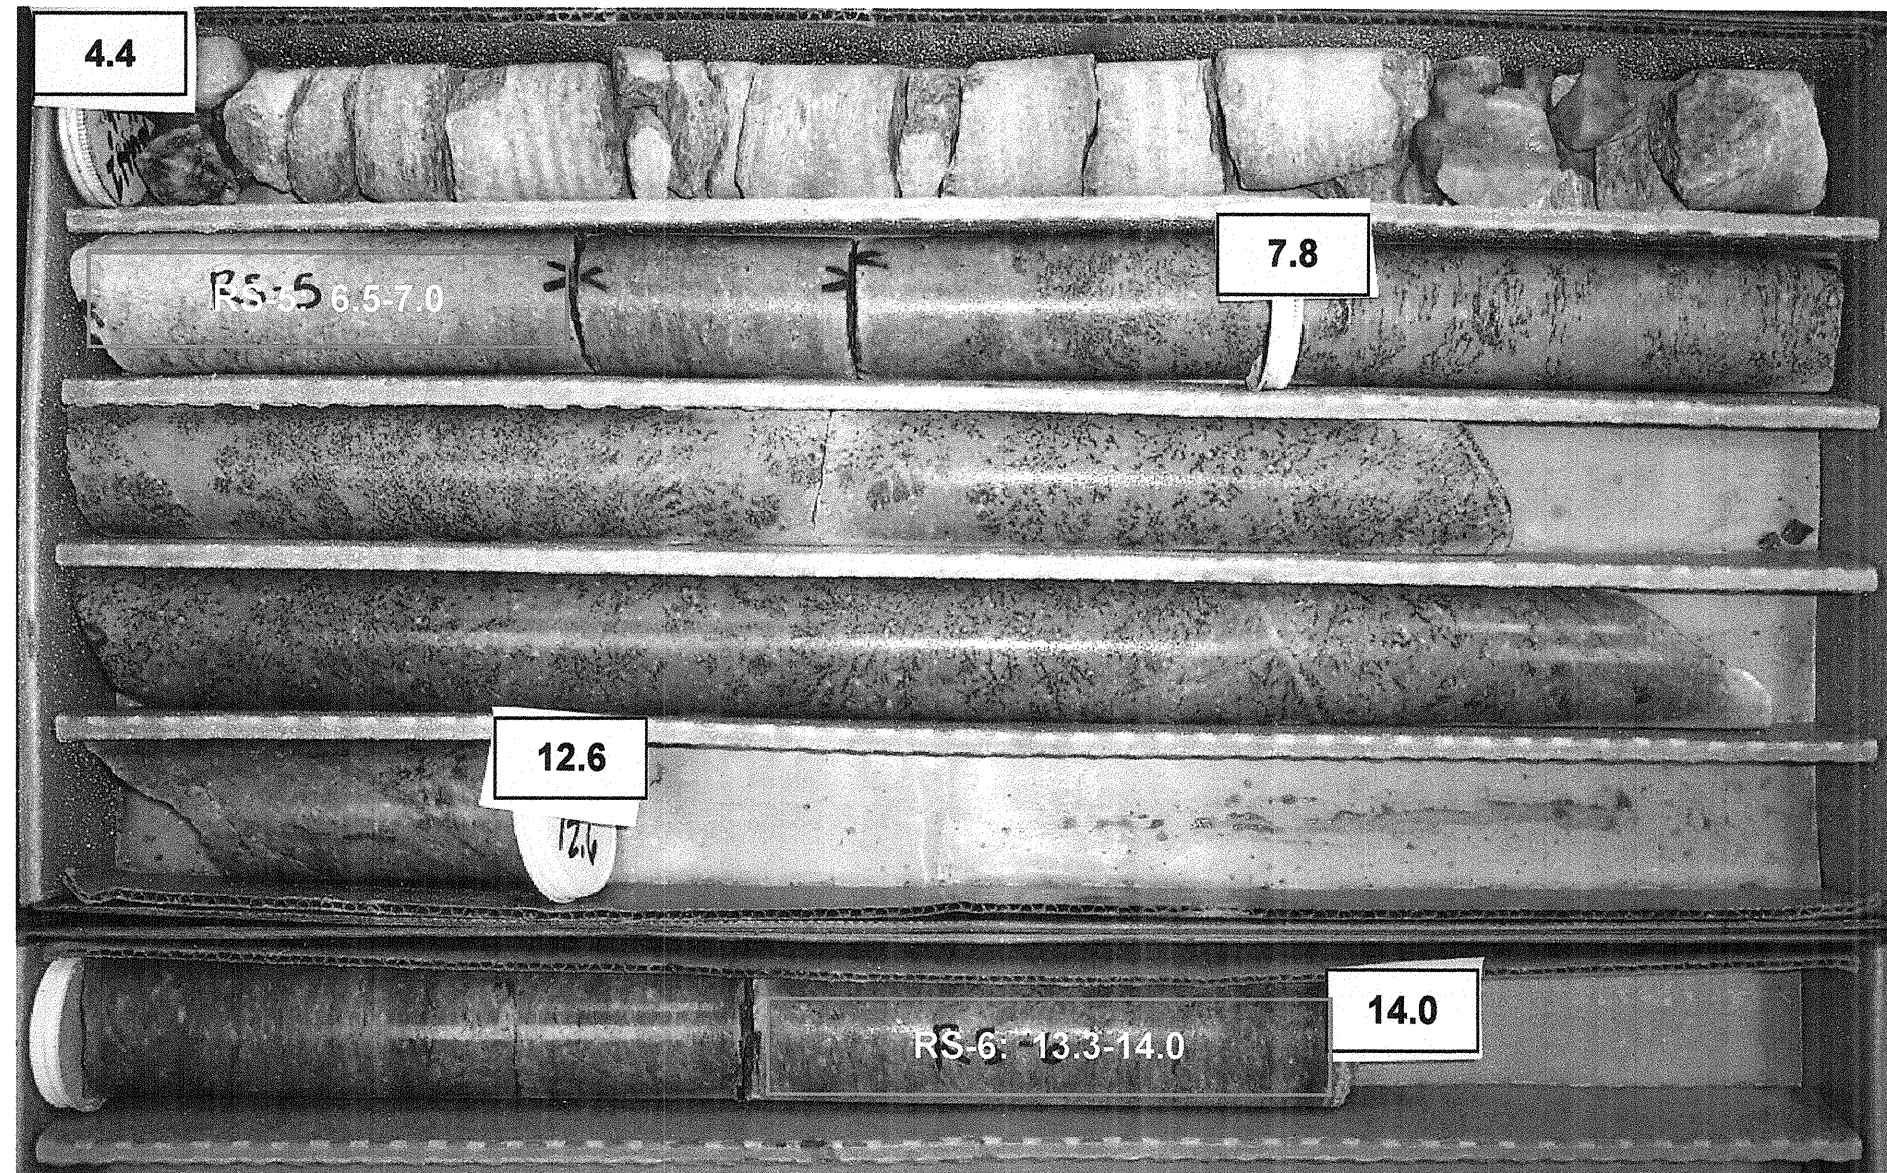
## B2-B

266.2	4.4	3:03 4:07 4:39 3:55/4	3.4	3.1 (91%)	1.3 (38%)	RS-5 6.5'-7.0'	Crystalline rock, gray, hard to very hard, fresh to slightly weathered, closely to widely fractured, Gneiss

262.8	7.8	4:35 4:26 8:53 12:06	4.8	4.4 (92%)	4.4 (92%)		Crystalline rock, gray, hard to very hard, fresh to slightly weathered, moderately closely to widely fractured, Gneiss

258.0	12.6	9:44/08					
258.0	12.6	12:22 10:00/4	1.4	1.4 (100%)	1.4 (100%)	RS-6 13.3'-14.0'	Crystalline rock, gray, hard to very hard, fresh to slightly weathered, moderately closely fractured, Gneiss

BOXES 1 & 2: 4.4-14.0 FEET

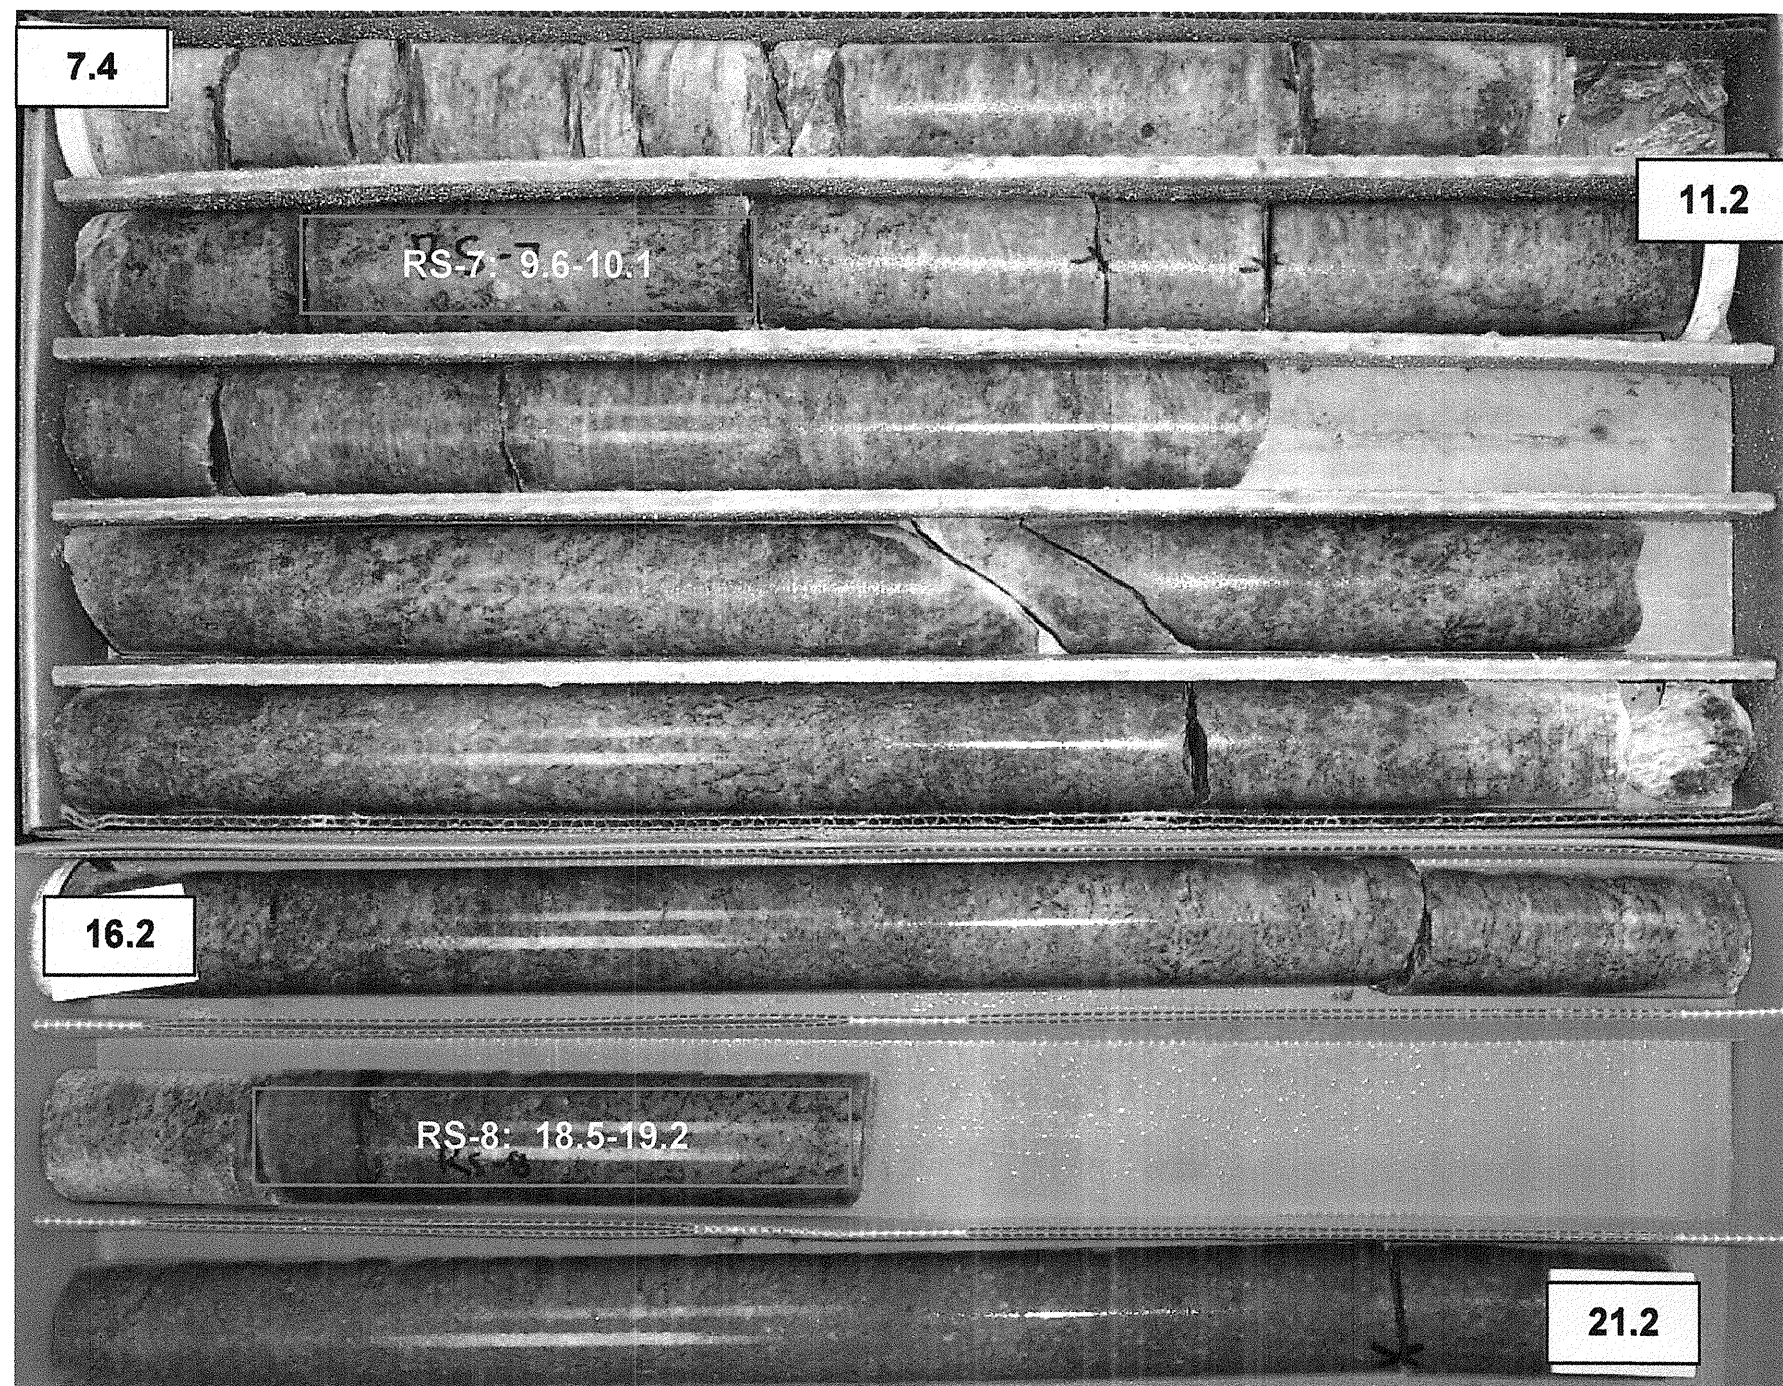
## B3-A

ELEV (ft)	DEPTH (ft)	DRILL RATE (min/ft)	RUN (ft)	REC (ft) (%)	RQD (ft) (%)	SAMPLE NUMBER	FIELD CLASSIFICATION and REMARKS
266.7	7.4	2:20	3.8	3.6	3.6	RS-7 9.6'-10.1'	Crystalline rock ,gray, hard to very hard, fresh to slightly weathered, closely fractured, Gneiss
		1:58					
		2:00					
		2:00/8		(95%)	(95%)		
262.9	11.2		5.0	5.0	5.0		Crystalline rock ,gray, hard to very hard, fresh to slightly weathered, closely to moderately closely fractured, Gneiss
262.9	11.2	2:00					
		2:00					
		3:15		(100%)	(100%)		
257.9	16.2	2:50	5.0	4.8	4.6	RS-8 18.5'-19.2'	Crystalline rock ,gray, hard to very hard, fresh to slightly weathered, closely to moderately closely fractured, Gneiss
257.9	16.2	4:15					
		3:50					
		3:45		(96%)	(92%)		
252.9	21.2	3:15					
BOREHOLE TERMINATED AT ELEVATION OF 252.9 FEET, IN CRYSTALLINE ROCK.

BOXES 1 & 2: 7.4-21.2 FEET
