GEOTECHNICAL I	ENGINEERING	UNIT

STATE OF NORTH CAROLINA
DEPARTMENT OF TRANSPORTATION
RALEIGH

PLAN AND SECTION VIEWS ROCK PLATED REINFORCED SOIL SLOPE (RPRSS)

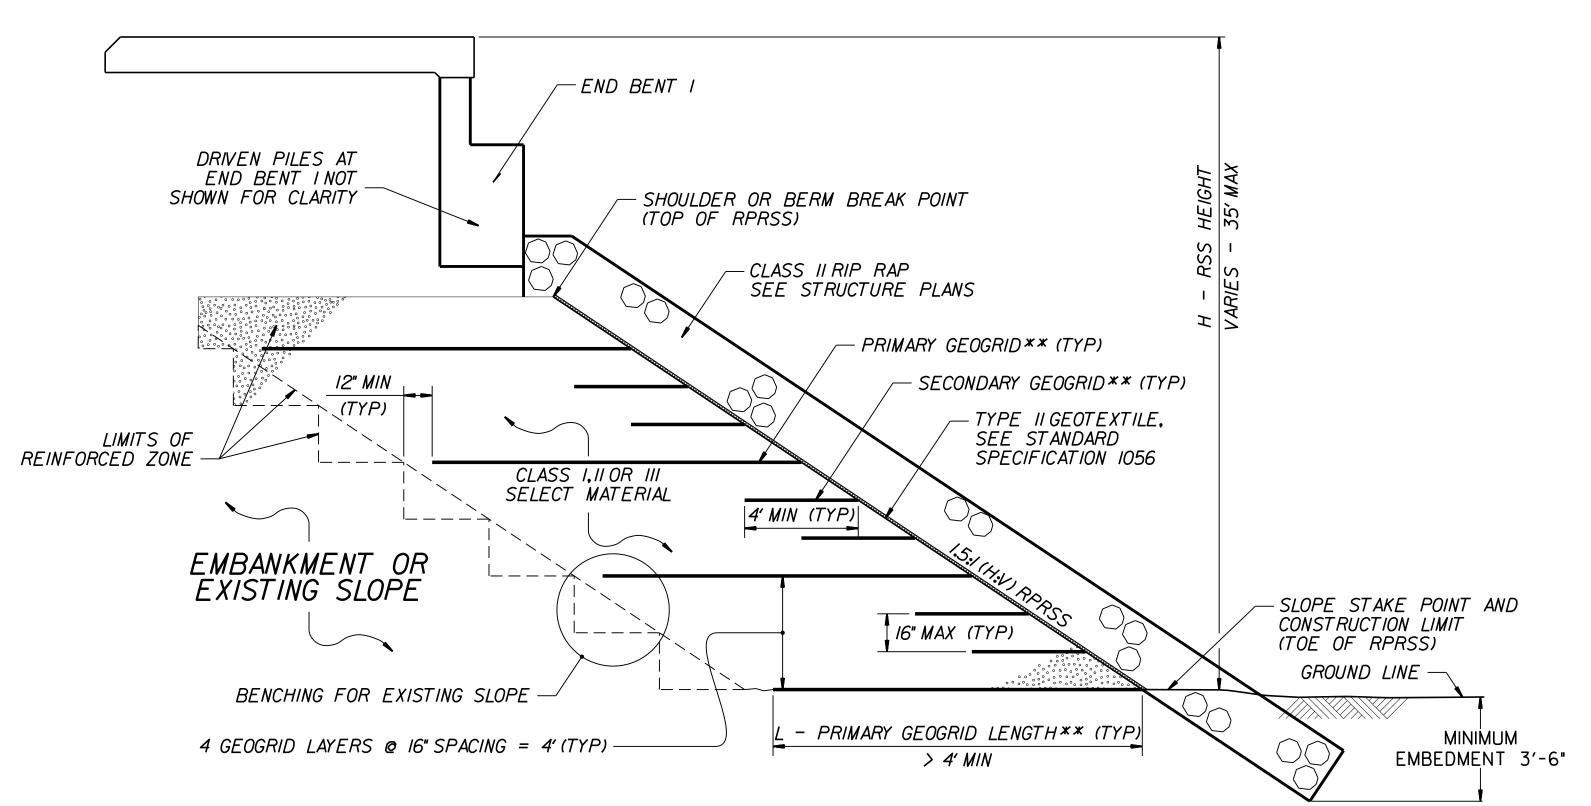
EB1 END SLOPE RPRSS WITH SELECT MATERIAL THAT DOES NOT MEET ARTICLE 1019–2 OF THE STANDARD SPECIFICATIONS

**SEE TABLES ON SHEET 2 AND GEOGRID PLACEMENT DETAILS.

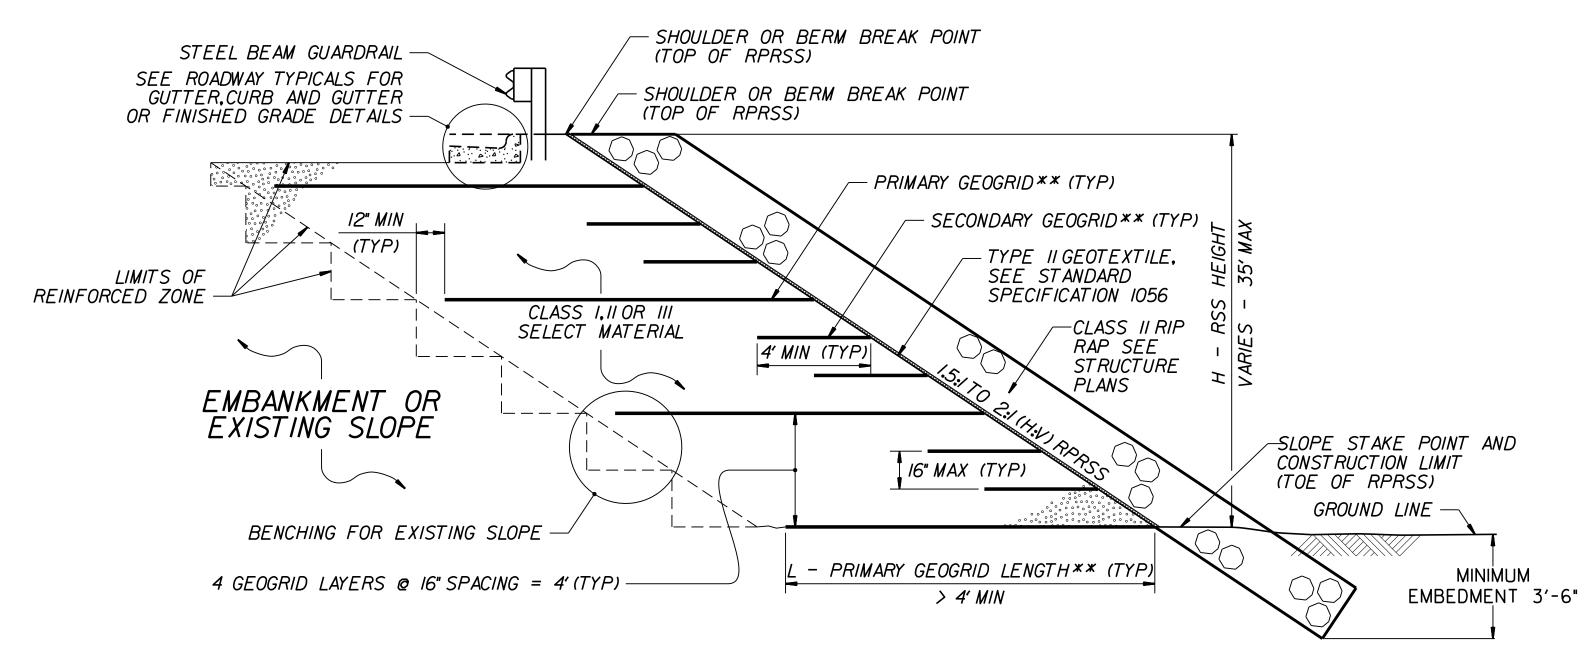
TRANSITION SLOPE 1.5:1 TO 2:1 RPRSS WITH SELECT MATERIAL THAT DOES NOT MEET ARTICLE 1019–2 OF THE STANDARD SPECIFICATIONS

**SEE TABLES ON SHEET 2 AND GEOGRID PLACEMENT DETAILS.

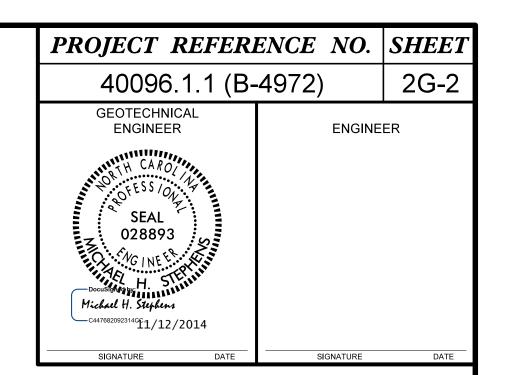
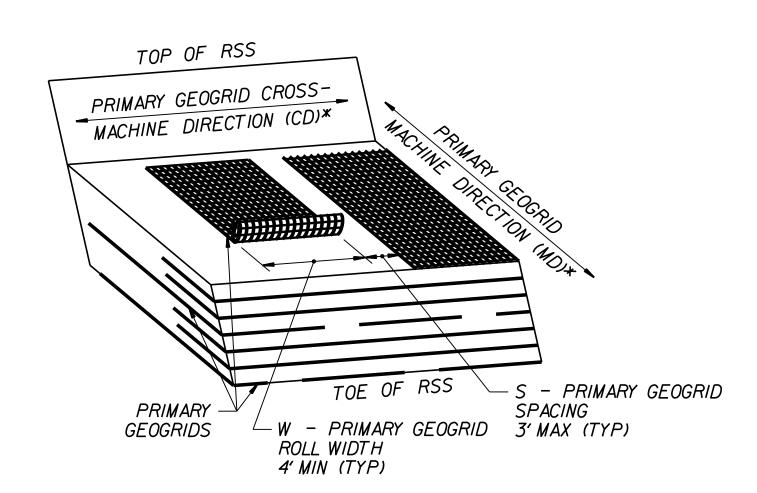
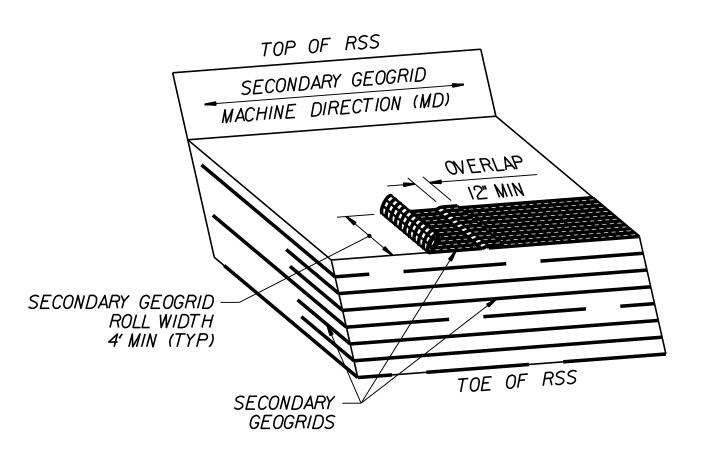
GEOGRID PLACEMENT DETAILS

(% COVERAGE = $\frac{W}{W+S}$ x 100 \geq 75%)

*SEE NOTES 8 AND 9 ON SHEET 2.
