PROJECT NO. I-5756  
HAYWOOD COUNTY  
 BRIDGE NO. 183

STATE OF NORTH CAROLINA  
 DEPARTMENT OF TRANSPORTATION  
 RALEIGH

**BEAM REPAIR LOCATIONS**

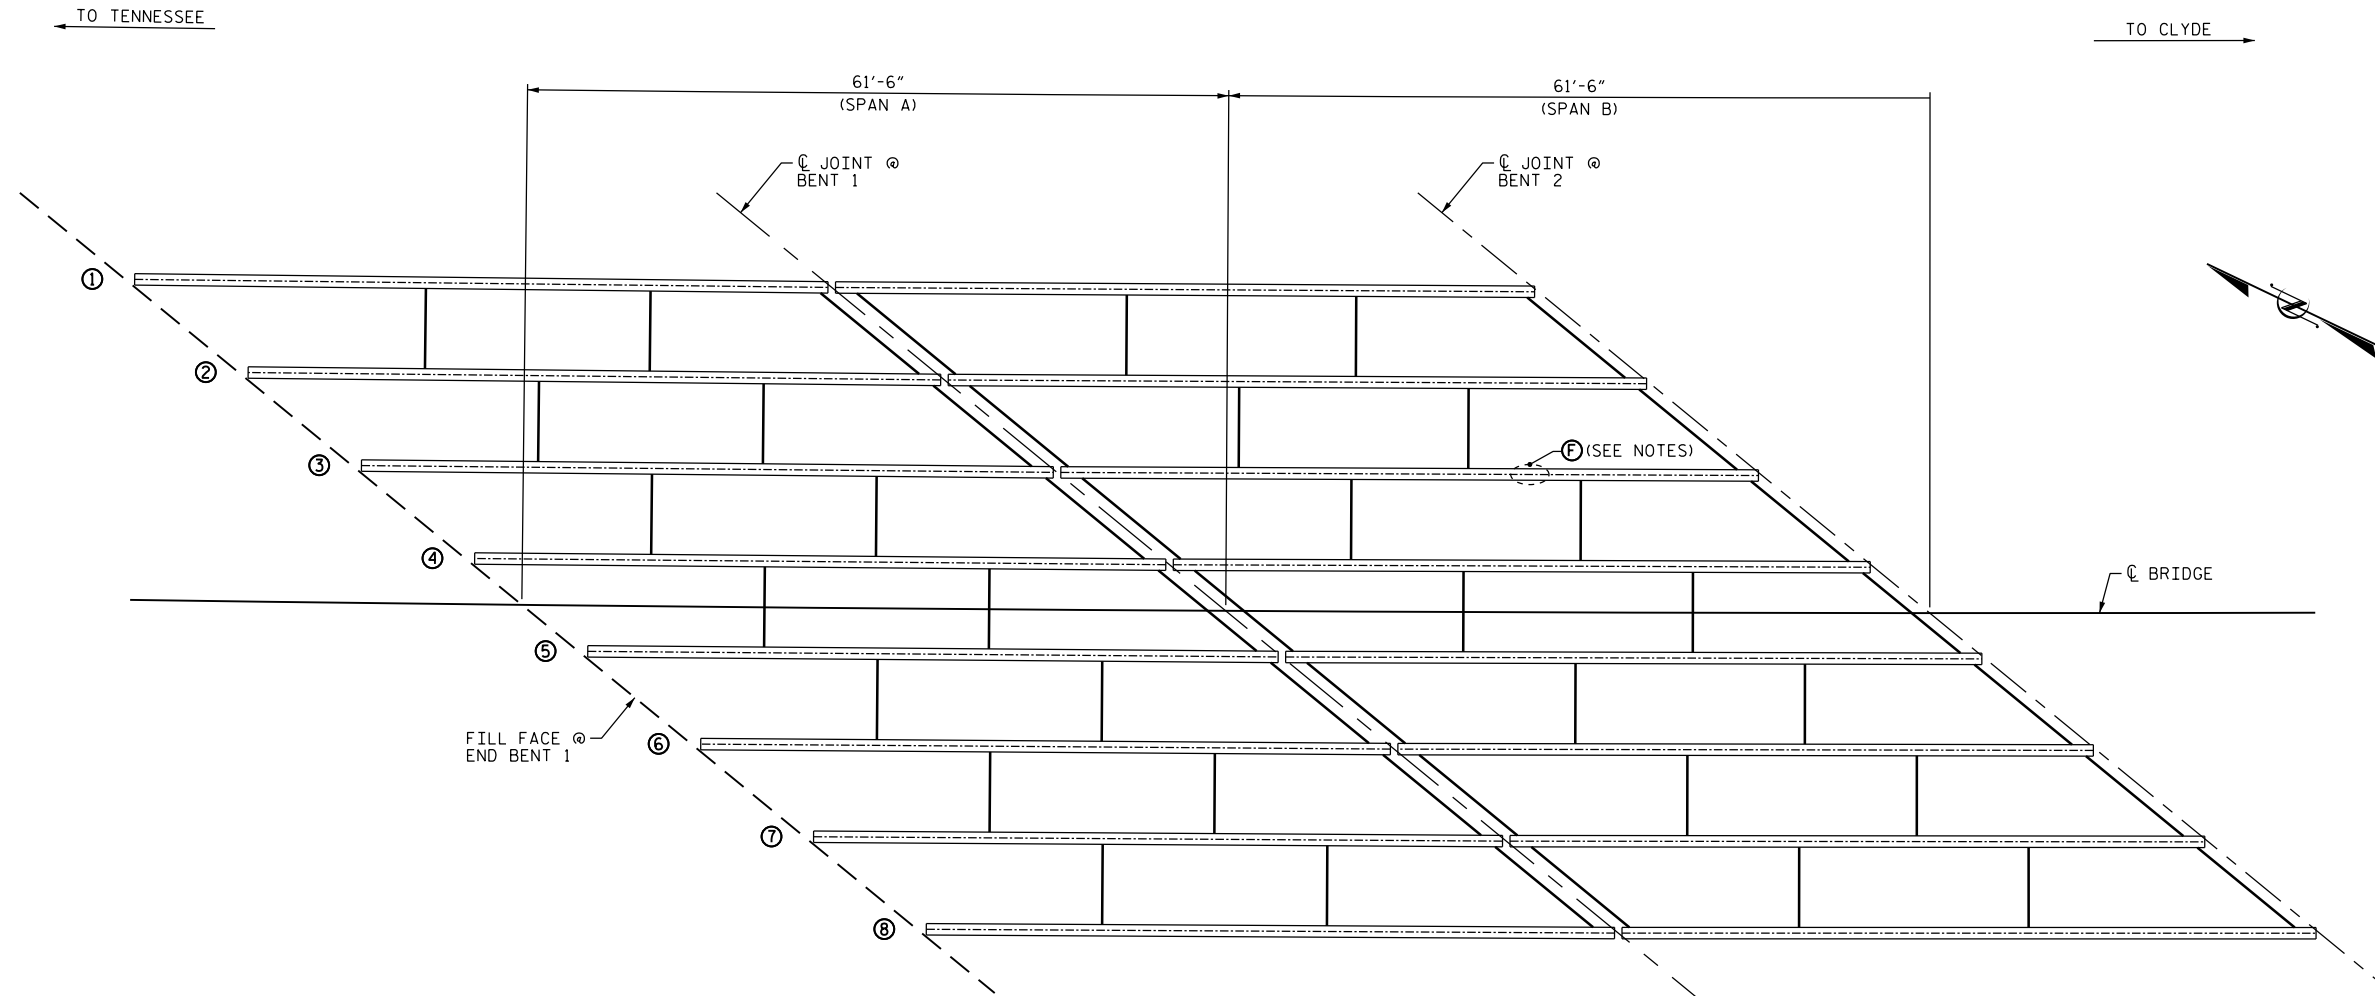
**BEAM REPAIR LOCATIONS**  
(OTHER LOCATIONS MAY EXIST, SEE NOTES)

- Ⓑ BEAM END REPAIR
- Ⓕ FLANGE REPAIR
- Ⓖ STIFFENER REPAIR
- ① BEAM NUMBER

ANTICIPATED BEAM REPAIR LOCATIONS						
SPAN	BEAM	LOCATION	DIM "A"	DIM "B"	DIM "C"	DIM "D"
B	3	MIDSPAN				SEE NOTES FOR FLANGE REPAIR

THE LOCATIONS AND DIMENSIONS OF THE AREAS FOR REPAIR ARE BASED ON THE BEST INFORMATION AVAILABLE. THE CONTRACTOR, IN CONJUNCTION WITH THE ENGINEER, SHALL VERIFY THE LOCATION AND EXTENT OF REPAIR AREAS PRIOR TO STEEL FABRICATION.

FOR FLANGE REPAIR ON BEAM 3 IN SPAN B, REMOVE DISTORTED FLANGE MATERIAL THAT EXTENDS ABOVE THE BOTTOM FLANGE LIMITS. AFTER REMOVAL OF EXCESS MATERIAL, GRIND THE REMAINING FLANGE AREA SMOOTH AND LEVEL WITH THE EXISTING FLANGE.
