PROJECT NO. I-5825
MECKLENBURG COUNTY
 BRIDGE NO. 215

SHEET 2 OF 2

BENT 3
 SPAN D FACE

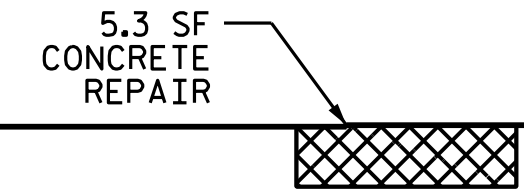
ELEVATION

SPAN C
SPAN D

BOTTOM OF CAP

CLEAN AND REMOVE DEBRIS FROM THE TOP OF THE CAP AND APPLY EPOXY PROTECTIVE COATING. EPOXY COATING SHALL BE APPLIED TO THE TOP SURFACE OF THE CAP. THE CONTRACTOR SHALL NOT COAT THE AREA OF THE CAP BENEATH THE MASONRY PLATES. FOR EPOXY COATING, SEE SPECIAL PROVISIONS.

CONCRETE REPAIRS TO THE BENT CAP MAY REQUIRE BRIDGE JACKING. FOR BRIDGE JACKING, SEE "JACKING DETAILS" SHEET.

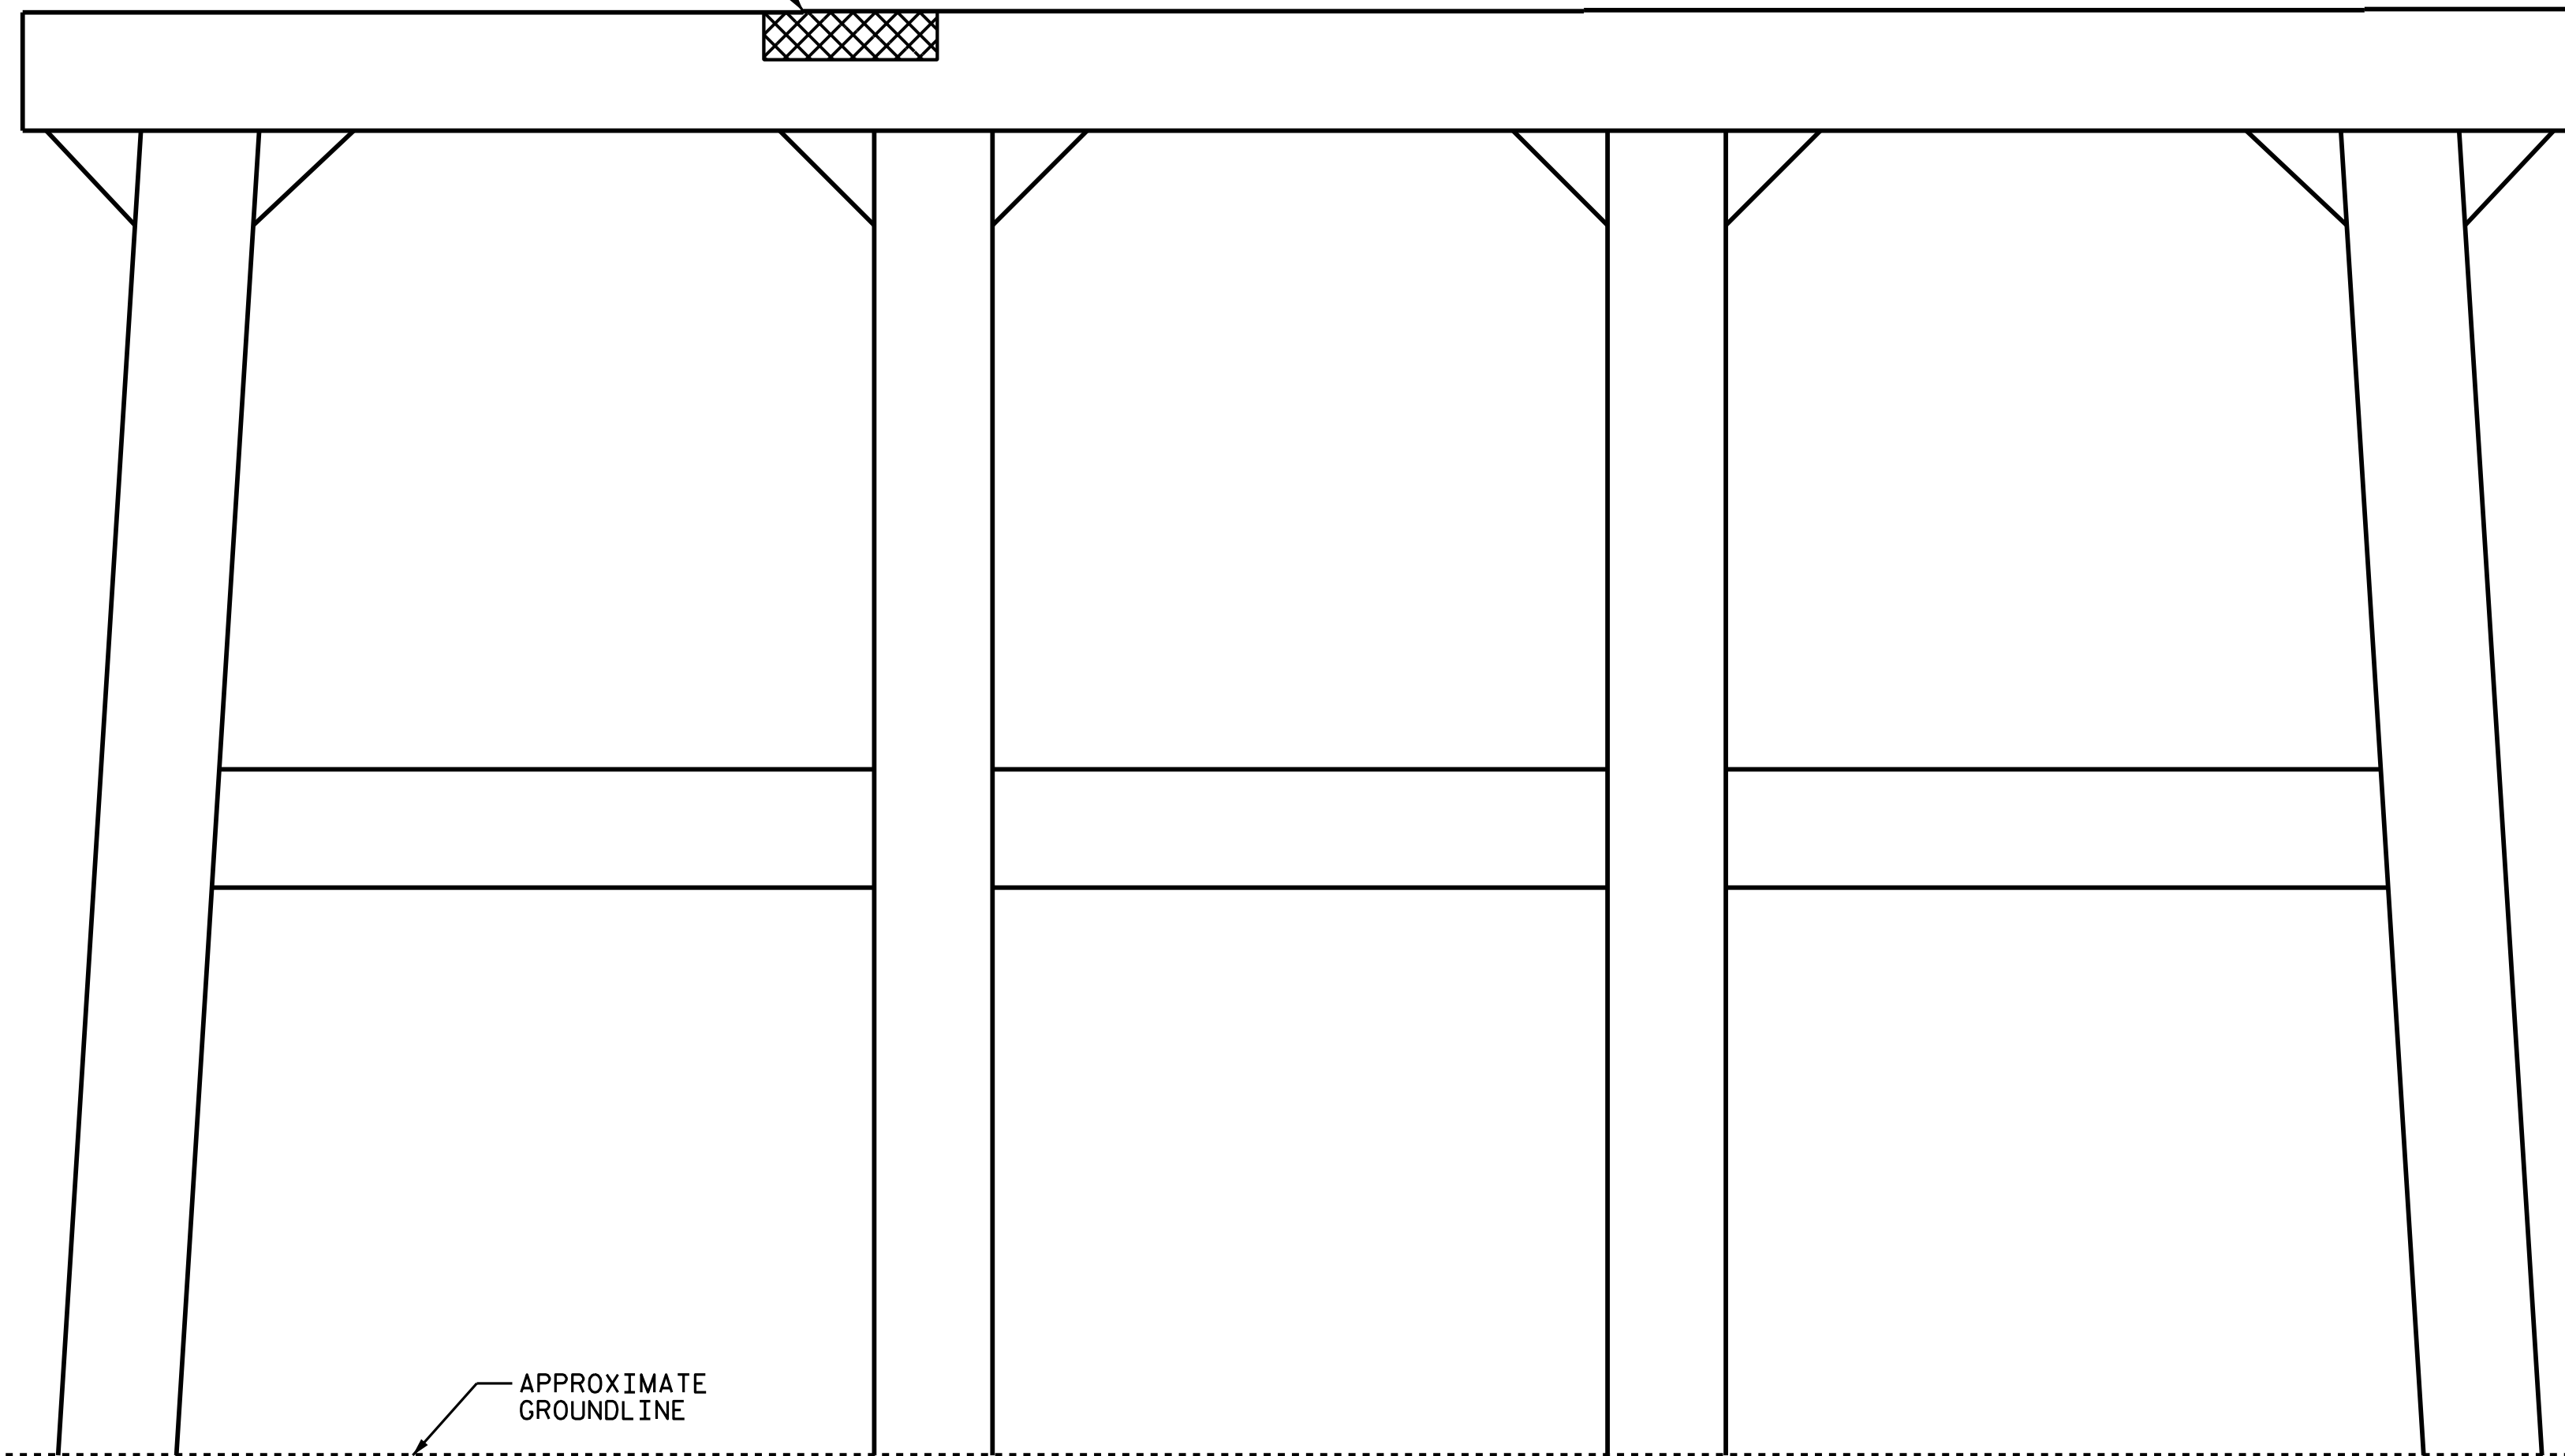
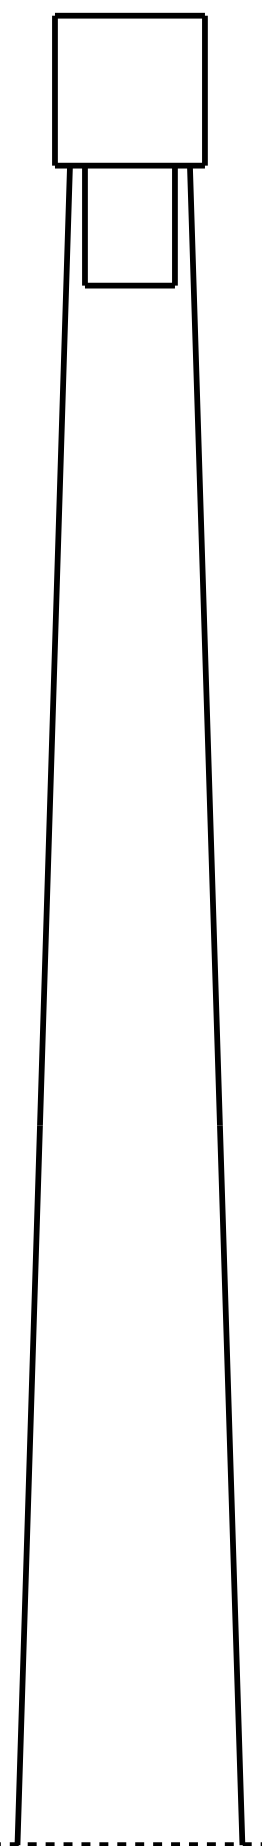
END VIEW
