PLAN OF SPAN D

PROJECT NO. I-5795 FORSYTH ___ COUNTY BRIDGE NO. 330509

SHEET 3 OF 4

SURFACE PREPARATION & SILANE DECK TREATMENT

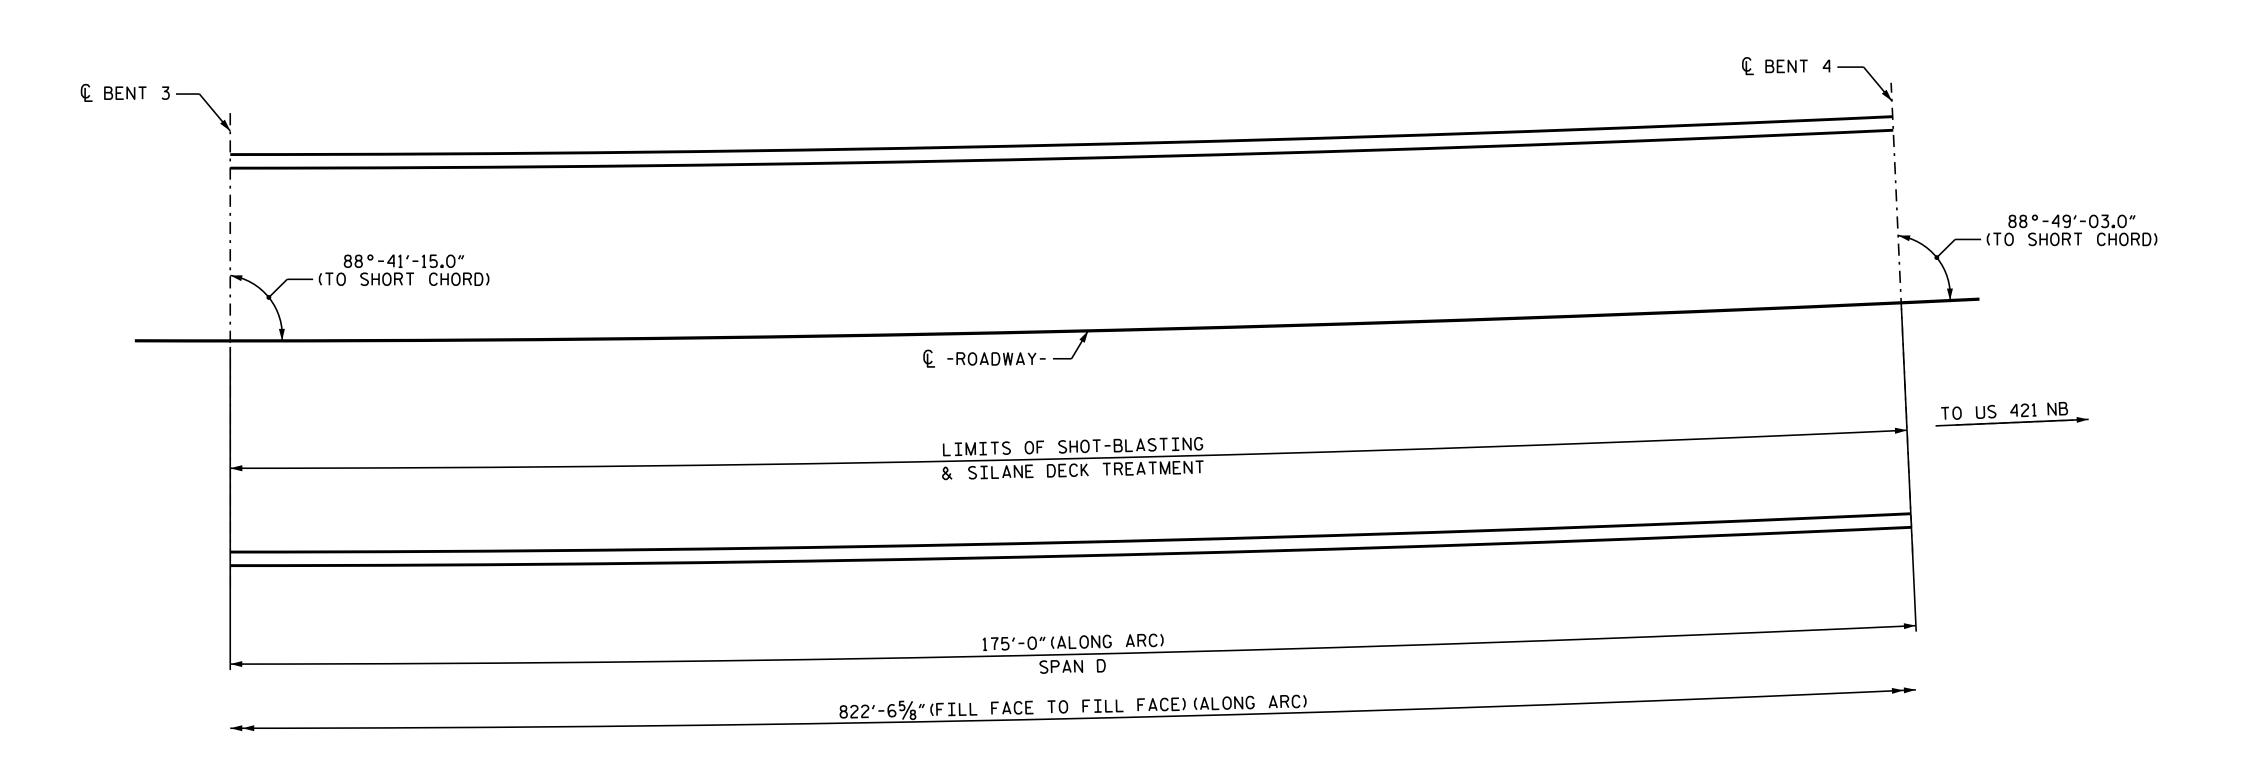
ONLY INNER SURFACE AND TOP SURFACE OF BARRIER WILL BE TREATED WITH SILANE PENETRANT SEALER.

CONCRETE DECK REPAIR FOR SILANE DECK TREATMENT

SHOTBLAST BRIDGE DECK AND SILANE DECK TREATMENT
