PROJECT REFERENCE NO. SHEET NO. 2022CPT.09.01.10291 2022CPT.09.02.20291 10

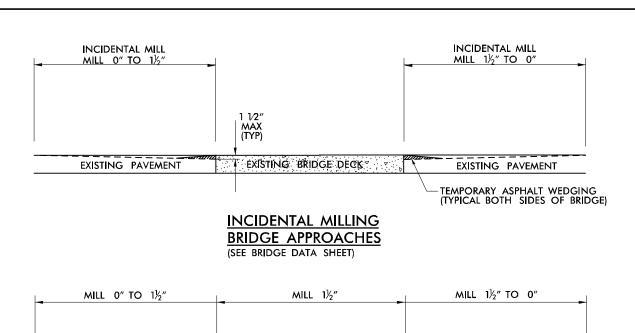
INCIDENTAL TIE-IN MILLING DETAIL

TEMPORARY ASPHALT WEDGING (TYPICAL BOTH SIDES OF BRIDGE) INCIDENTAL MILLING

EXISTING PAVEMENT

BRIDGE APPROACHES (SEE BRIDGE DATA SHEET)

EXISTING BRIDGE DECK

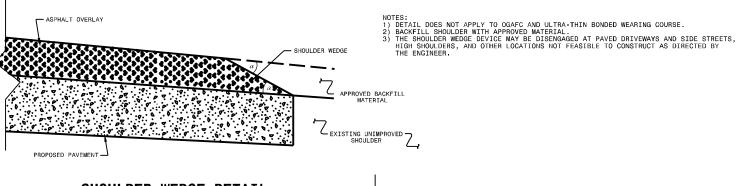
SHOULDER WEDGE DETAIL

(Resurfacing Projects w/ Widening or with Existing Paved Shoulder having no dropoffs)

- ASPHALT OVERLAY ZEXISTING UNIMPROVED 7 EXISTING PAVEMENT
