PROJECT NO. 15BPR.124.3 **DURHAM** COUNTY 310306 BRIDGE NO. \_\_\_\_

STATE OF NORTH CAROLINA DEPARTMENT OF TRANSPORTATION

SUBSTRUCTURE REPAIR

BENT 1 SPAN B FACE

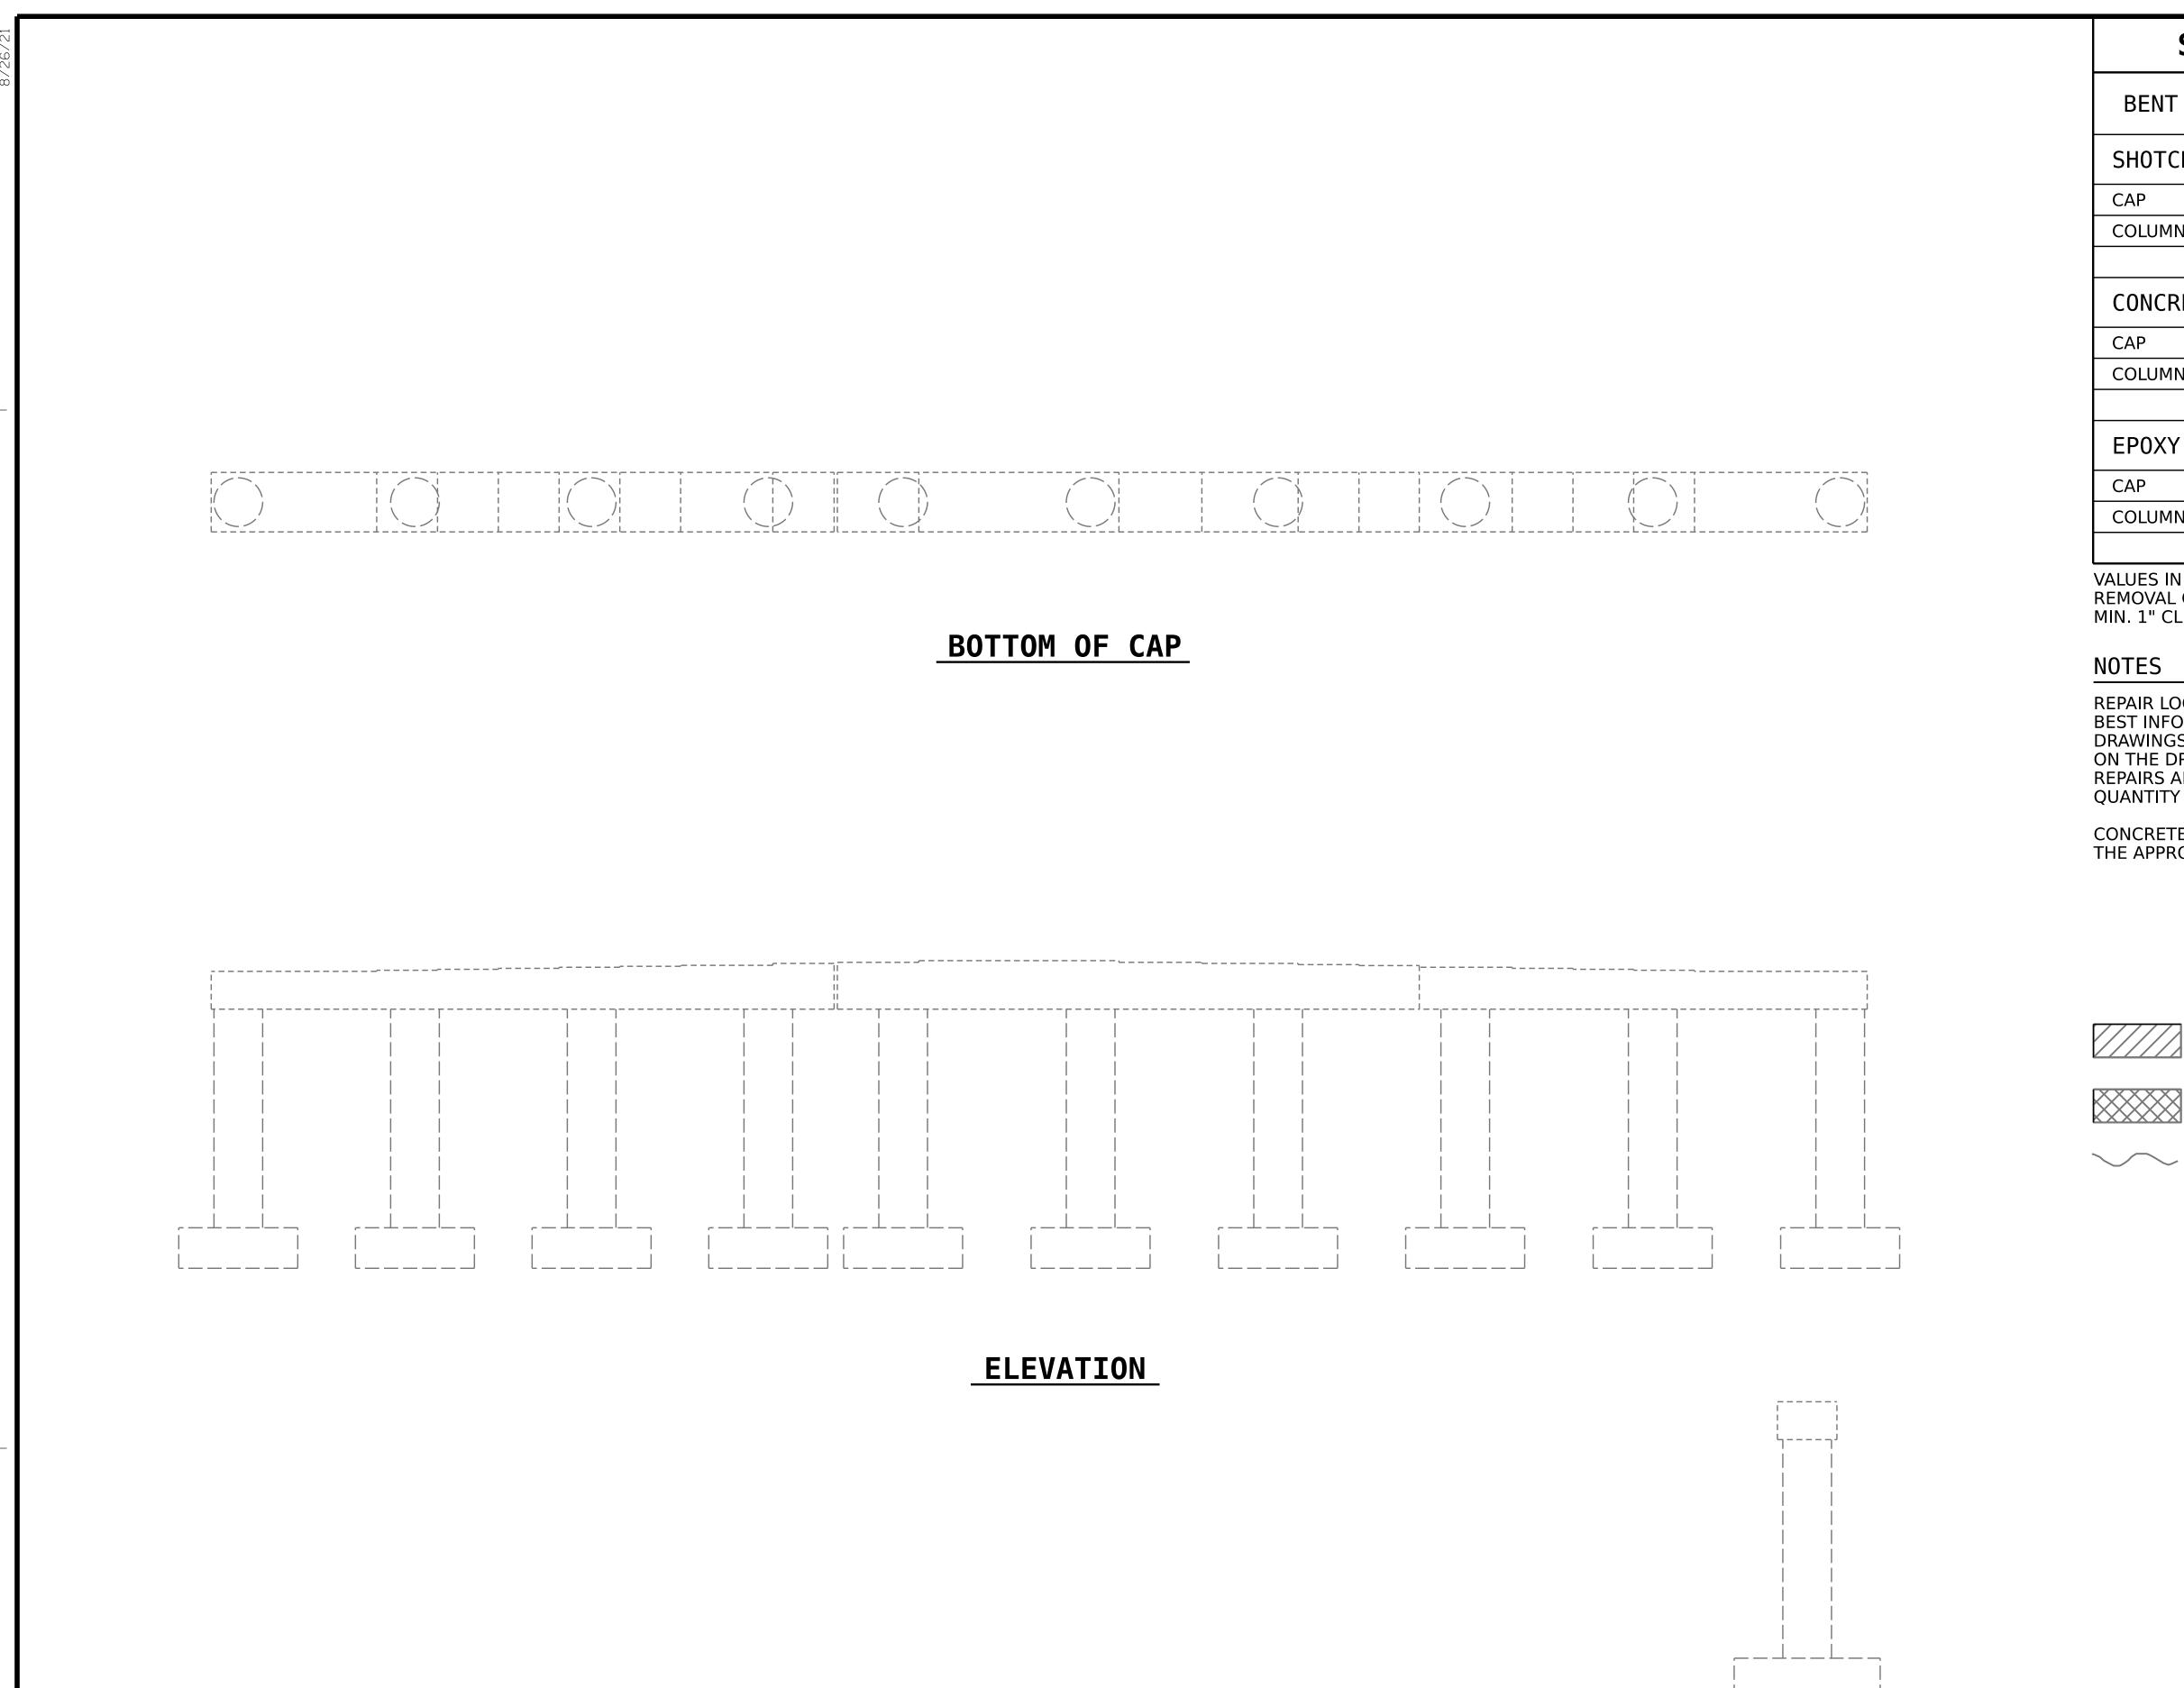
REVISIONS						SHEET NO.
ח	NO.	BY:	DATE:	NO.	BY:	DATE:	S1-13
٦	1			3			TOTAL SHEETS
	2			4			15

SHOTCRETE REPAIR AREA

**EAST END**

CONCRETE REPAIR AREA

**EPOXY RESIN INJECTION**

VALUES IN CHART REPRESENT ESTIMATED REPAIR TOTALS AFTER REMOVAL OF UNSOUND CONCRETE MIN. OF 1" BEHIND REBAR AND MIN. 1" CLEAR TO SAWCUT. SEE REPAIR DETAILS.

CONCRETE REPAIRS MAYBE SUBSTITUTED IN LIEU OF SHOTCRETE REPAIRS WITH THE APPROVAL OF THE ENGINEER.
