PROJEC	WAK	E		4.3 UNTY
SEAL DE LESSOLANTINI SEAL DE LESSOLANTINI OSTATOS DE LESSOLANTINI DE L	STATE OF NORTH CAROLINA DEPARTMENT OF TRANSPORTATION RALEIGH SUBSTRUCTURE REPAIR BENT 2 SPAN C FACE REVISIONS				
DOCUMENT NOT CONSIDERED	NO. BY:	DATE:	NO. BY:	DATE:	S4-16
FINAL UNLESS ALL SIGNATURES COMPLETED	1 2		<u> ৩</u> ব্র		total sheets 21

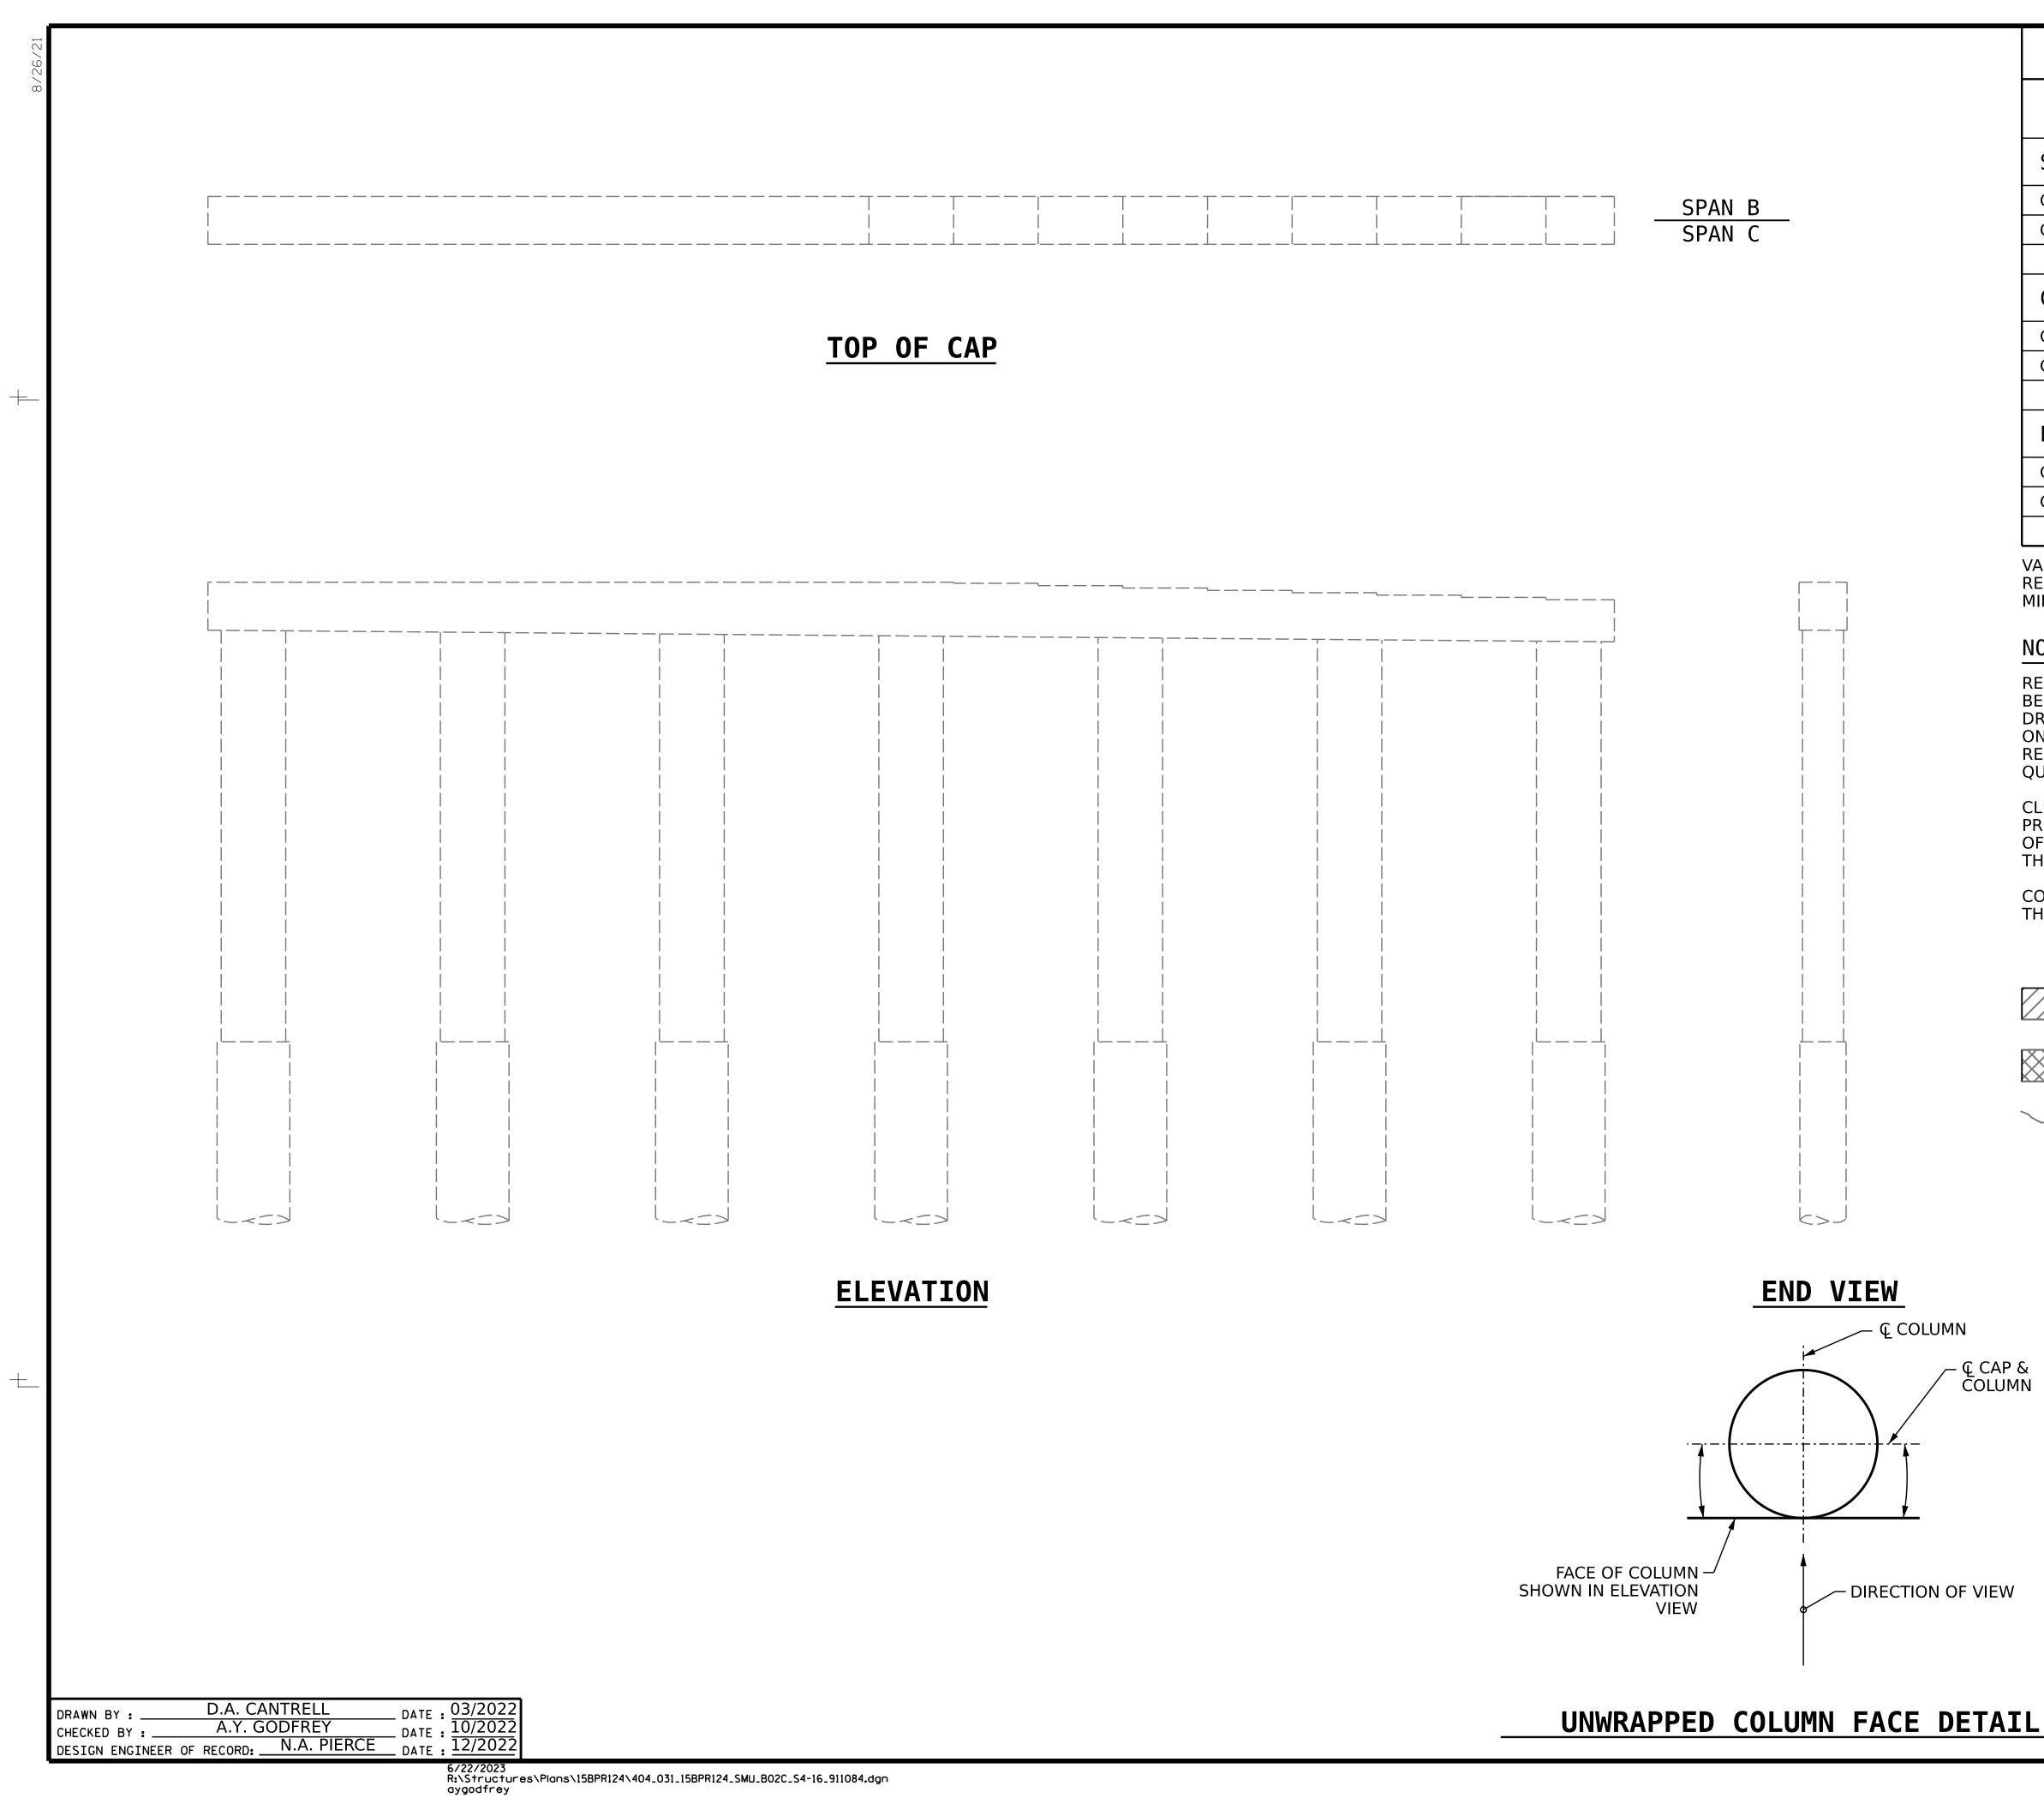
SHOTCRETE REPAIR AREA

CONCRETE REPAIR AREA

EPOXY RESIN INJECTION

CLEAN AND REMOVE DEBRIS FROM THE TOP OF THE CAP AND APPLY EPOXY PROTECTIVE COATING. EPOXY COATING SHALL BE APPLIED TO THE TOP SURFACE OF THE CAP. THE CONTRACTOR SHALL NOT COAT THE AREA OF THE CAP BENEATH THE MASONRY PLATES. FOR EPOXY COATING, SEE SPECIAL PROVISIONS.

CONCRETE REPAIRS MAYBE SUBSTITUTED IN LIEU OF SHOTCRETE REPAIRS WITH THE APPROVAL OF THE ENGINEER.
