PROJECT NO. HI-0016
ROBESON COUNTY
 BRIDGE NO. 770465

STATE OF NORTH CAROLINA
 DEPARTMENT OF TRANSPORTATION
 RALEIGH
GENERAL DRAWING
 FOR BRIDGE ON US 74/NC 130
 OVER LUMBER RIVER OVERFLOW
 (EBL)

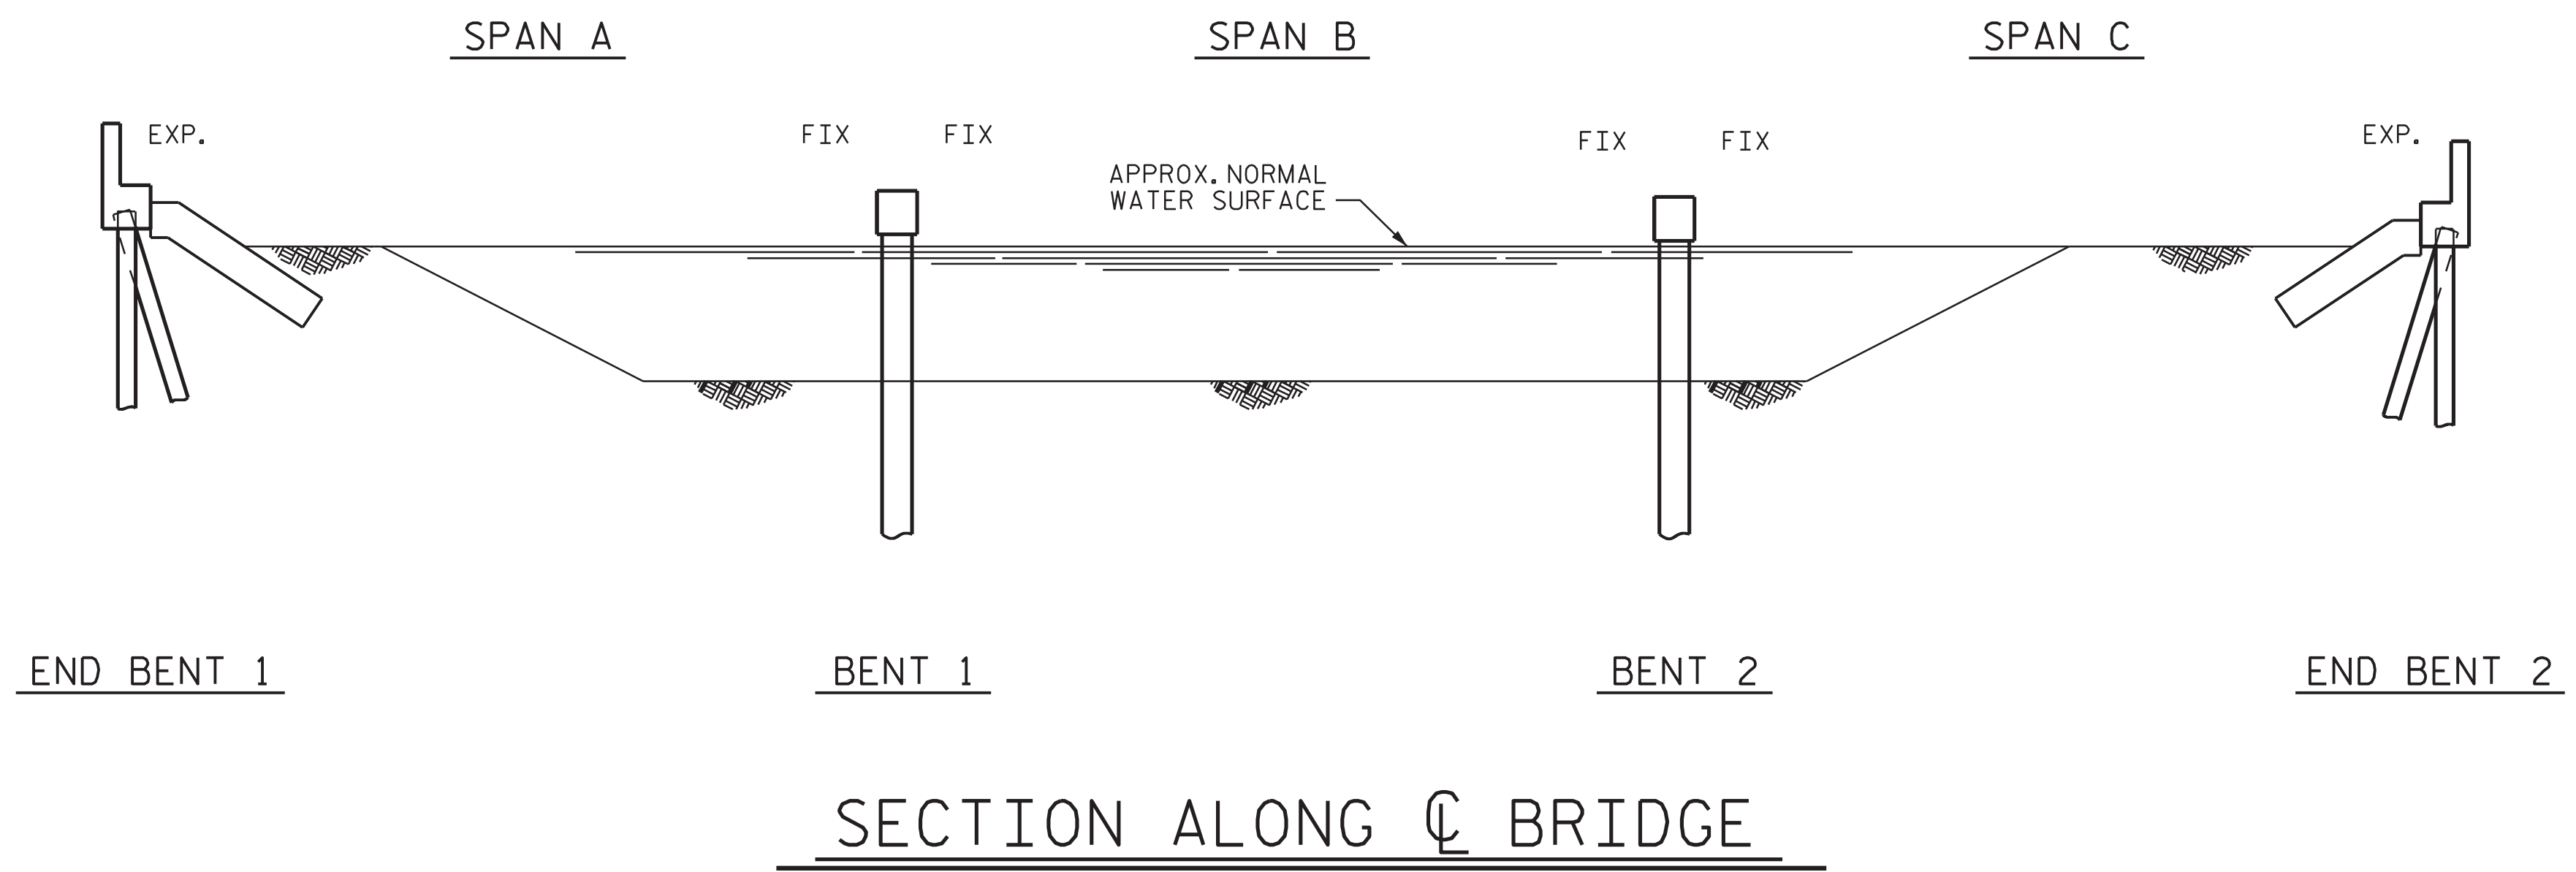
PROFILE INFORMATION IS TAKEN FROM ORIGINAL PLANS AND THE ROUTINE INSPECTION REPORT DATED 04/21/2022.
 BRIDGE ORIENTATION CONFORMS TO EXISTING BRIDGE PLANS.

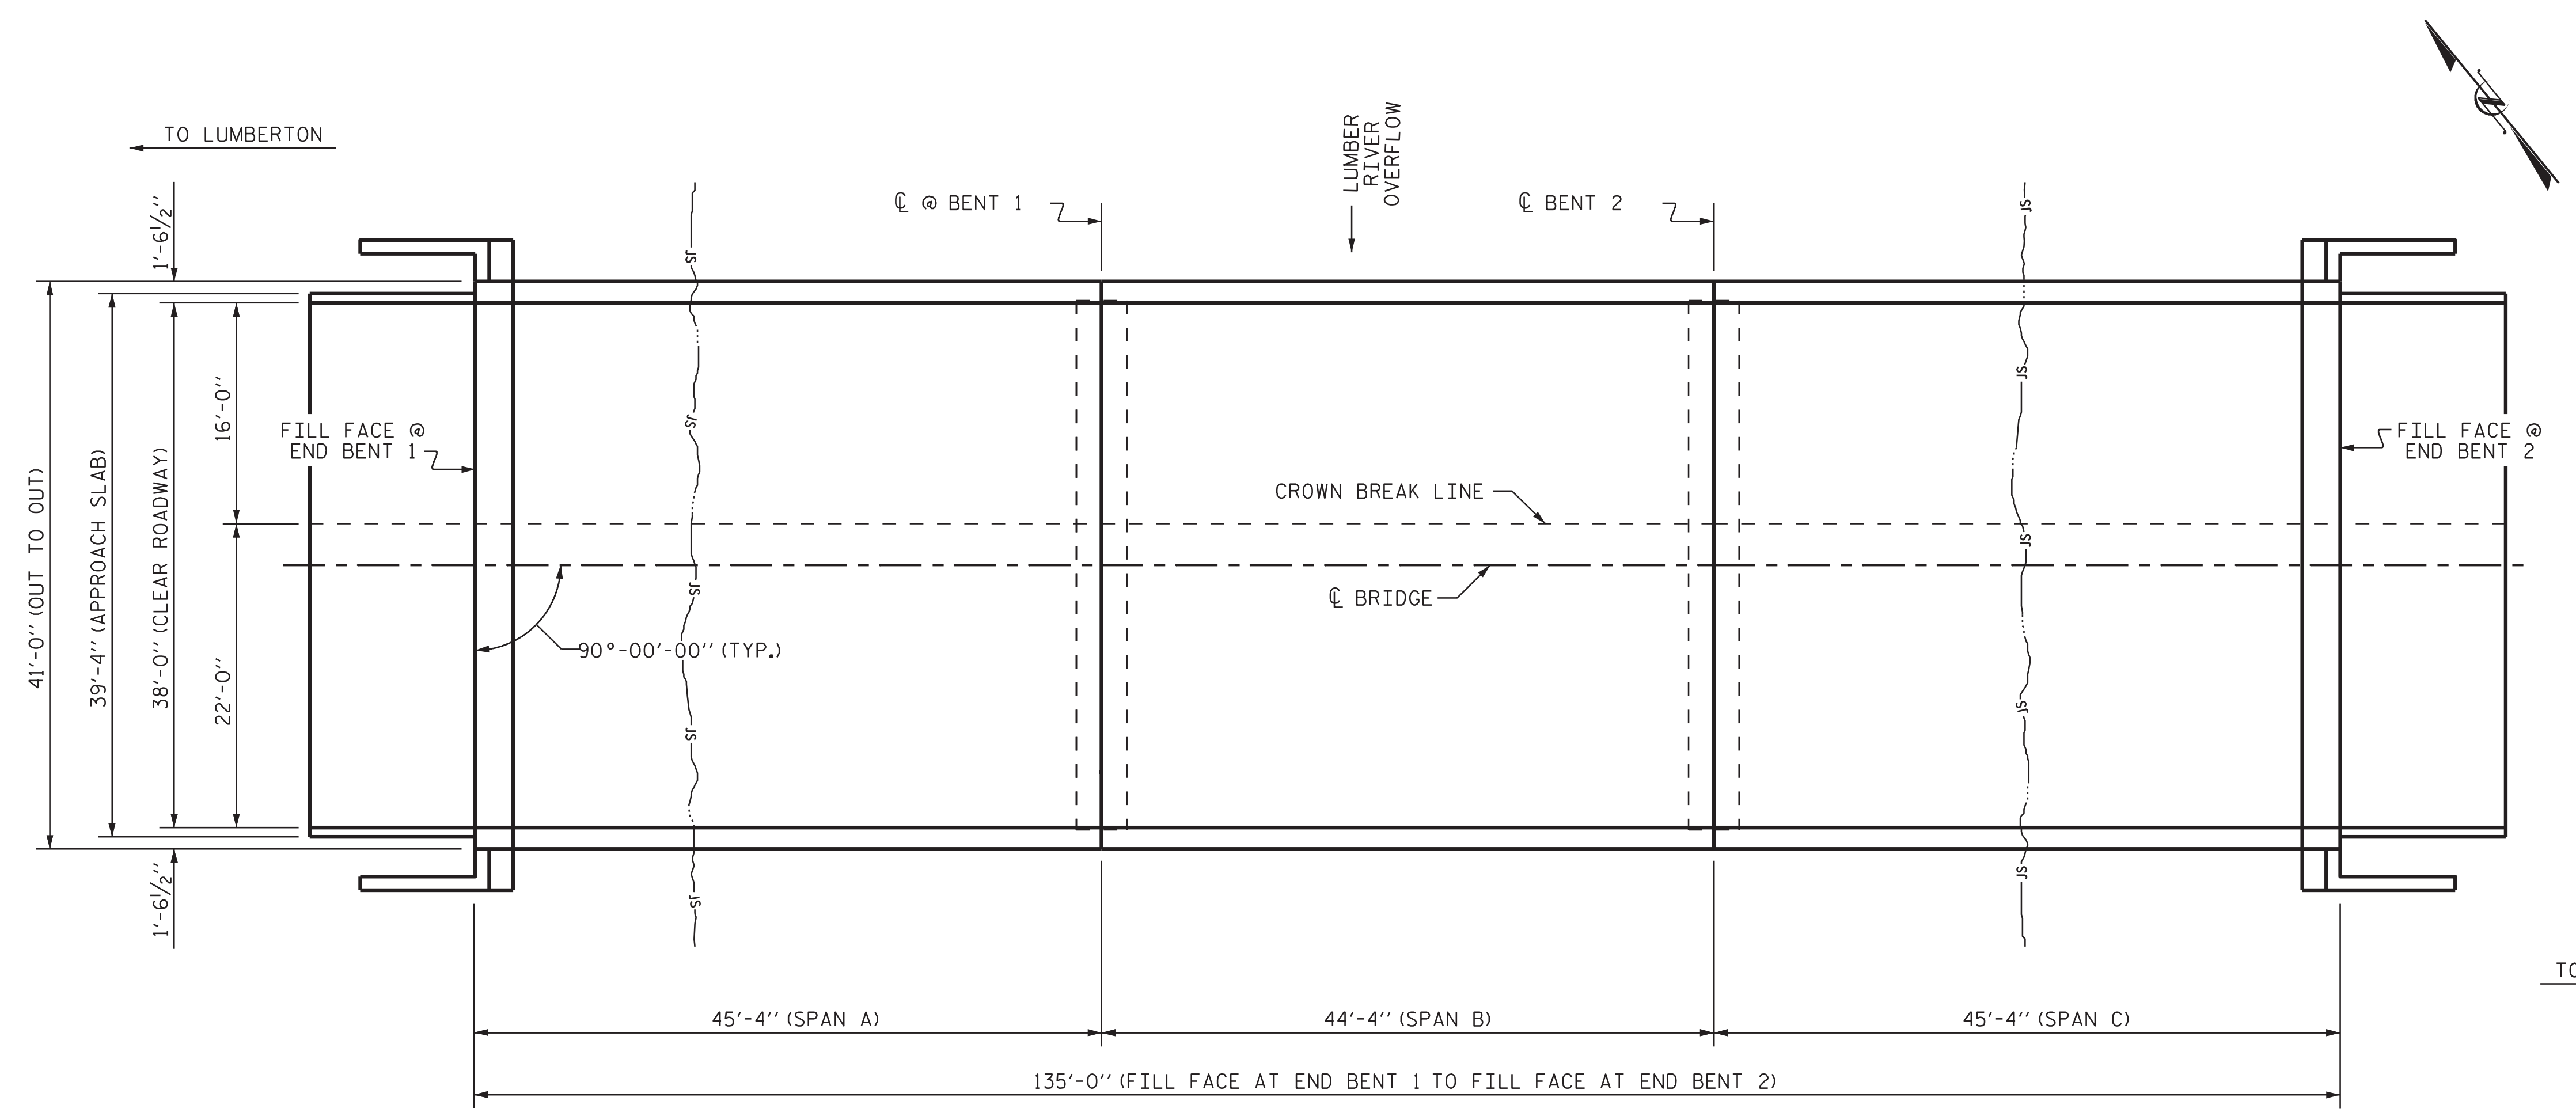
PLAN
 (PILES NOT SHOWN FOR CLARITY)

SHOTBLAST DECK AND APPLY SILANE DECK TREATMENT.
 PREPARE SURFACE AND APPLY SILANE BARRIER RAIL TREATMENT.
 DEMOLISH AND RECONSTRUCT HEADERS AND INSTALL FOAM JOINT SEALS.
