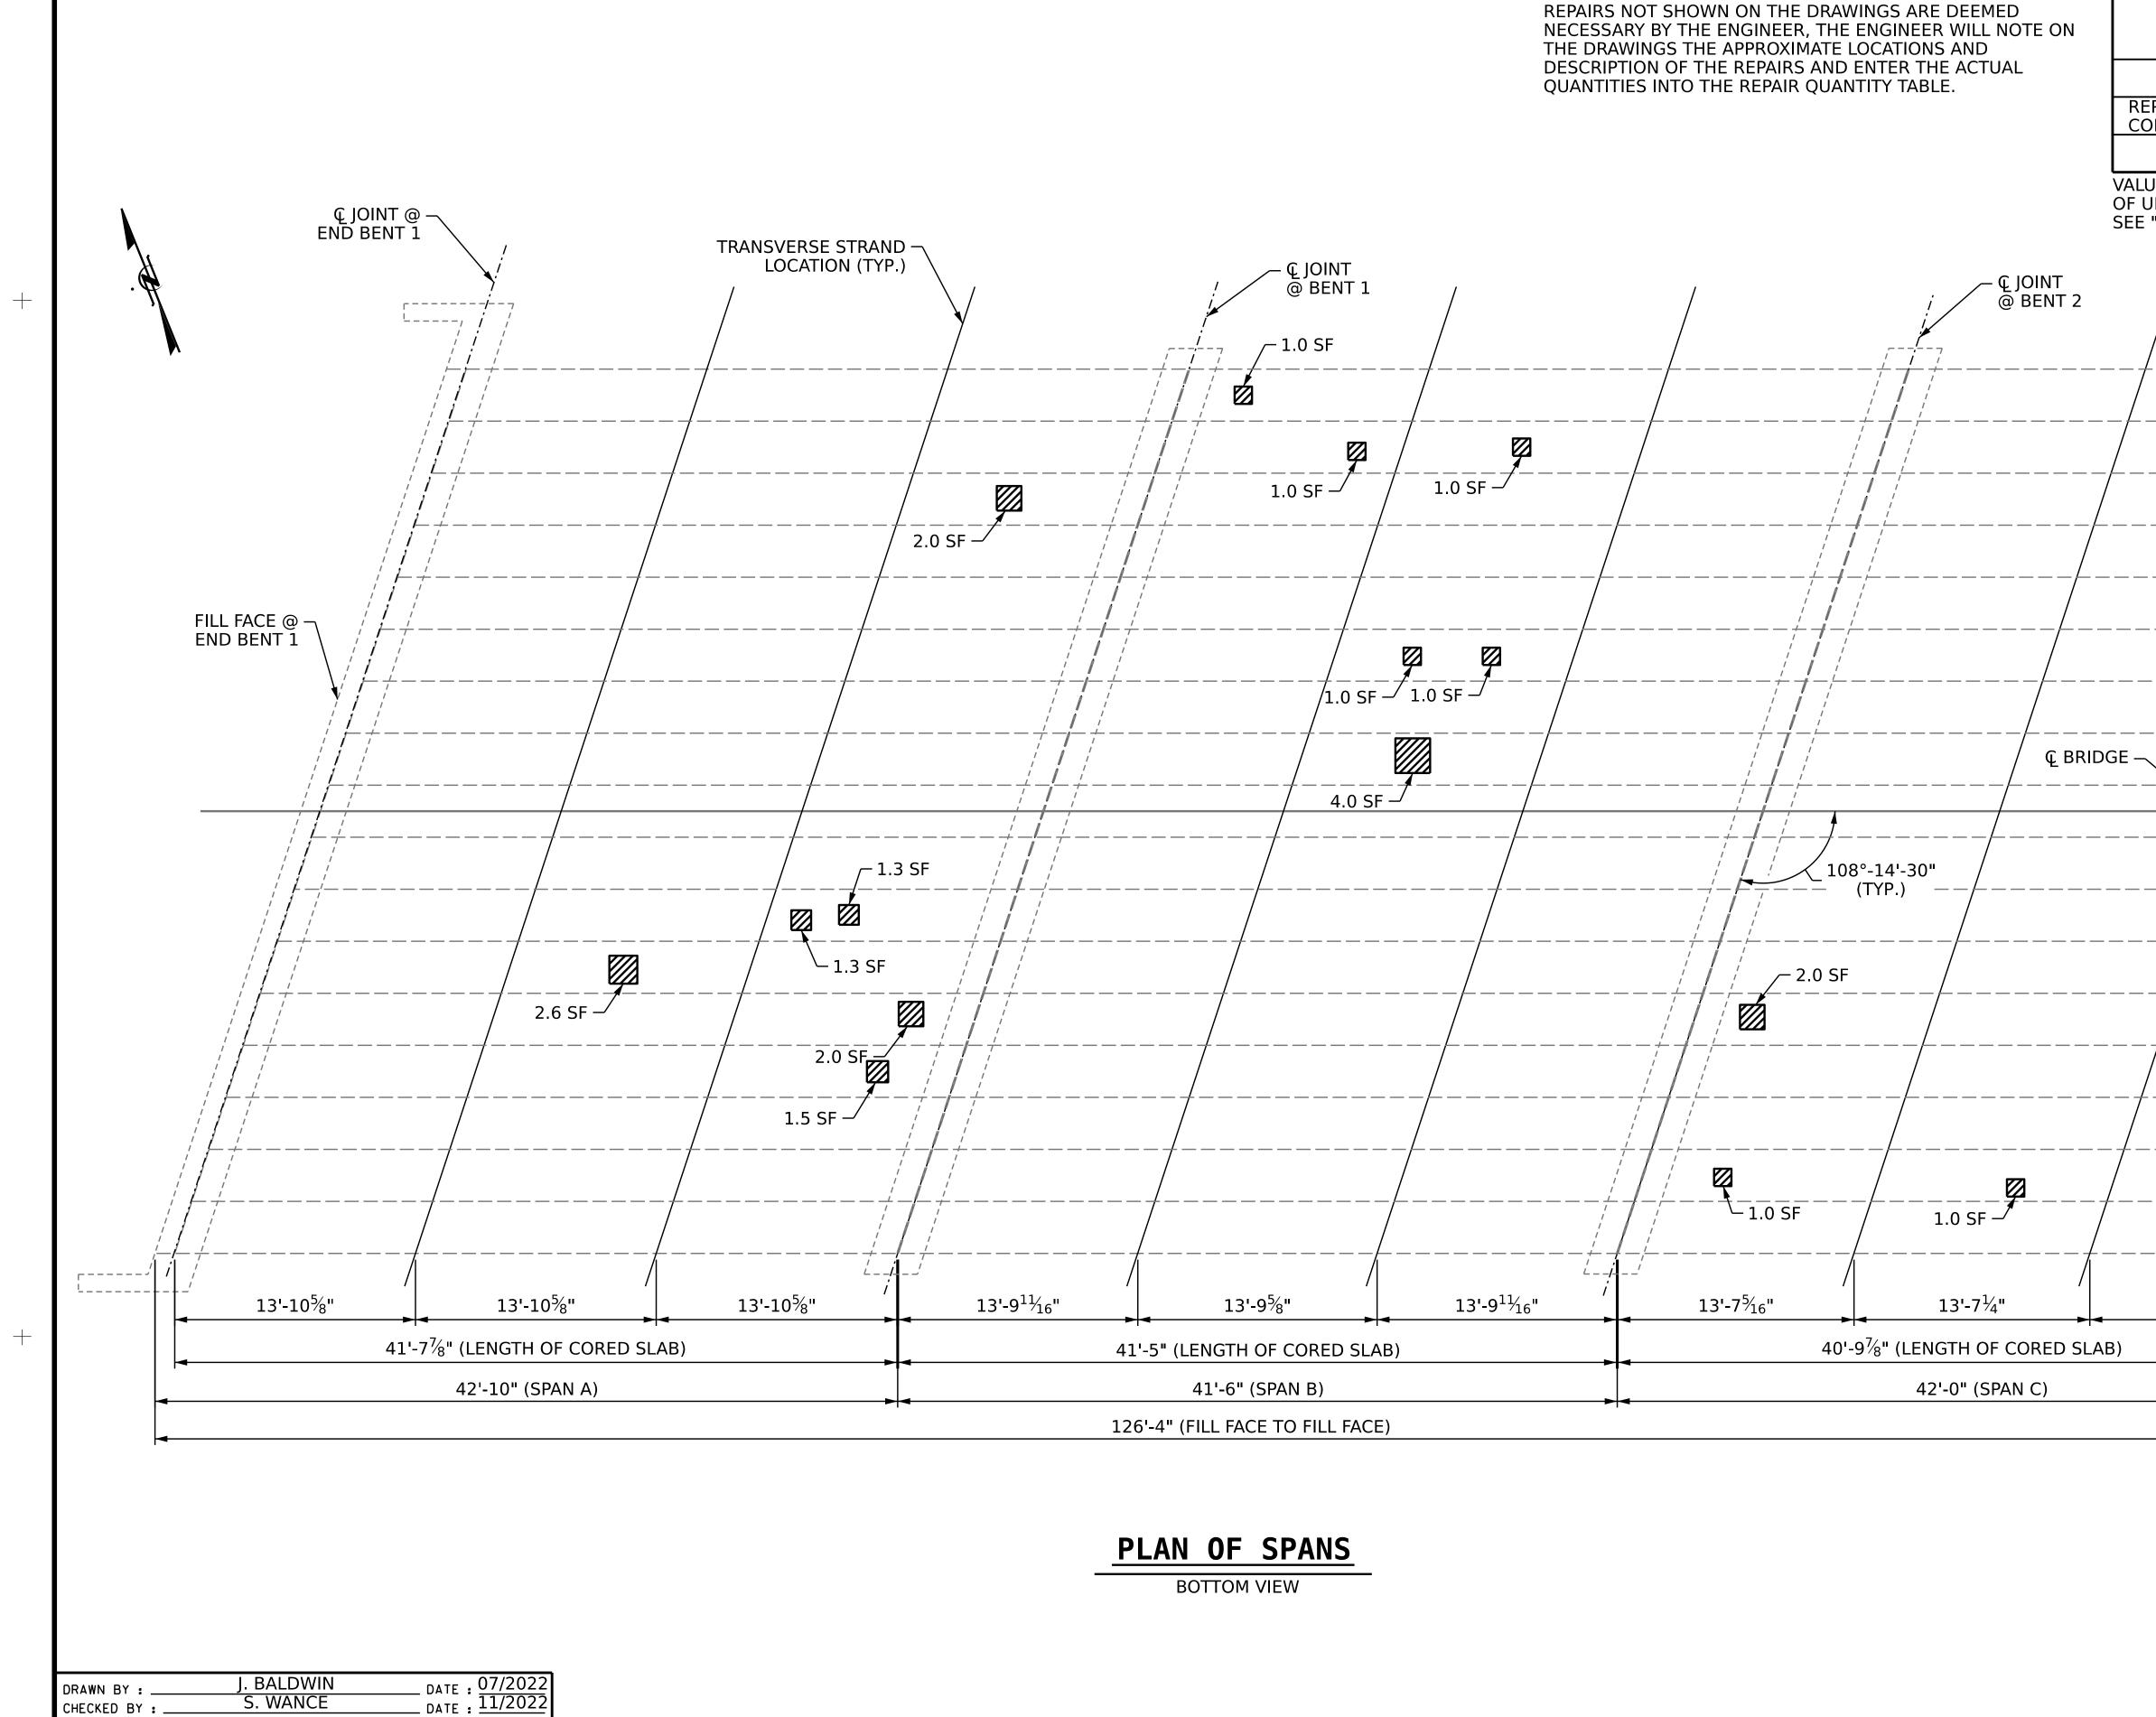
REPAIR LOCATIONS AND ESTIMATE OF QUANTITIES ARE BASED ON THE BEST INFORMATION AVAILABLE. IF ADDITIONAL

DECK UNDERSIDE REPAIR QUANTITY TABLE QUANTITIES PCCS REPAIRS ACTUAL ESTIMATE VOLUME VOLUME AREA AREA CF SF SF CF REPAIRS TO PRESTRESSED 23.7 4.2 CONCRETE CORED SLABS VALUES IN CHART REPRESENT ESTIMATED REPAIR TOTALS AFTER REMOVAL OF UNSOUND CONCRETE, MINIMUM OF 2" CLEARANCE TO SAWCUT. SEE "TYPICAL PCCS REPAIR DETAILS" SHEET S4-7. ହୁ JOINT @ END BENT 2 -----FILL FACE @ END BENT 2 HI-0017 PROJECT NO. 13'-7⁵⁄₁₆" ROBESON _ COUNTY 770454 BRIDGE NO.____ STATE OF NORTH CAROLINA DEPARTMENT OF TRANSPORTATION BEAL O30024 UNDERSIDE OF CORED SLAB REPAIR LOCATIONS Aster Abraha DDA094AED5104FD.. 09/29/2023 SHEET NO. REVISIONS S4-6 DATE: NO. BY: DATE: BY: DOCUMENT NOT CONSIDERED FINAL UNLESS ALL SIGNATURES COMPLETED total sheets 7
