PROJECT NO. HI-0015 COLUMBUS COUNTY

230086 BRIDGE NO. ___

STATE OF NORTH CAROLINA DEPARTMENT OF TRANSPORTATION

SUBSTRUCTURE END BENT 1

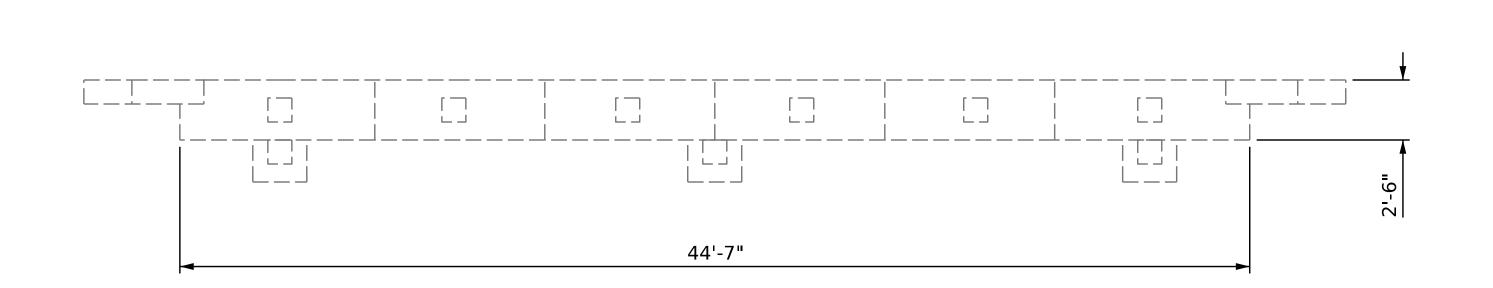
PLAN

CLEAN AND REMOVE DEBRIS FROM THE TOP OF THE CAP AND APPLY EPOXY PROTECTIVE COATING. EPOXY COATING SHALL BE APPLIED TO THE TOP SURFACE OF THE CAP. THE CONTRACTOR SHALL NOT COAT THE AREA OF THE CAP BENEATH THE MASONRY PLATES. FOR EPOXY COATING, SEE SPECIAL PROVISIONS.
