Subject: **Request for Permit Modification of Section 404 Individual Permit, Section 10, and 401 Individual Water Quality Certification** for the proposed I-26 Asheville Connector, From I-40 east of SR 1224, to US 19/23 near the Broadway St Interchange; Federal Aid Project No. NHF26-1(53), Division 13. TIP No. I-2513. WBS 34165.1.2.

## Monitoring Plan

This proposed monitoring plan will provide a comprehensive characterization of stability within the hydraulic zone of influence of the French Broad River in connection with the NCDOT I-26 Connector Project bridge construction.

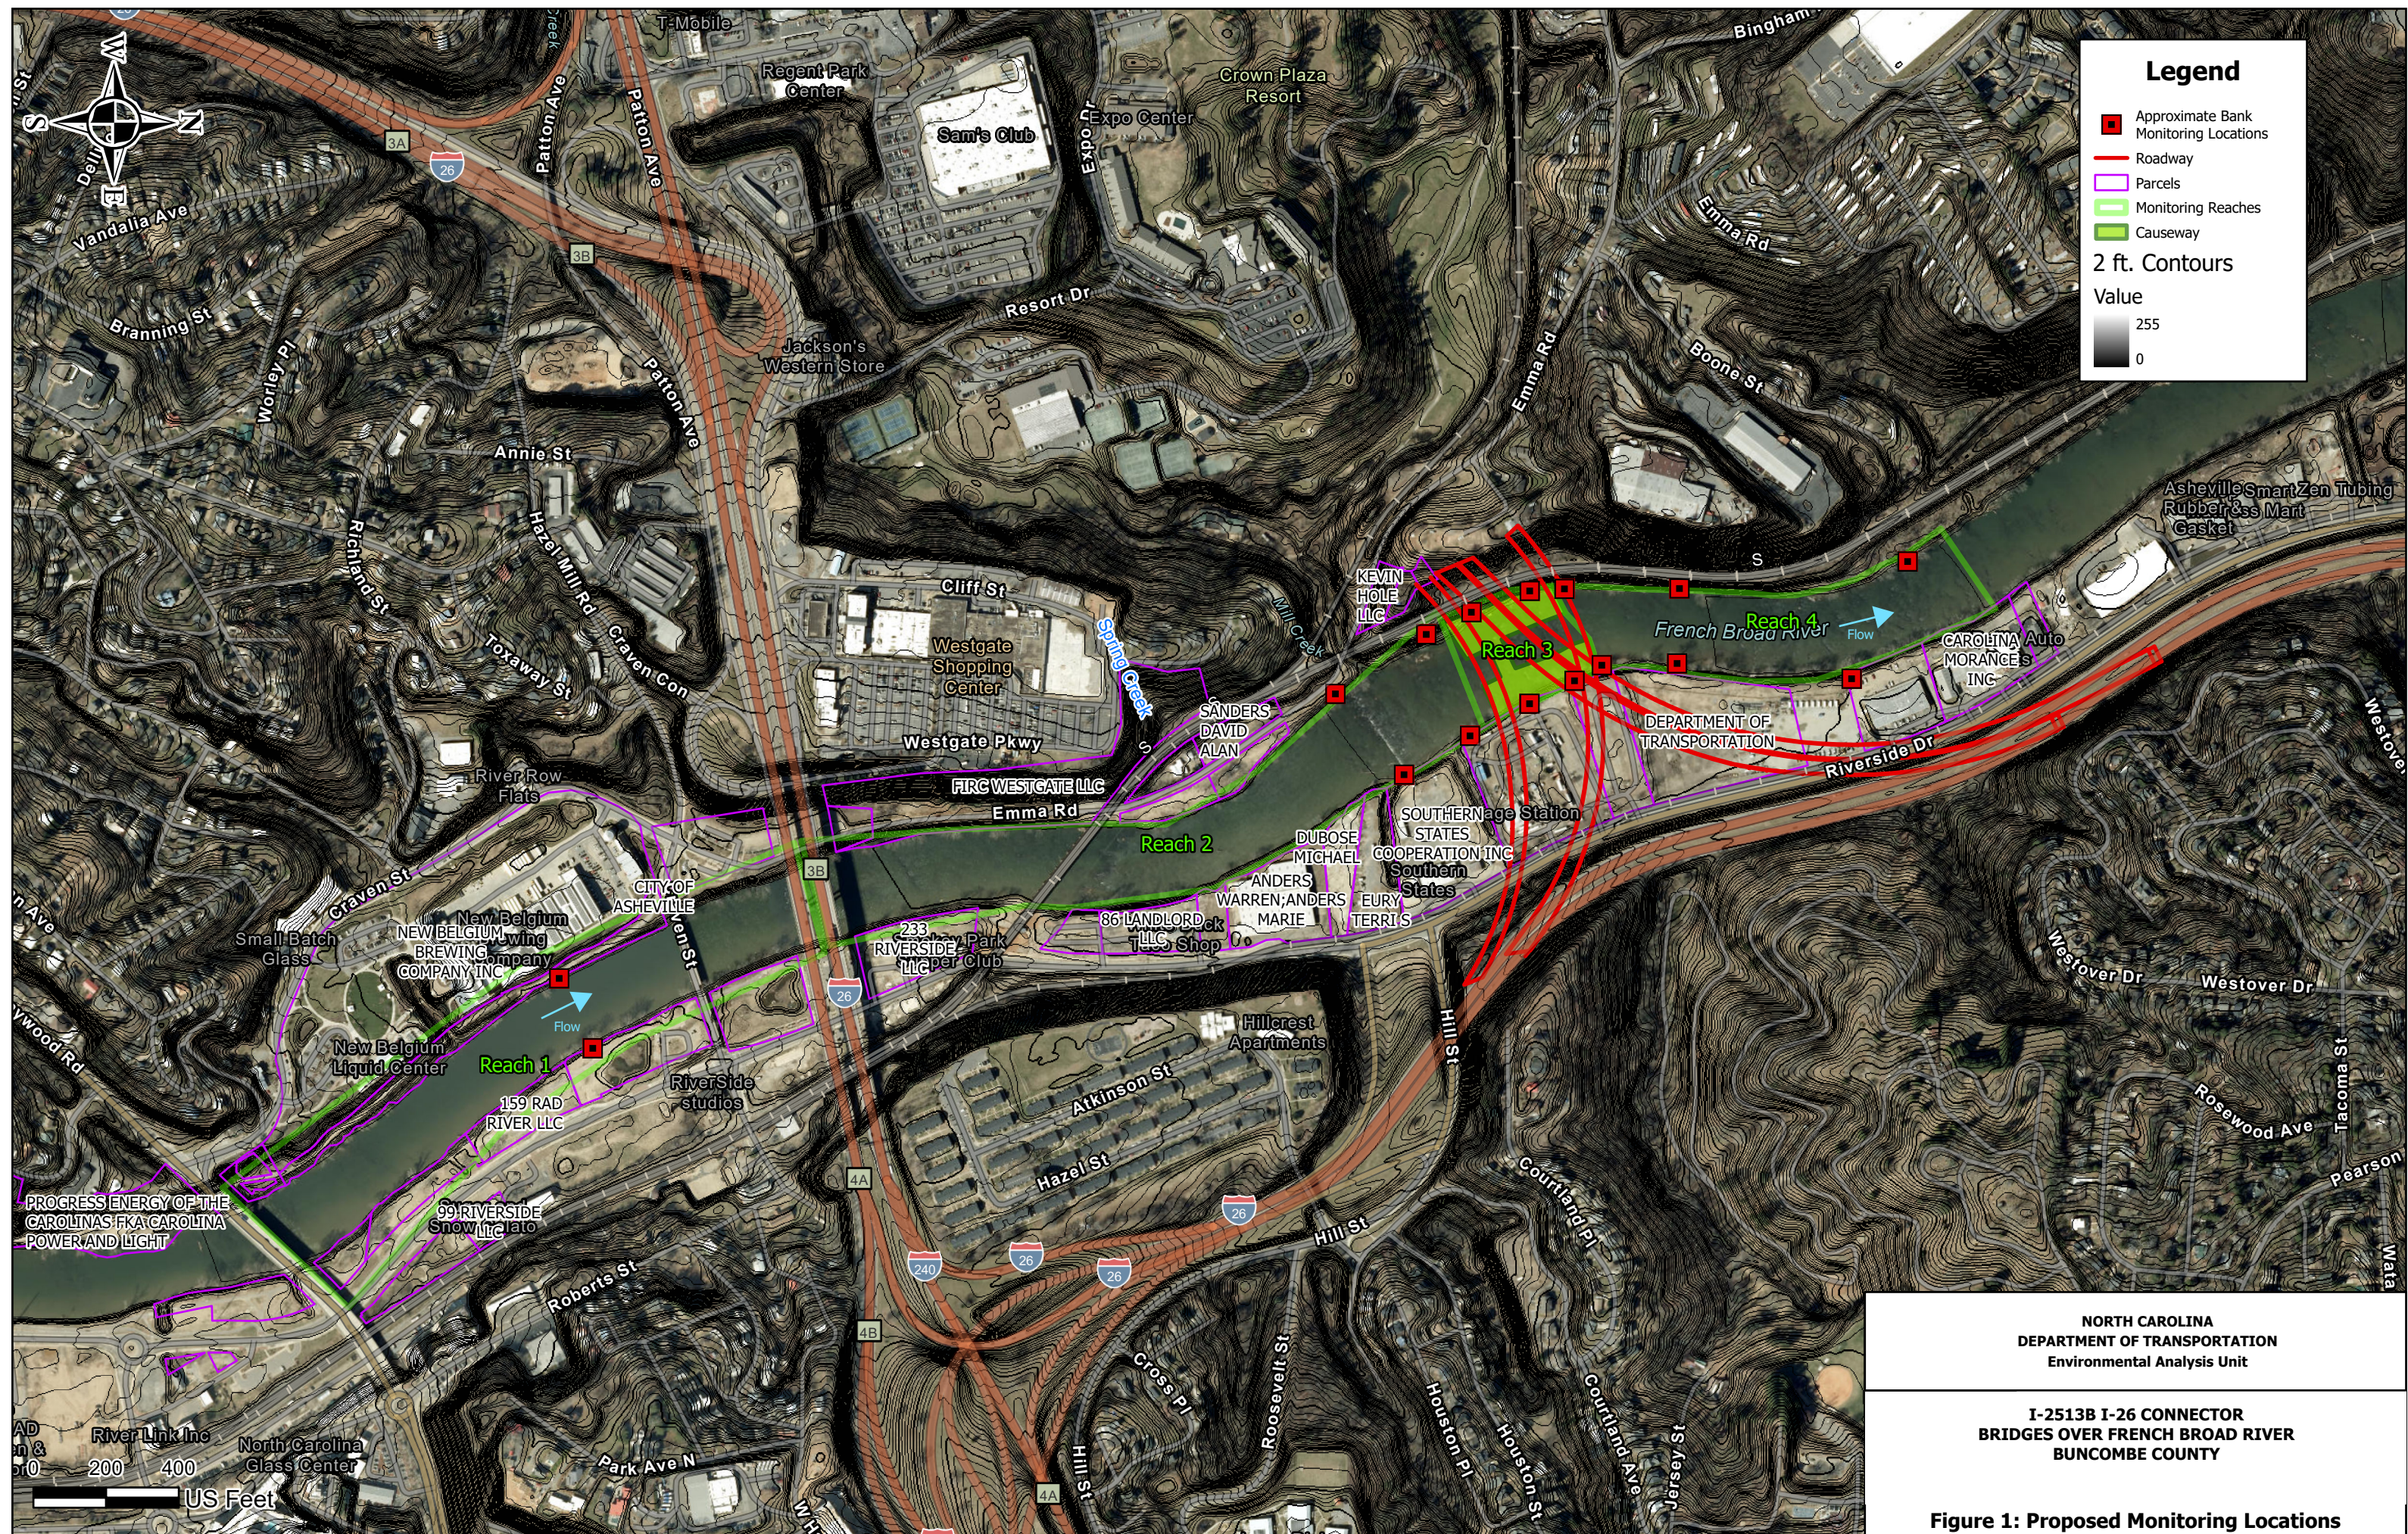
Monitoring will be conducted within four specific reaches along the French Broad River. The reach breakouts are defined in Table 1 and can be seen in Figure 1.

Figure 1 provides an overview of the proposed monitoring reaches as well as examples of potential monitoring locations throughout Reaches 1-4. Reach 1 extends a considerable distance upstream of the proposed activity as flow constriction is expected to cause a 'stacking' effect increasing water levels for the duration of in-stream construction activity. Most of the bank profile monitoring locations are proposed adjacent to or immediately upstream and downstream of the causeways. These areas are anticipated to experience increased shear stress and have higher potential for instability to occur. Final monitoring locations will be determined in the field subject to site access, safety considerations, landowner coordination, construction phasing, and constraints included in this section.

The Reach 2 bank profile monitoring locations will be placed beginning no more than 200 yards upstream of the causeway.

Reach 4 bank profile monitoring locations will be placed beginning no more than 200 yards from the upstream terminus of the Reach.

Reach 3 encompasses the temporary causeway and bridge construction area. Due to active construction within this reach, bank profile monitoring locations may be subject to disturbance, burial, relocation, or re-establishment over the course of the monitoring period. Such changes may result from activities including, but not limited to, riprap placement and removal, installation and removal of temporary access features, and construction phasing.

In addition, one pair of bank profiles will be established at the upstream and downstream extents of Reach 1 and Reach 4, respectively, to evaluate reference conditions outside of the primary construction influence area. Placement of these reference profiles will be subject to site access, safety considerations, and best professional judgment. Final bank profile survey locations will be documented in a base-line monitoring report and provided to the permitting agencies following the schedule noted in the 'Reporting' section below.
