SUBJECT: **Nationwide Permit 23, 33 and 13 Application** for the replacement of Bridge No. 211 over Richland Creek on SR 1519 in Haywood County. Division 14, Federal Aid Project No. BRZ-1519(2), State Project No. 8.2942601, WBS Element 33493.1.1, TIP No. B-4144.

PROJECT: 33493.1.1 (B-4144)  
REPLACEMENT OF BRIDGE NO.211  
OVER RICHLAND CREEK

Haywood County  
Bridge No. 211 on SR 1519 over Richland Creek  
Federal-Aid Project No. BRZ-1519(2)  
State Project 8.2942601  
WBS # 33493.1.1  
TIP Project No. B-4144

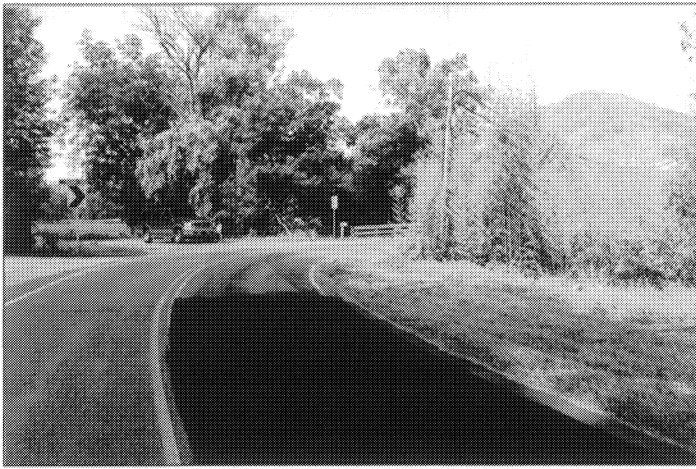
FIGURE 4 – COLOR PHOTOGRAPHS  
B-4144 Haywood County  
Bridge No. 211 on SR 1519 over  
Richland Creek

Looking Southwest Along SR 1519  
Toward Bridge No. 211

Bridge No. 211 was constructed in 1958. The existing structure is 71 feet in length and consists of two spans. The longest span is 35.8 feet in length. The clear roadway width is 19.2 feet, providing two 9.6-foot travel lanes with no effective shoulder width. The existing right of way width is 60 feet. The superstructure of Bridge No. 211 consists of a timber floor on I-beams with an asphalt wearing surface and timber railing. The substructure of the bridge consists of end bents and one interior bent. End bent 1 consists of a timber cap with timber piles and sheeting. Abutment 2 consists of Yount Masonry. The interior bent consists of a timber cap on timber piles with concrete sills. The bed to crown height is 18.4 feet. The normal depth of flow is 2.8 feet. The posted weight limit is 15 tons for single vehicles and 19 tons for truck-tractor semi-trailers.

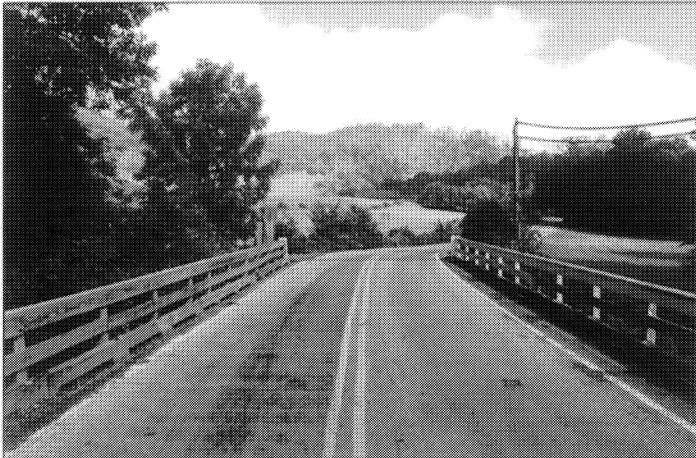
Looking Northwest Along SR 1519 on  
Bridge No. 211

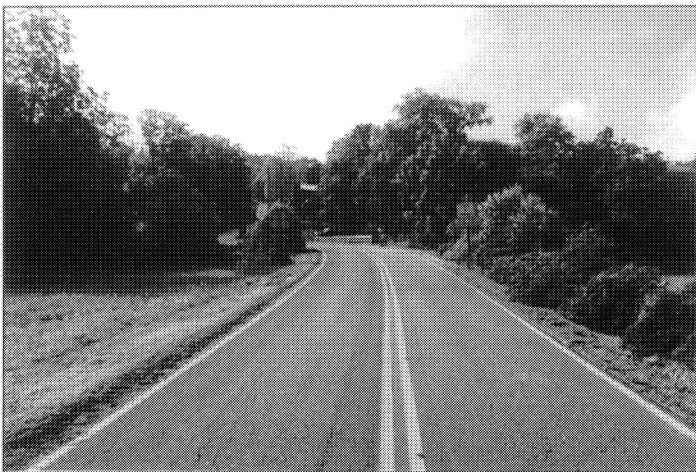
Looking Southeast Along SR 1519  
Toward Bridge No. 211

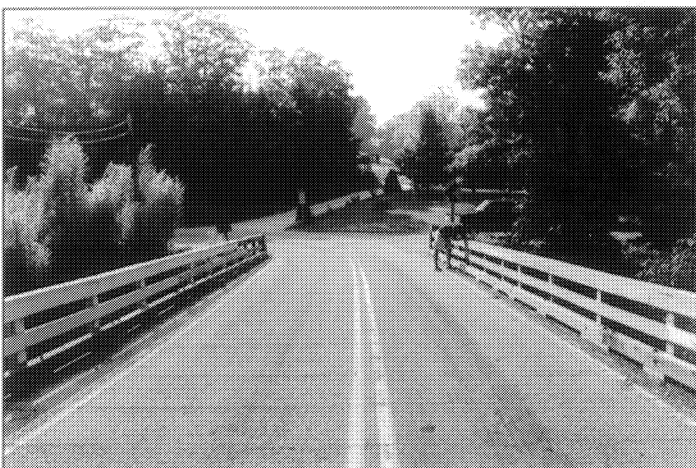
Looking Southeast Along SR 1519 on  
Bridge No. 211
