15-08-0019

## HISTORIC ARCHITECTURE AND LANDSCAPES NO HISTORIC PROPERTIES PRESENT OR AFFECTED FORM

| <b>Project No:</b> | W-5601AT | <b>County:</b> | Columbus |

Wedging and resurfacing curves on US 701 at SR 1005 (Peacock Road). Project length is 0.459 miles. There is no proposed new right-of-way to be acquired. Project area is located near the Wooten Crossroads area of Columbus County.

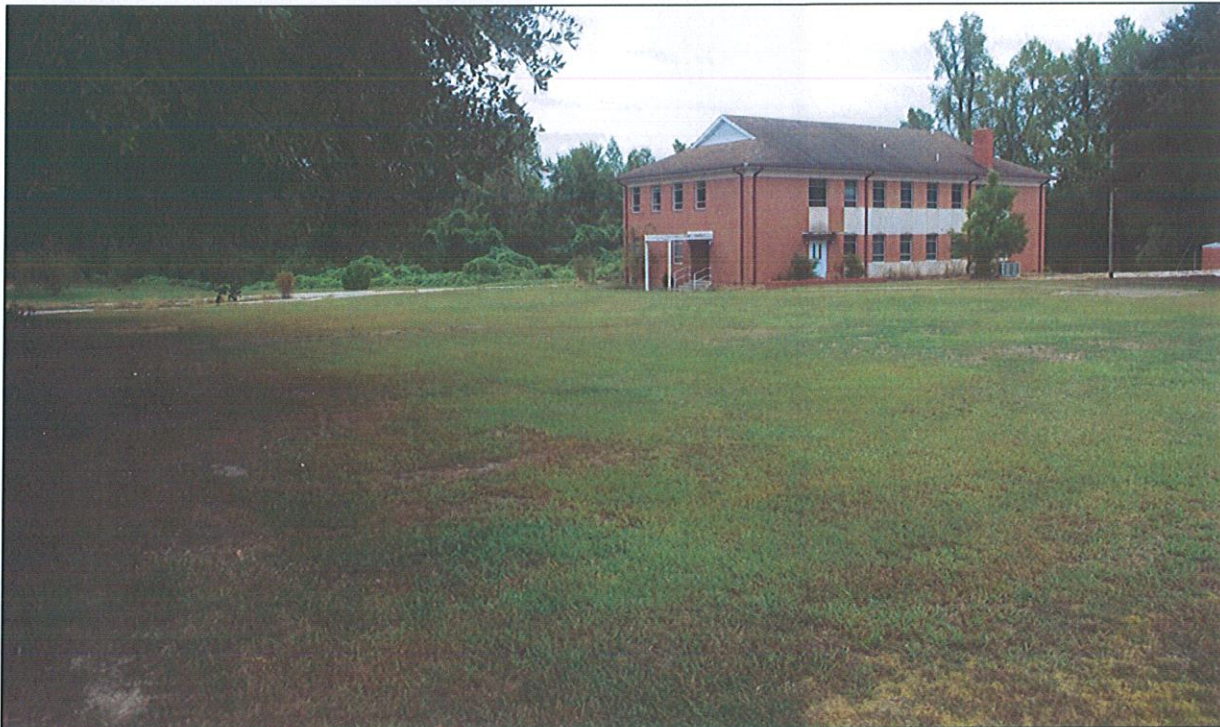
*Ca. 1950 Western Prong Baptist Church (now gone) site, with educational/office building still standing in the background, Peacock Road, Columbus County.*

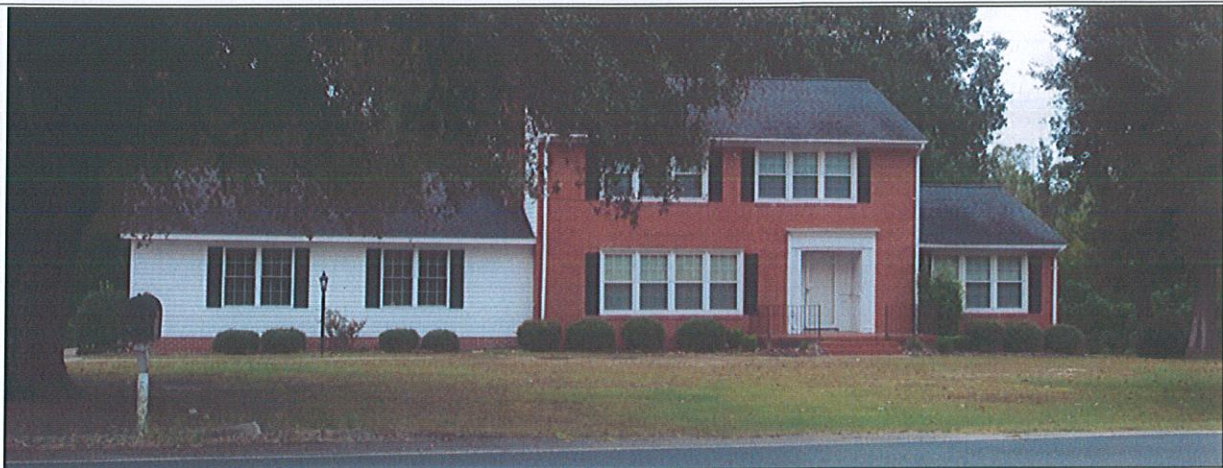
*Western Prong Baptist Church Parsonage, ca. 1945-1955, Peacock Rd, Columbus County.*

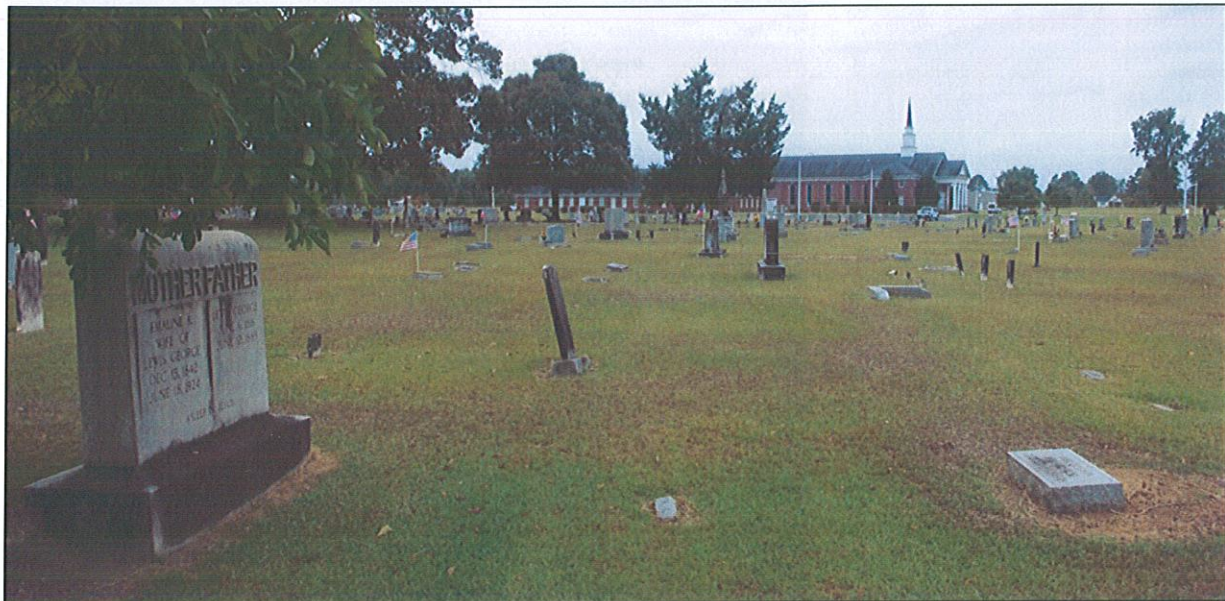
*Western Prong Baptist Church Cemetery with new ca. 2002 church in the background, facing west, Columbus County.*

Cemeteries are not ordinarily considered eligible for listing in the NRHP unless they meet special Criteria Considerations C or D in addition to the basic criteria, and in this case the Western Prong Baptist Church cemetery does not meet the special requirements necessary for a cemetery to be NRHP-eligible. Most of the grave markers date to the twentieth century and the cemetery as a whole does not contain enough distinctive markers nor are there any graves having the level of historical importance needed to qualify for the National Register criteria.

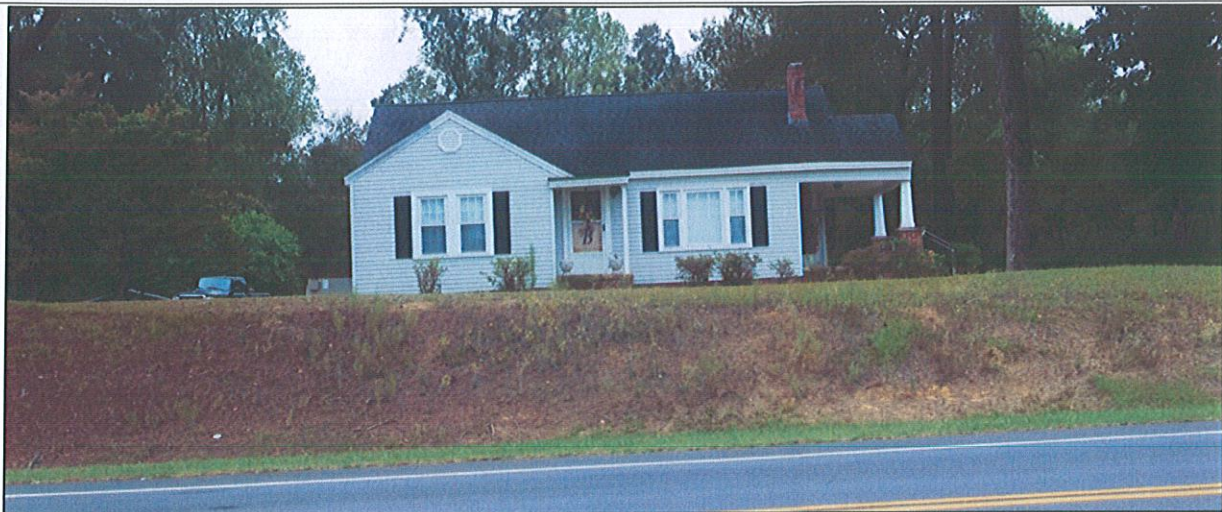
Neither of the individual houses that were surveyed appears to be eligible for the NRHP. The ca. 1935 house is a one-story, side-gabled minimal traditional house with an engaged carport supported by tapered posts atop brick piers. The façade features a projecting gabled wing on one side pierced with a 6/6 sash double window, a central single-leaf entrance door, and a tripartite picture window on the other side of the entrance. A brick interior chimney rises up from the roof. The house sites on a brick foundation and is clad with replacement siding. This house is unremarkable architecturally and does not possess the significance needed for potential eligibility for the NRHP.

*Ca. 1935 house within APE located on US 701, facing east, Columbus County.*

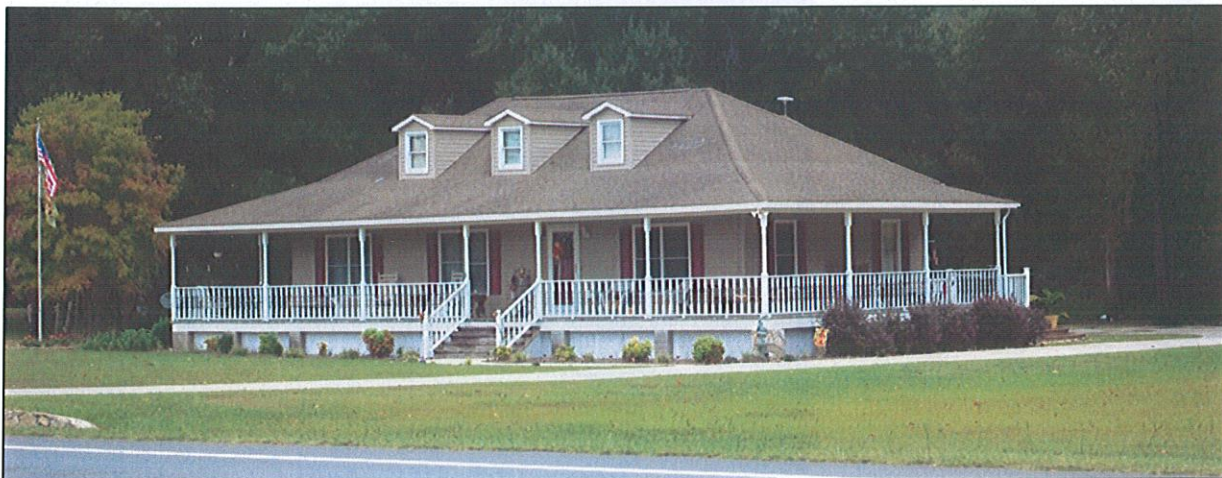
The second house, a ca. 1920 one-and-a-half-story dwelling, has been heavily altered with vinyl siding, replacement windows, changes to the porch and possible large additions. Its hipped roof is pierced by three dormer windows and continues outward to form an engaged wrap-around porch. It does not possess the integrity needed for eligibility to the NRHP.

*Ca. 1920 house, now severely altered, located on US 701, facing east, Columbus County.*

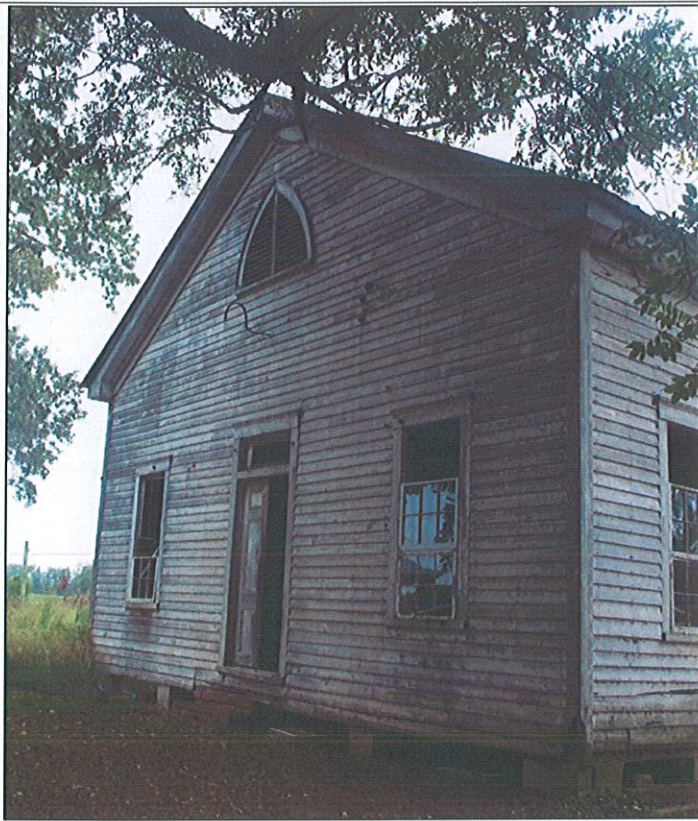
According to surviving signage at the former church site, Western Prong Baptist Church was established in 1843. However, the church's cemetery contains grave markers that date to earlier than 1843, suggesting an older church may have existed perhaps dating to the first quarter of the nineteenth century. Additionally, after talking with an older church member, we learned that a couple of different wooden church buildings preceded the ca. 1950 brick church. One of which was moved to the property directly west of the ca. 1950 brick church site and used as a farm outbuilding (see photo below).

*One of the wooden church buildings used for the Western Prong Baptist Church, pre-1950, Peacock Road, Columbus County.*

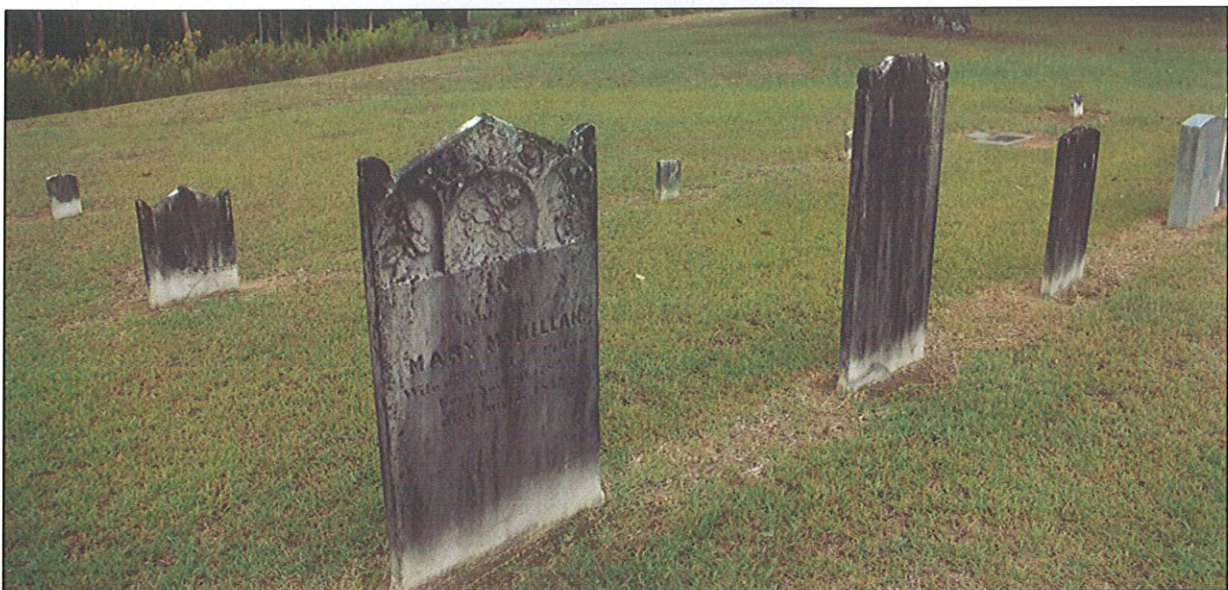
The church cemetery contains over 800 graves and its markers vary widely from high style substantial monuments and obelisks to military markers honoring Revolutionary, War of 1812, Confederate, and WWII Veterans, to family plots with defined borders and traditional headstones. Some of the more notable nineteenth century markers, such as those of the Wooten Family, contain traditional funerary motifs. The earliest markers found dated to the 1830s.

*Some of the older grave markers from the Western Prong Baptist Church Cemetery, Columbus County.*

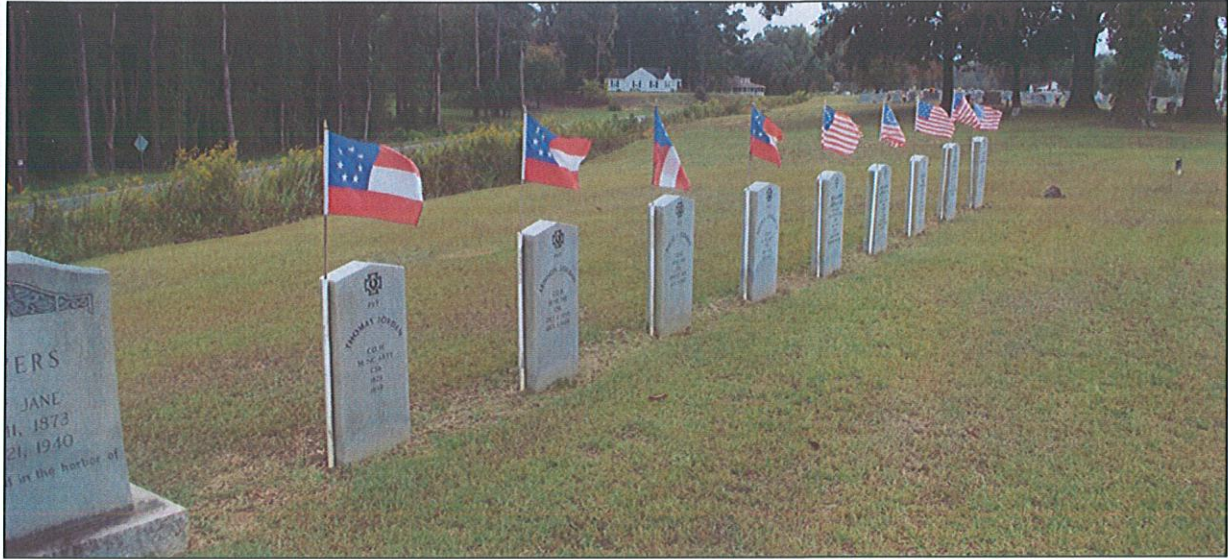
*Military markers from the Western Prong Baptist Church Cemetery, Columbus County.*

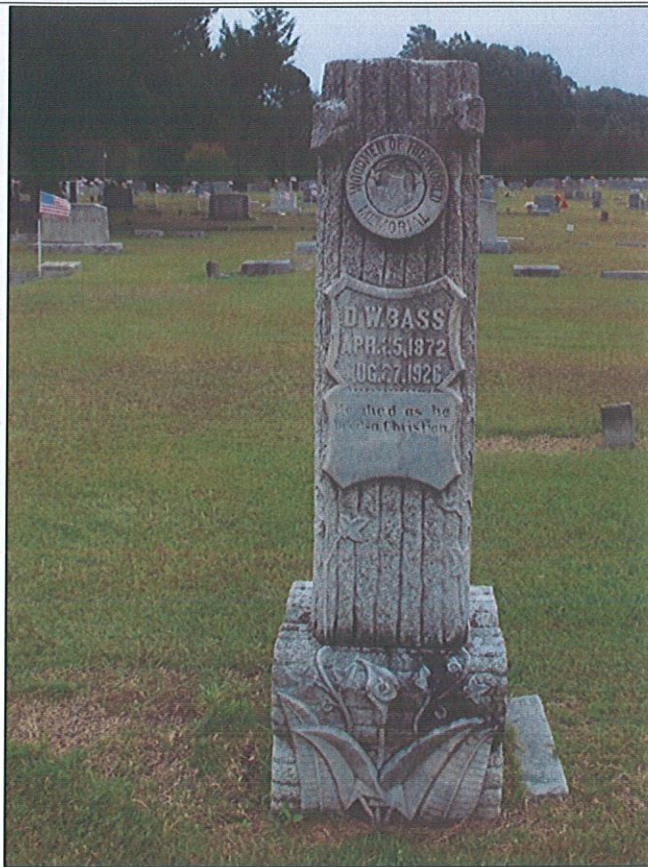
*A "Woodmen of the World" memorial gravestone marks the grave of D.W. Bass from the Western Prong Baptist Church Cemetery, Columbus County.*
