PROFILE 17' LT OF -L-	
BRIDGE 108 OVER LOWER BARTON'S CREEK ON SR 1834	
WAKE COUNTY	
Project No.: 8.2407901	Tip No.: B-3704
Federal No.: BRZ-1834 (2)	Vert. Scale: 1" = 10 FEET
Date: OCTOBER 2003	Horiz. Scale: 1" = 20 FEET
Drawn By: DJG	Drawing No.: 7

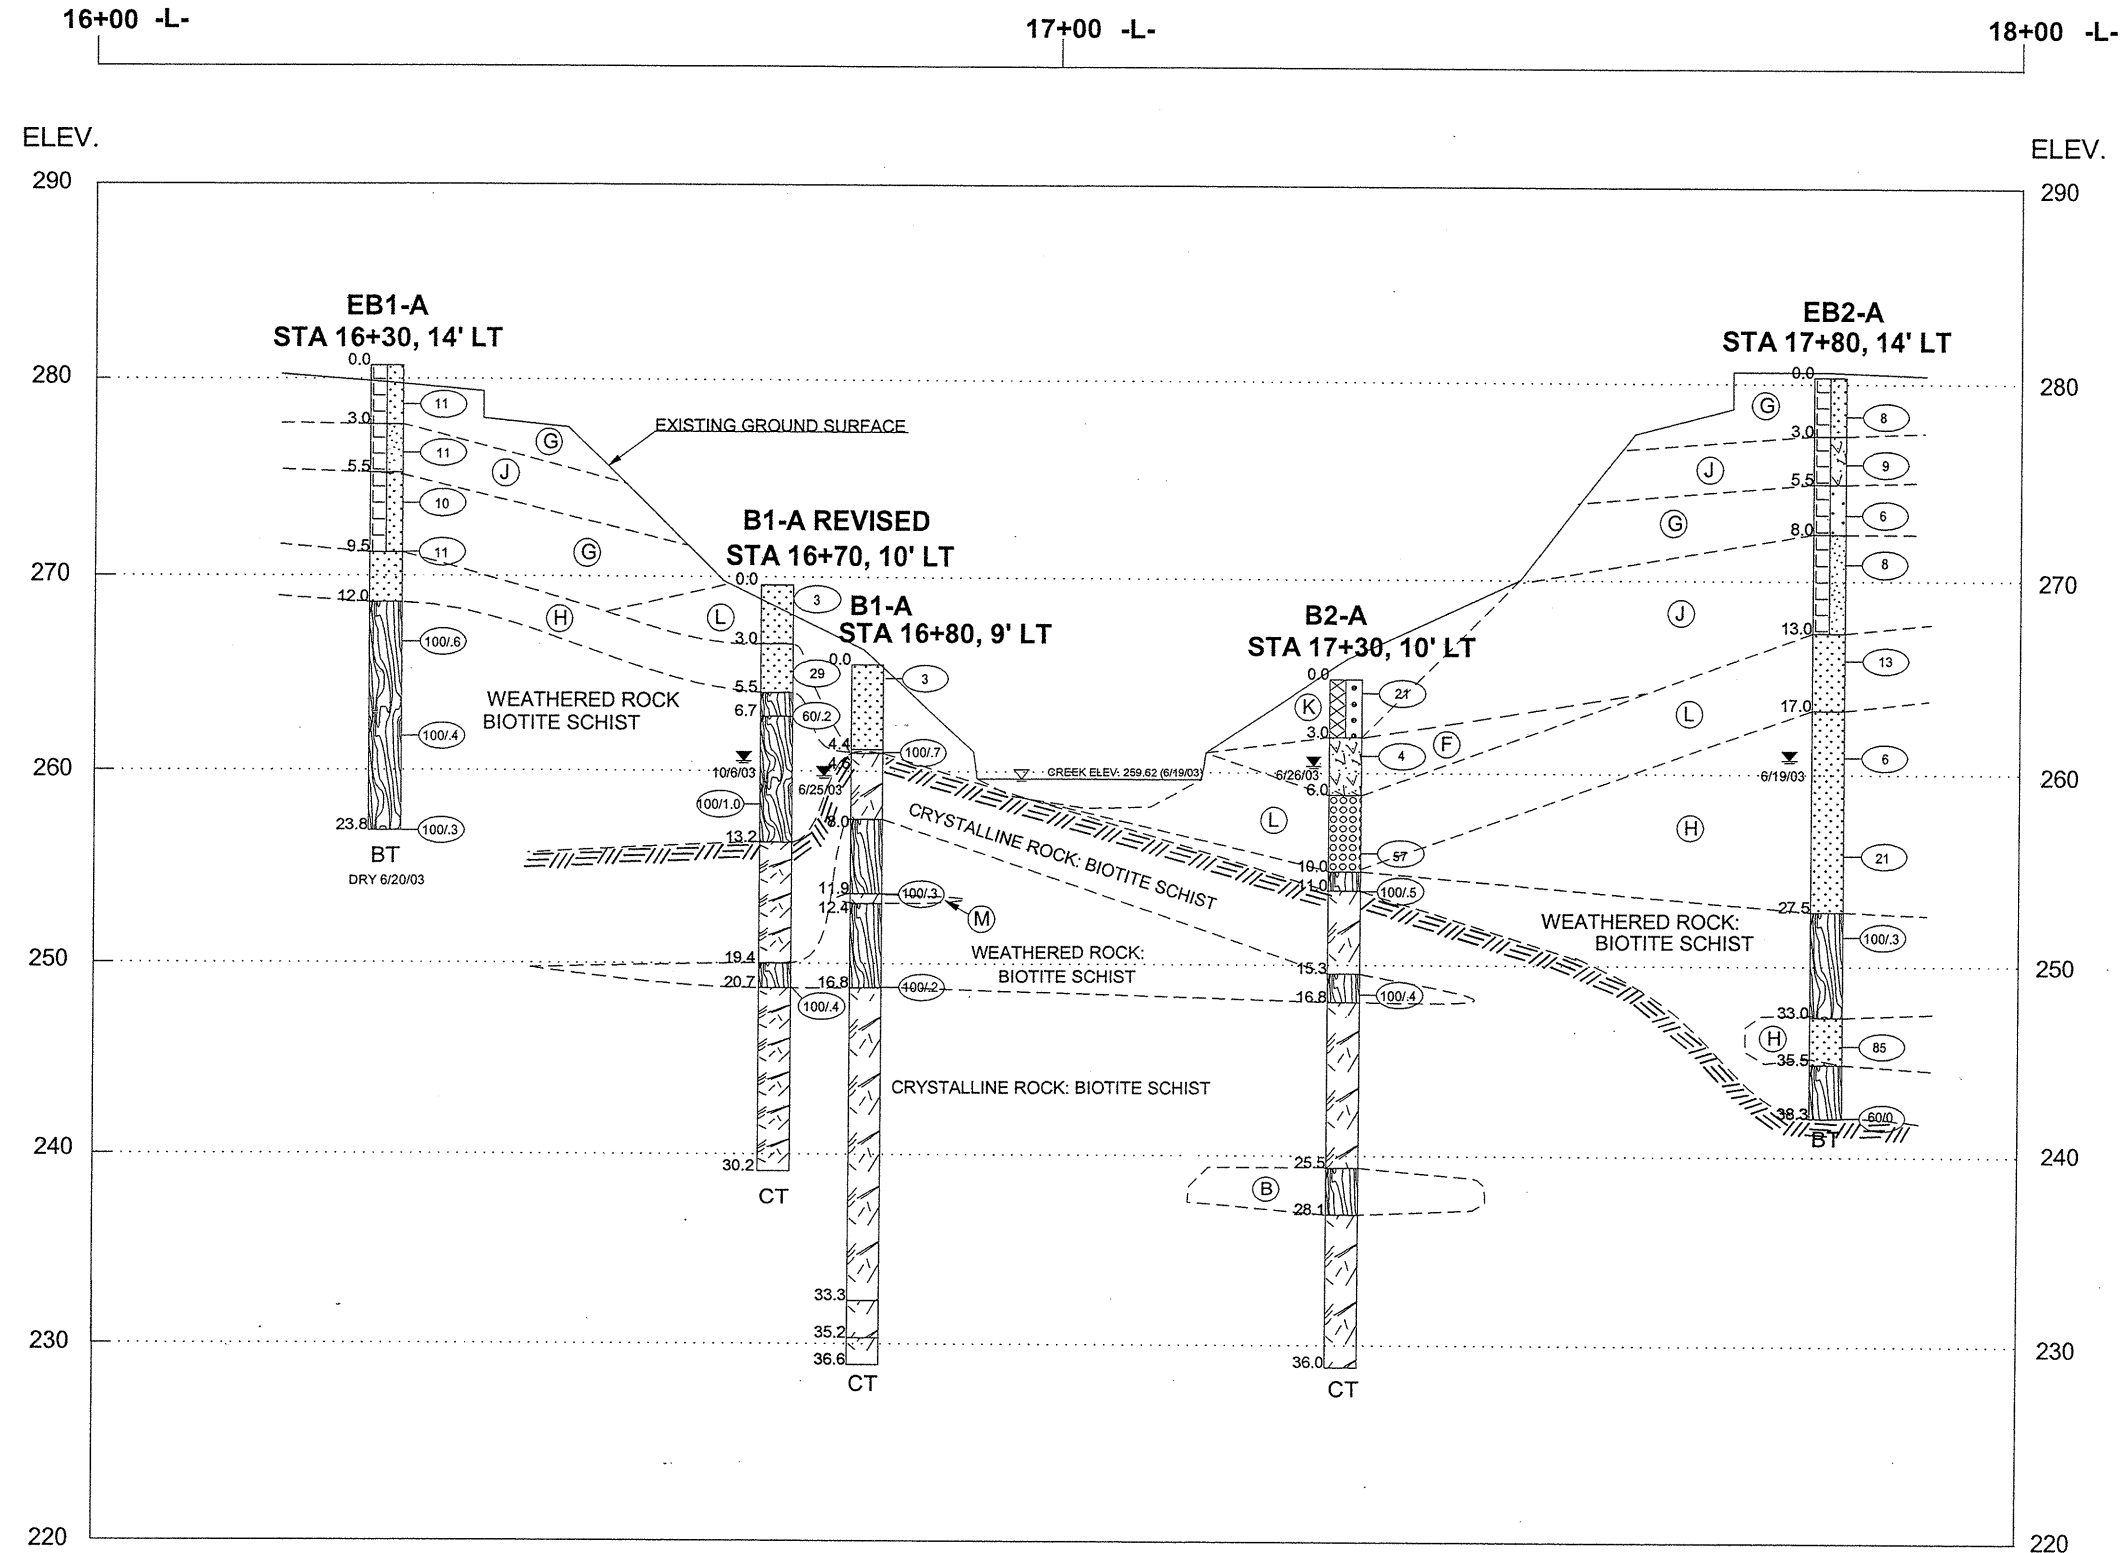
- (B) WEATHERED ROCK: BIOTITE SCHIST
- (F) ALLUVIAL: SOFT RED-BROWN MICACEOUS FINE SANDY CLAYEY SILT WITH GRAVEL (A-5)
- (G) ROADWAY EMBANKMENT: LOOSE TO MEDIUM DENSE BROWN AND GRAY MICACEOUS SILTY FINE TO COARSE SAND (A-2-4 / A-2-5)
- (H) RESIDUAL: LOOSE TO HARD TAN BROWN MICACEOUS SILTY COARSE TO FINE SAND (A-2-4)
- (J) ROADWAY EMBANKMENT: SOFT TO STIFF RED BROWN AND GRAY FINE TO COARSE SANDY CLAYEY SILT (A-4 / A-5)
- (K) ARTIFICIAL FILL / RIP RAP: INFILLED WITH ALLUVIAL: MEDIUM DENSE BROWN SILTY FINE TO COARSE SAND WITH SOME GRAVEL AND WOOD DEBRIS (A-3)
- (L) ALLUVIAL: VERY LOOSE TO VERY DENSE BROWN MICACEOUS SILTY COARSE TO FINE SAND WITH ORGANICS, GRAVEL AND COBBLES (A-2-4, A-1-b)
- (M) CRYSTALLINE ROCK: BIOTITE SCHIST

NOTE: REFER TO BORING/CORING LOGS FOR MORE DETAILED DESCRIPTIONS
