CROSS SECTION ALONG RIGHT LANE END BENT 1  
 SITE 1: DUAL STRUCTURES ON CLAYTON BYPASS (-L-) OVER WHITE OAK CREEK (AUSTIN POND)  
 NCDOT PROJECT No. 8.T311002 (R-2552AB)  
 F.A. PROJECT No. NHF-60-1(9)  
 JOHNSTON COUNTY, NORTH CAROLINA

MACTEC ENGINEERING & CONSULTING, INC.  
 RALEIGH, NORTH CAROLINA

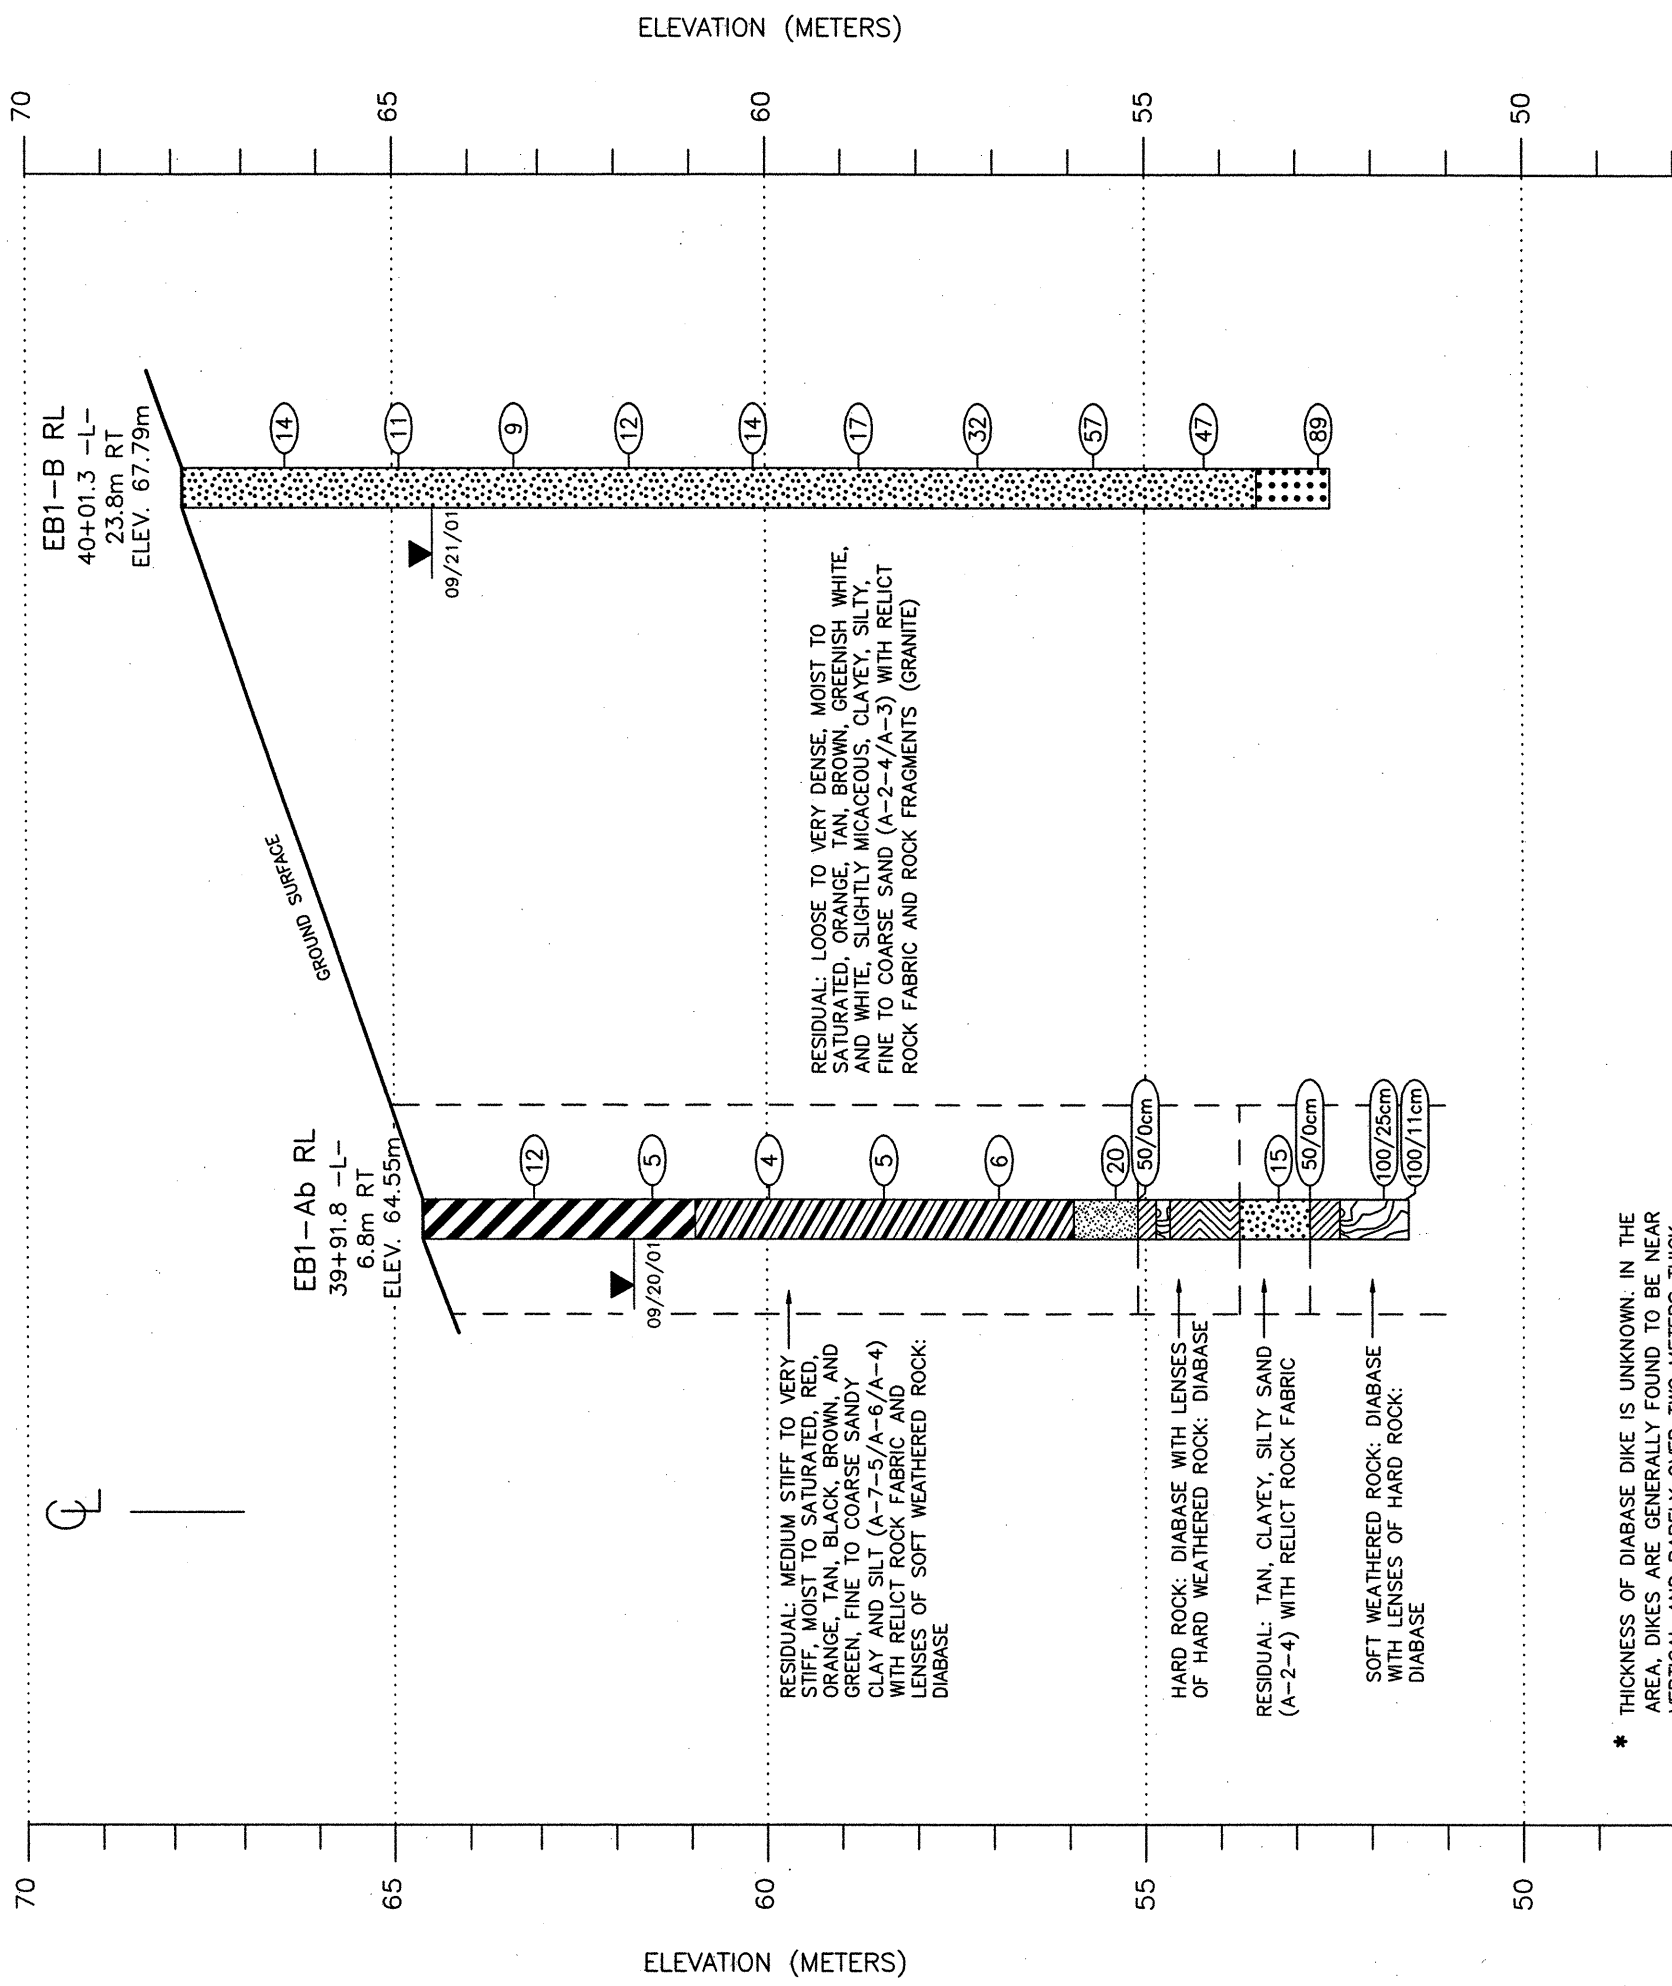
SHEET NO.	TOTAL SHEETS
57	107

RESIDUAL: LOOSE TO VERY DENSE, MOIST TO SATURATED, ORANGE, TAN, BROWN, GREENISH WHITE, AND WHITE, SLIGHTLY MICACEOUS, CLAYEY, SILTY, FINE TO COARSE SAND (A-2-4/A-3) WITH RELICT ROCK FABRIC AND ROCK FRAGMENTS (GRANITE)

RESIDUAL: MEDIUM STIFF TO VERY STIFF, MOIST TO SATURATED, RED, ORANGE, TAN, BLACK, BROWN, AND GREEN, FINE TO COARSE SANDY CLAY AND SILT (A-7-5/A-6/A-4) WITH RELICT ROCK FABRIC AND LENSES OF SOFT WEATHERED ROCK: DIABASE

HARD ROCK: DIABASE WITH LENSES OF HARD WEATHERED ROCK: DIABASE

RESIDUAL: TAN, CLAYEY, SILTY SAND (A-2-4) WITH RELICT ROCK FABRIC

SOFT WEATHERED ROCK: DIABASE WITH LENSES OF HARD ROCK: DIABASE

\* THICKNESS OF DIABASE DIKE IS UNKNOWN. IN THE AREA, DIKES ARE GENERALLY FOUND TO BE NEAR VERTICAL AND RARELY OVER TWO METERS THICK. WE ASSUME DIKE THICKNESS AT THE SITE TO BE 2 METERS.
