SUBSURFACE INVESTIGATION REPORT

Electromagnetic Induction, Magnetic Detection & *GPR Survey*

**Anderson, James Arthur Property (Parcel 66)
Andy's Garage
1104 Myrtle Street
Greenville, North Carolina**

July 19, 2012

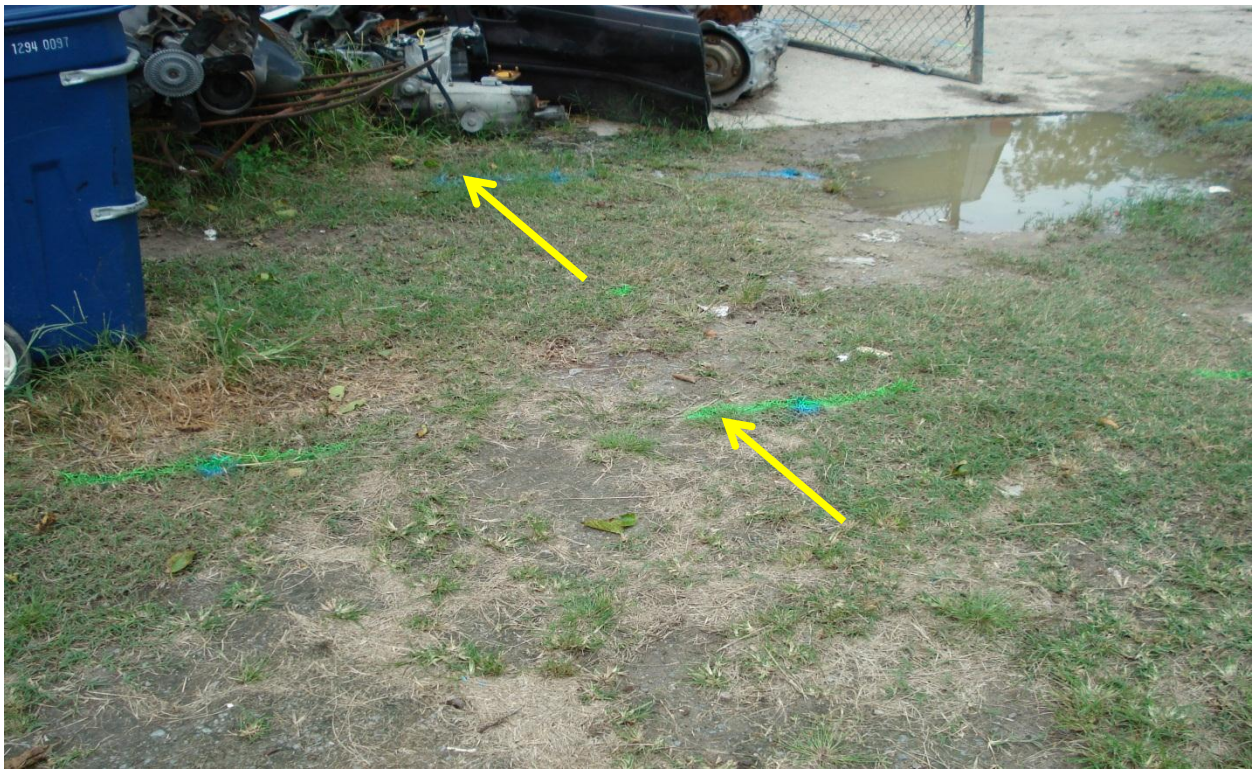
5. An unknown utility was discovered west of the building traveling in a northerly direction from Myrtle Street. This was detected using Surface Ground Penetrating Radar. A sketch of this area is included on page 10.

6. A Gravity Sanitary pipe was detected to the west of the building from Myrtle Street. This was detected using Surface Ground Penetrating Radar. A sketch of this area is included on page 10.

Unknown utility marked in blue and Sanitary Sewer marked in green
