PLAN OF SPAN E

PROJECT NO. I-5788  
CUMBERLAND COUNTY  
 BRIDGE NO. 158

STATE OF NORTH CAROLINA  
 DEPARTMENT OF TRANSPORTATION  
 RALEIGH  
 SUPERSTRUCTURE  
 REPAIR  
 SPAN E  
 SBL

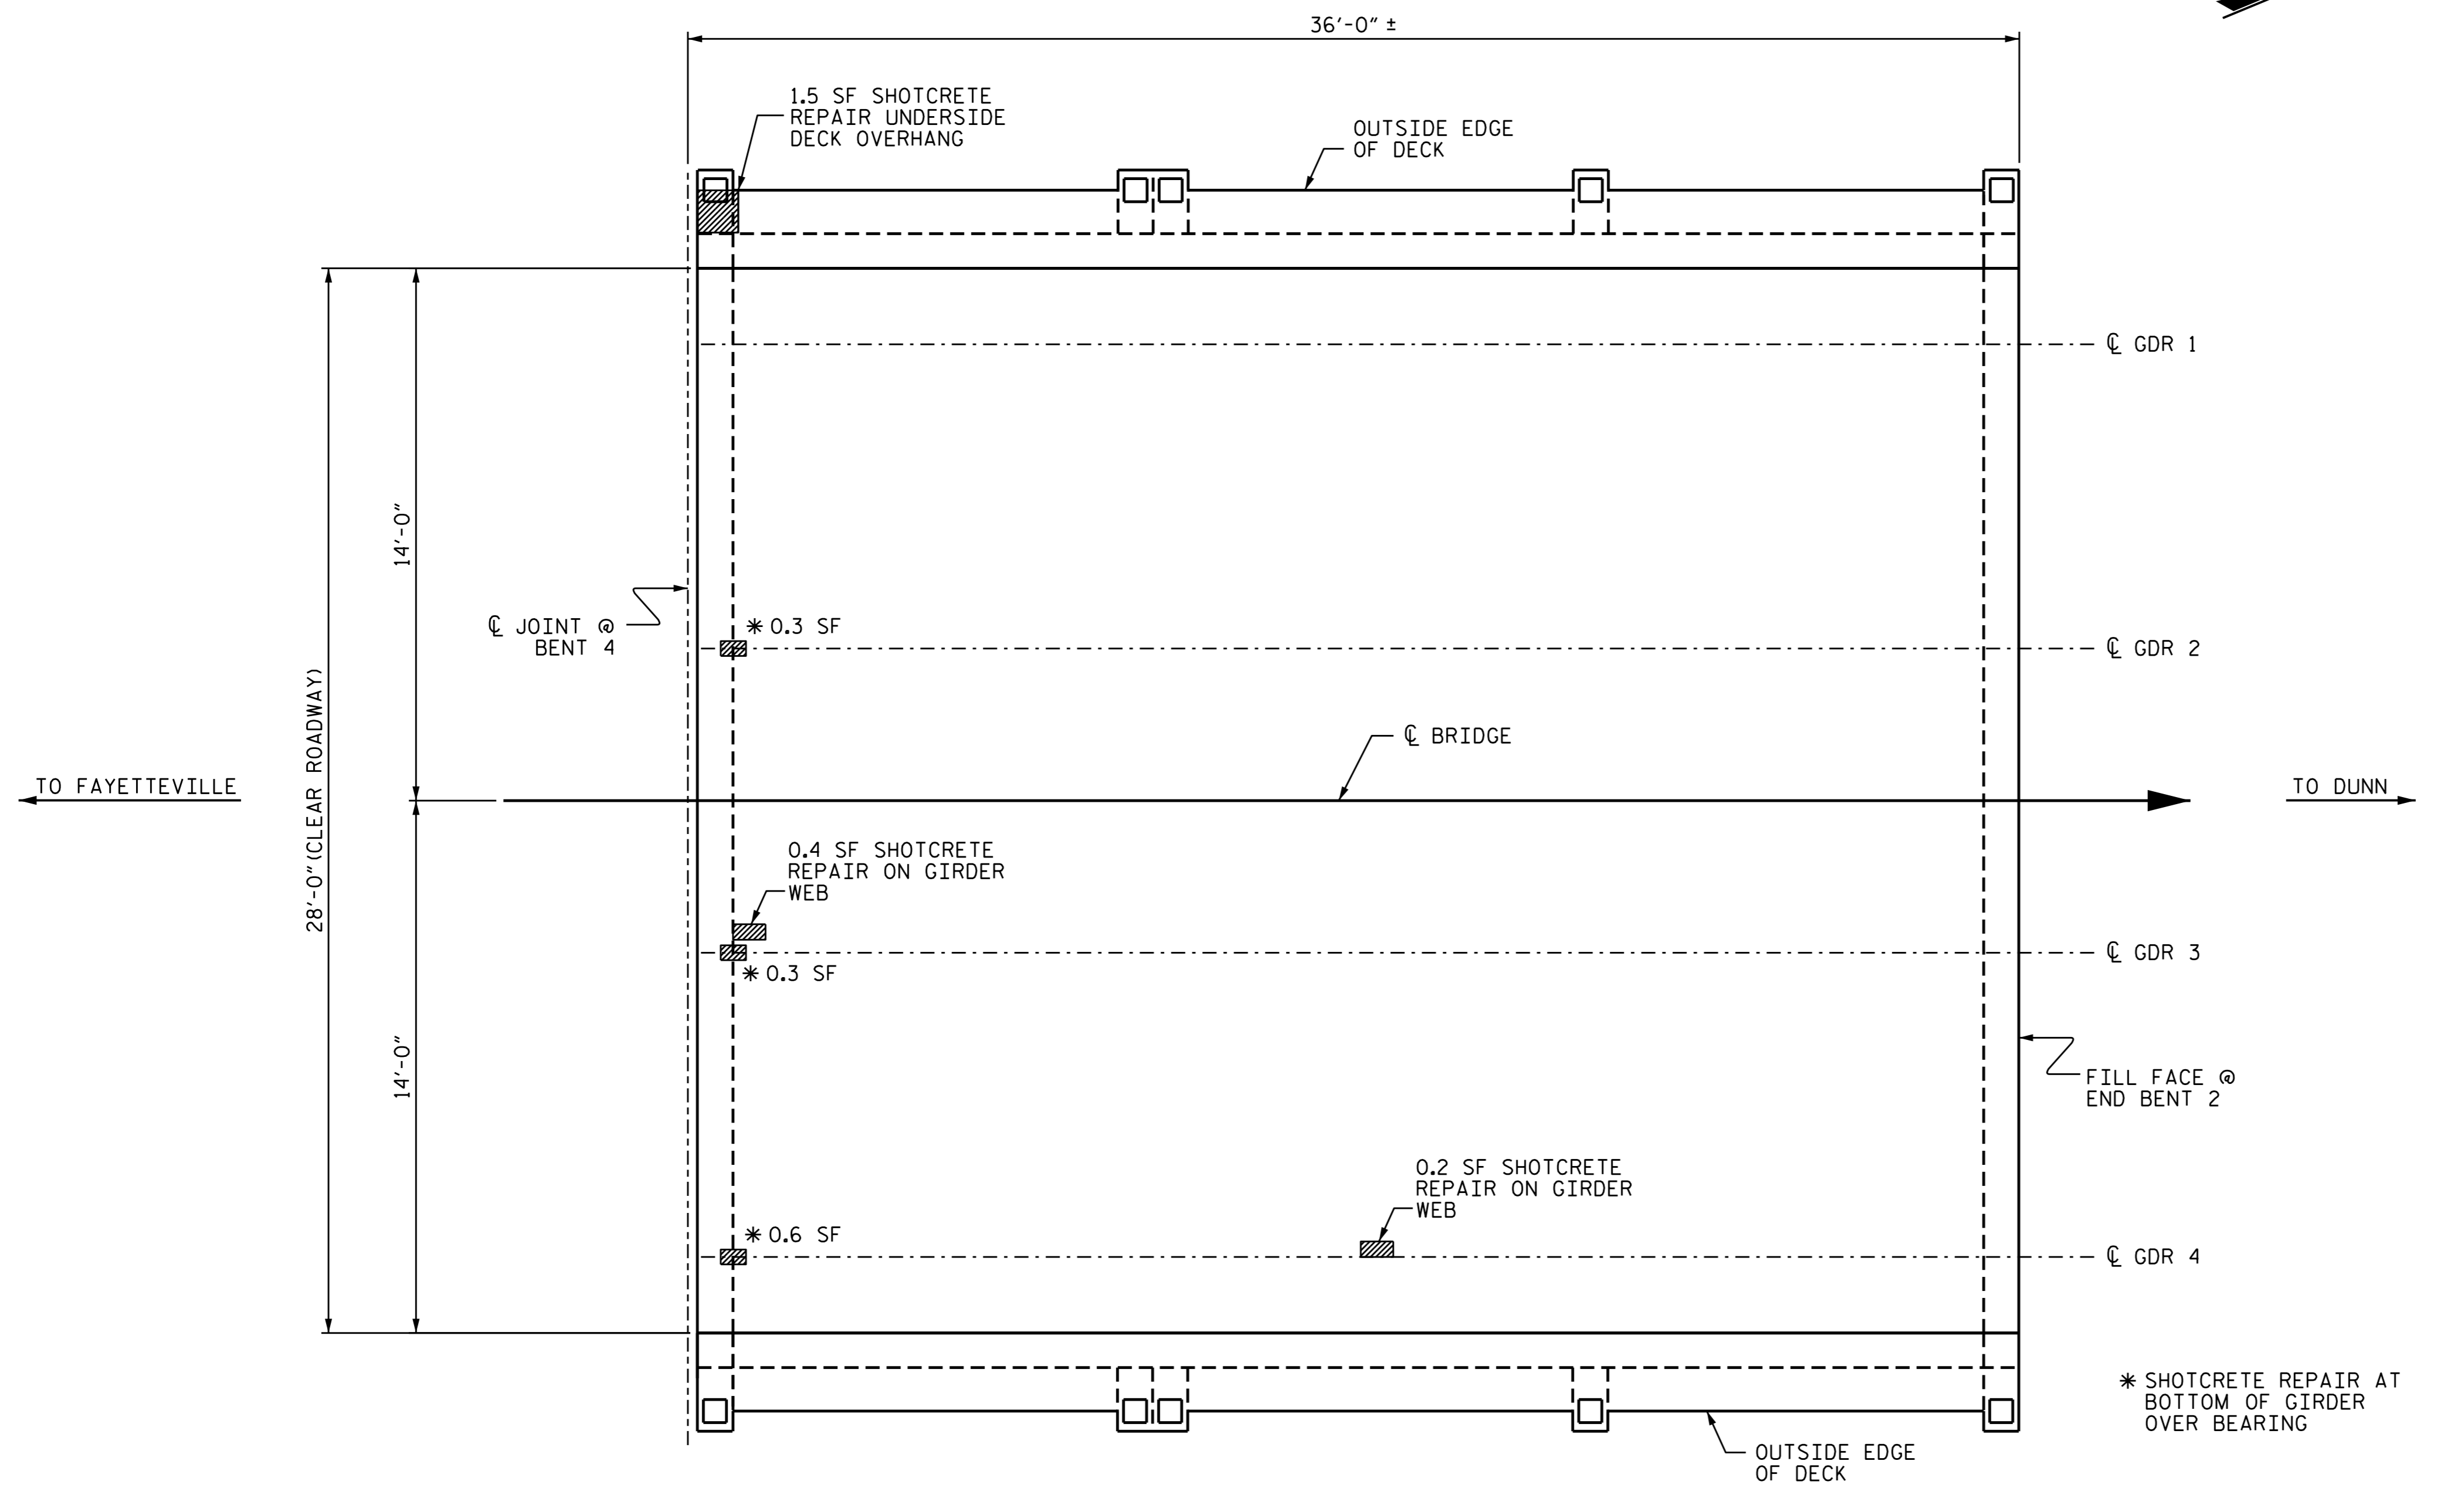
REPAIR CONCRETE BENT DIAPHRAGMS AS DIRECTED BY THE ENGINEER.

\* SHOTCRETE REPAIR AT BOTTOM OF GIRDER OVER BEARING

FOR BENT DIAPHRAGM AND RC DECK GIRDER REPAIR DETAILS SEE SHEET S-24.
