DETAILS OF REPAIRING EXISTING PAVEMENT PRIOR TO RESURFACING FOR FULL DEPTH AND MILLING

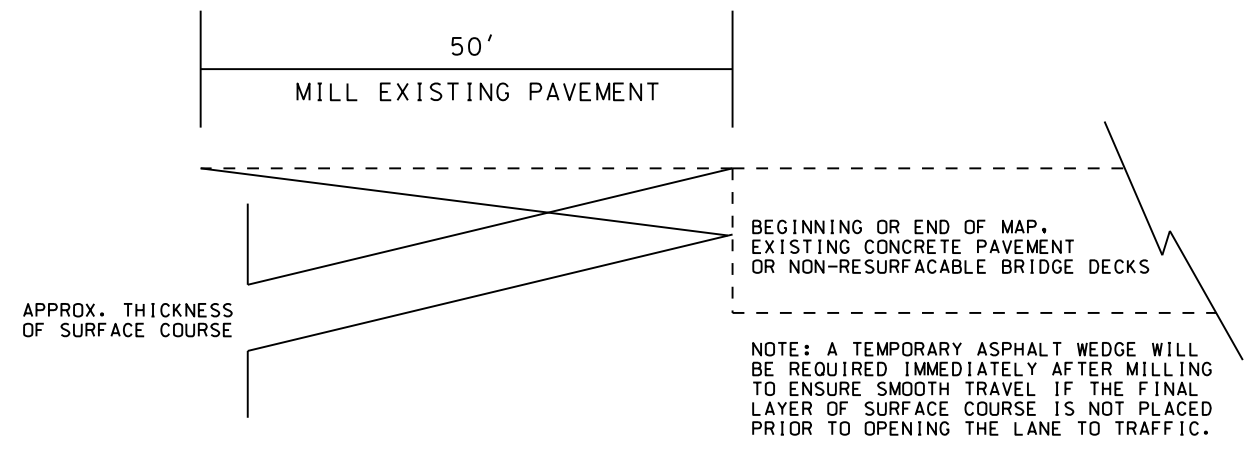
DETAIL FOR INCIDENTAL MILLING:
BEGINNING OR END OF MAP & BRIDGES
