PROJECT NO. I-5892
BUNCOMBE COUNTY
BRIDGE NO. 422

SHEET 2 OF 4

BENT 1
SPAN B FACE

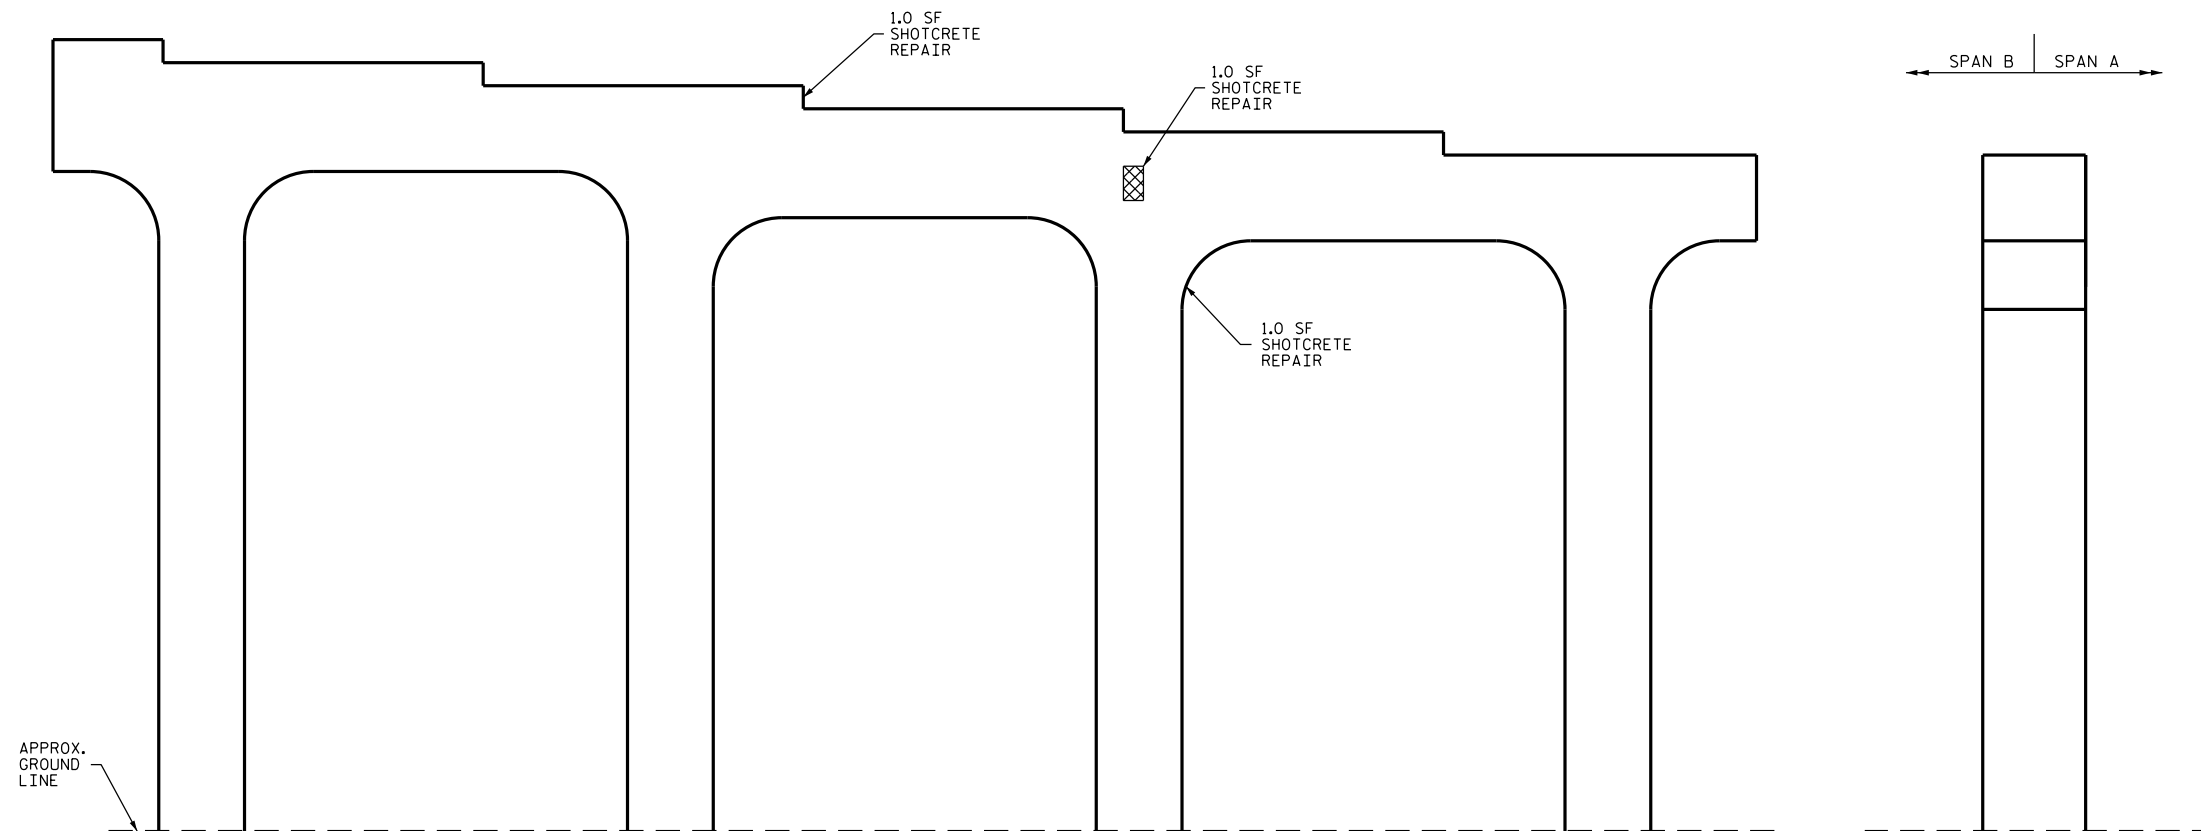
ELEVATION
(SPAN B FACE)

DAMAGED AREA

EPOXY RESIN INJECTION

BOTTOM OF CAP

APPROX. GROUND LINE

FOR REPAIRS, SEE "TYPICAL CAP AND COLUMN REPAIR DETAILS" SHEET.

CLEAN AND REMOVE DEBRIS FROM THE TOP OF THE CAP AND APPLY EPOXY PROTECTIVE COATING. EPOXY COATING SHALL BE APPLIED TO THE TOP FACE OF THE CAP. THE CONTRACTOR SHALL NOT COAT THE AREA OF THE CAP BENEATH THE MASONRY PLATES. FOR EPOXY COATING, SEE SPECIAL PROVISION.
