PROJECT NO. I-5892
BUNCOMBE COUNTY
 BRIDGE NO. 429
 SHEET 3 OF 3

**BENT 3
 COLUMN SIDE VIEWS**

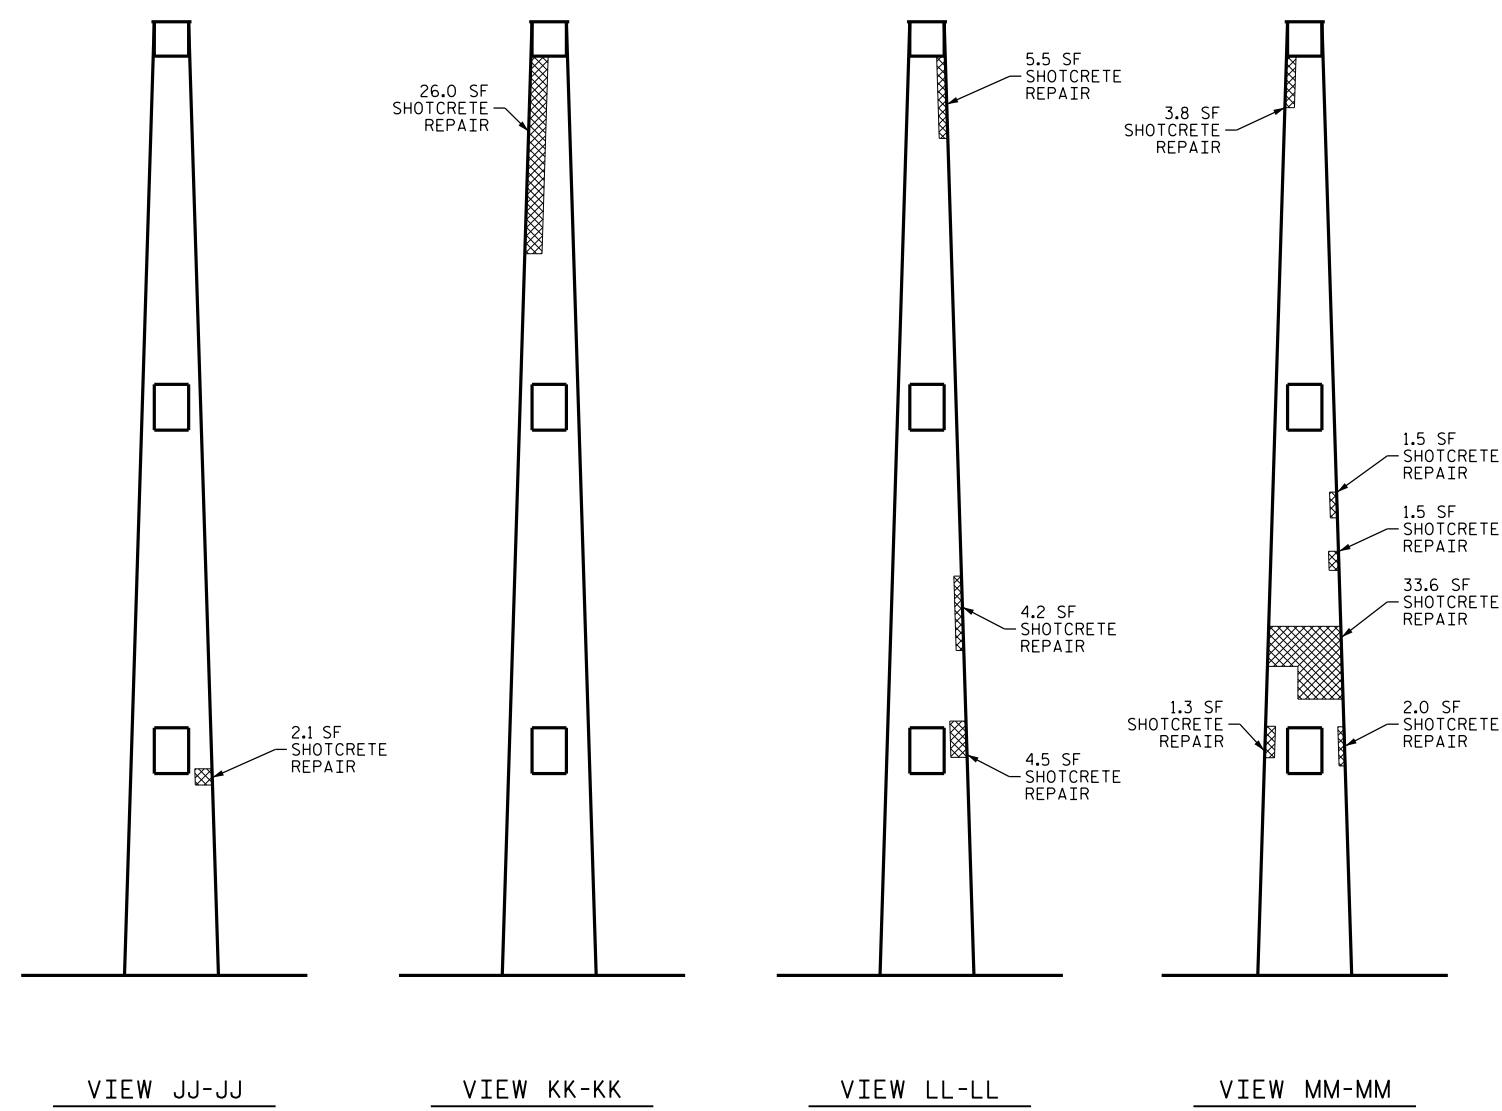
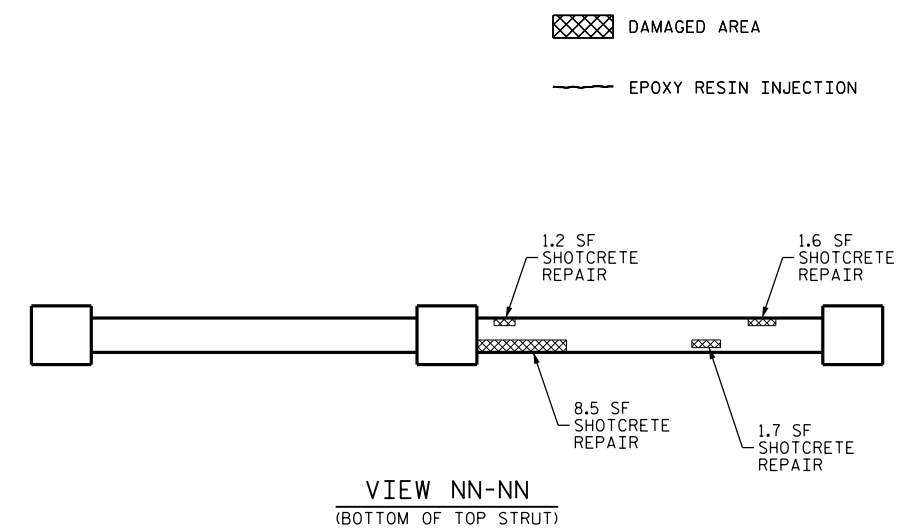
DAMAGED AREA
 EPOXY RESIN INJECTION

BENT 3

FOR REPAIRS, SEE "TYPICAL CAP AND COLUMN REPAIR DETAILS" SHEET.

CLEAN AND REMOVE DEBRIS FROM THE TOP OF THE CAP AND APPLY EPOXY PROTECTIVE COATING. EPOXY COATING SHALL BE APPLIED TO THE TOP FACE OF THE CAP. THE CONTRACTOR SHALL NOT COAT THE AREA OF THE CAP BENEATH THE MASONRY PLATES.
