| DocuSigned by: | | | | | | |
|--|---|---|---|---|---|---|
| | DEPARTMENT OF TRANSPORTATION | | | | | |
| 12/13/2016 | SUBSTRUCTURE CONC.<br>REPAIR - BENT 135 | | | | | |

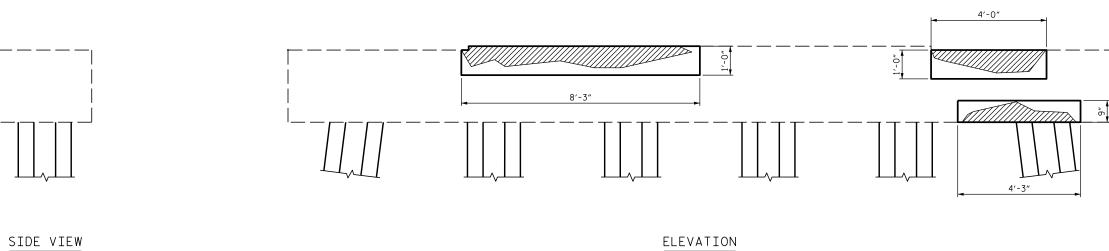
| DocuSigned by: | | | | | | |
|--|---|---|---|---|---|---|
| DOCUMENT NOT CONSIDERED | NO. BY: | DATE: | NO. | BY: | DATE: | S-154 |

SUBSTRUCTURE SPALL/DELAMINATION

PROPOSED REPAIR AREAS
