B-5938 PROJECT NO.\_\_\_\_ CARTERET COUNTY 68 BRIDGE NO.

STATE OF NORTH CAROLINA DEPARTMENT OF TRANSPORTATION

FRAMING PLAN SPANS 27 & 28

S1-28

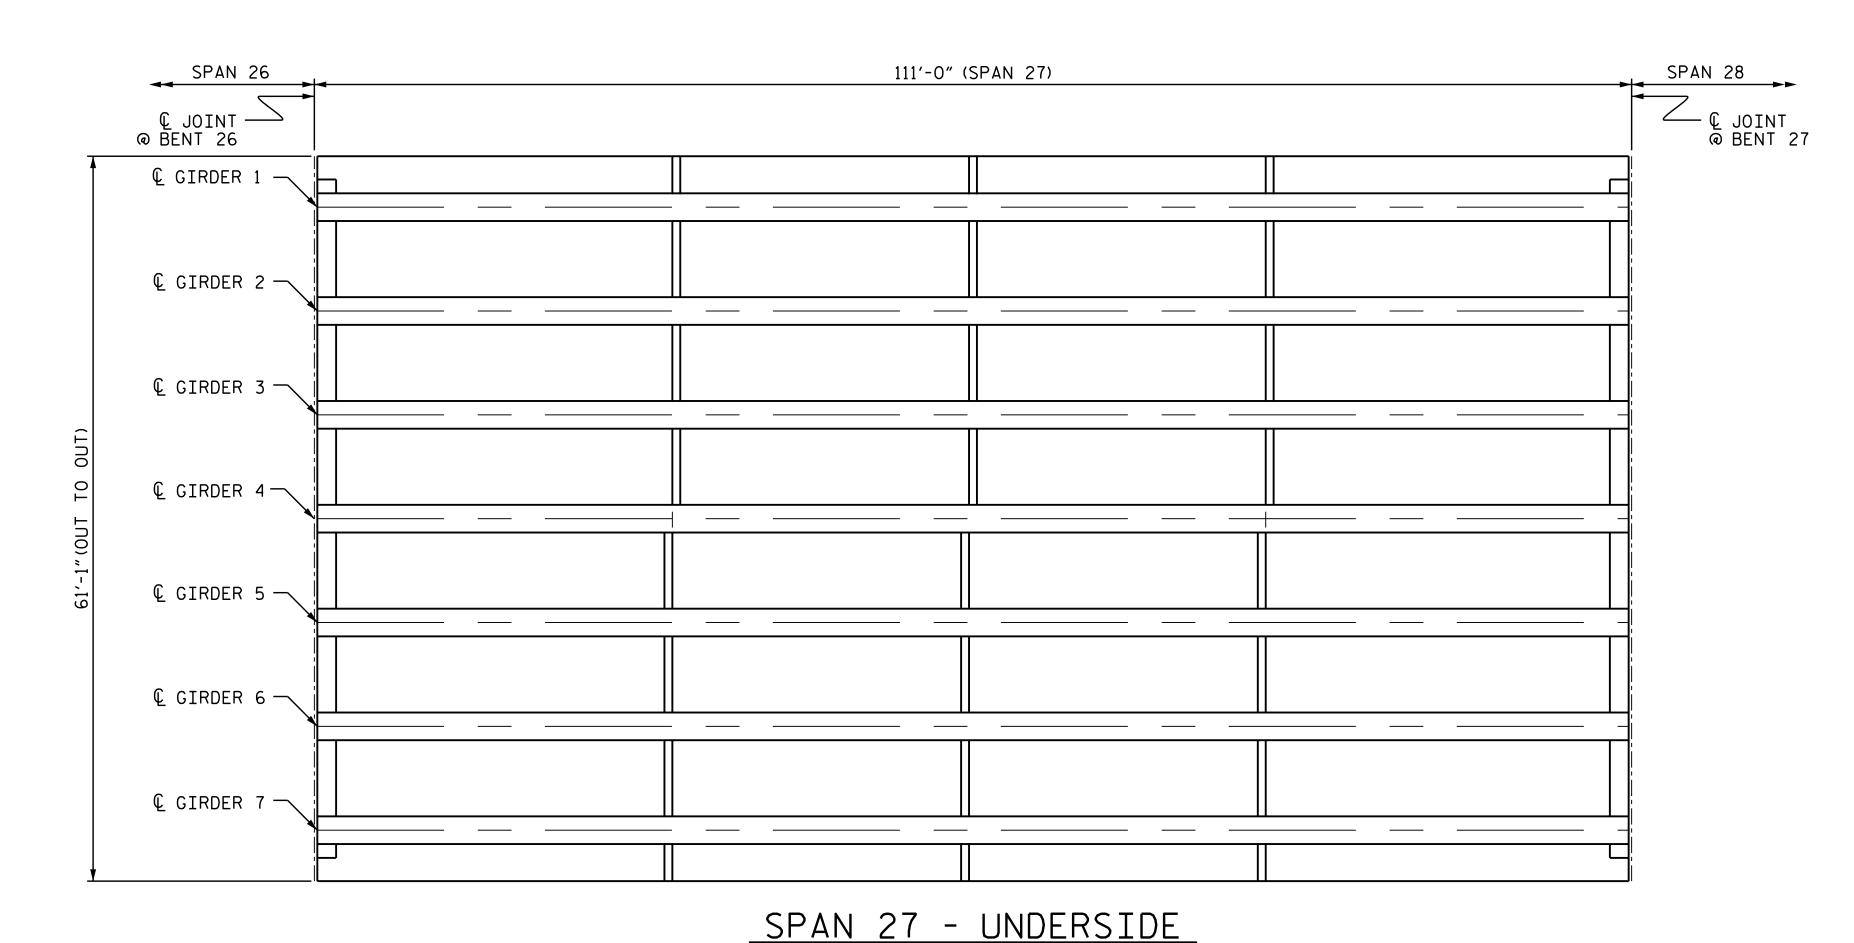
VALUES IN CHART REPRESENT ESTIMATED REPAIR TOTALS AFTER REMOVAL OF UNSOUND CONCRETE TO REPAIR DEPTH AND MIN. 1"CL. TO SAW CUT. SEE REPAIR DETAILS.

FOR GIRDER & DIAPHRAGM AND UNDERDECK REPAIRS SEE "TYPICAL GIRDER, UNDERDECK AND DIAPHRAGM REPAIR DETAILS" SHEET.

FOR PRESTRESSED CONCRETE GIRDER REPAIR, SEE "PRESTRESSED CONCRETE GIRDERS WITH THERMAL SPRAY ANODE" SPECIAL PROVISION.

FOR SHOTCRETE REPAIRS, SEE SPECIAL PROVISIONS.
