PROJECT NO. B-5938 CARTERET _ COUNTY 68 BRIDGE NO. _

STATE OF NORTH CAROLINA DEPARTMENT OF TRANSPORTATION

FRAMING PLAN SPANS 47, 48 & 49

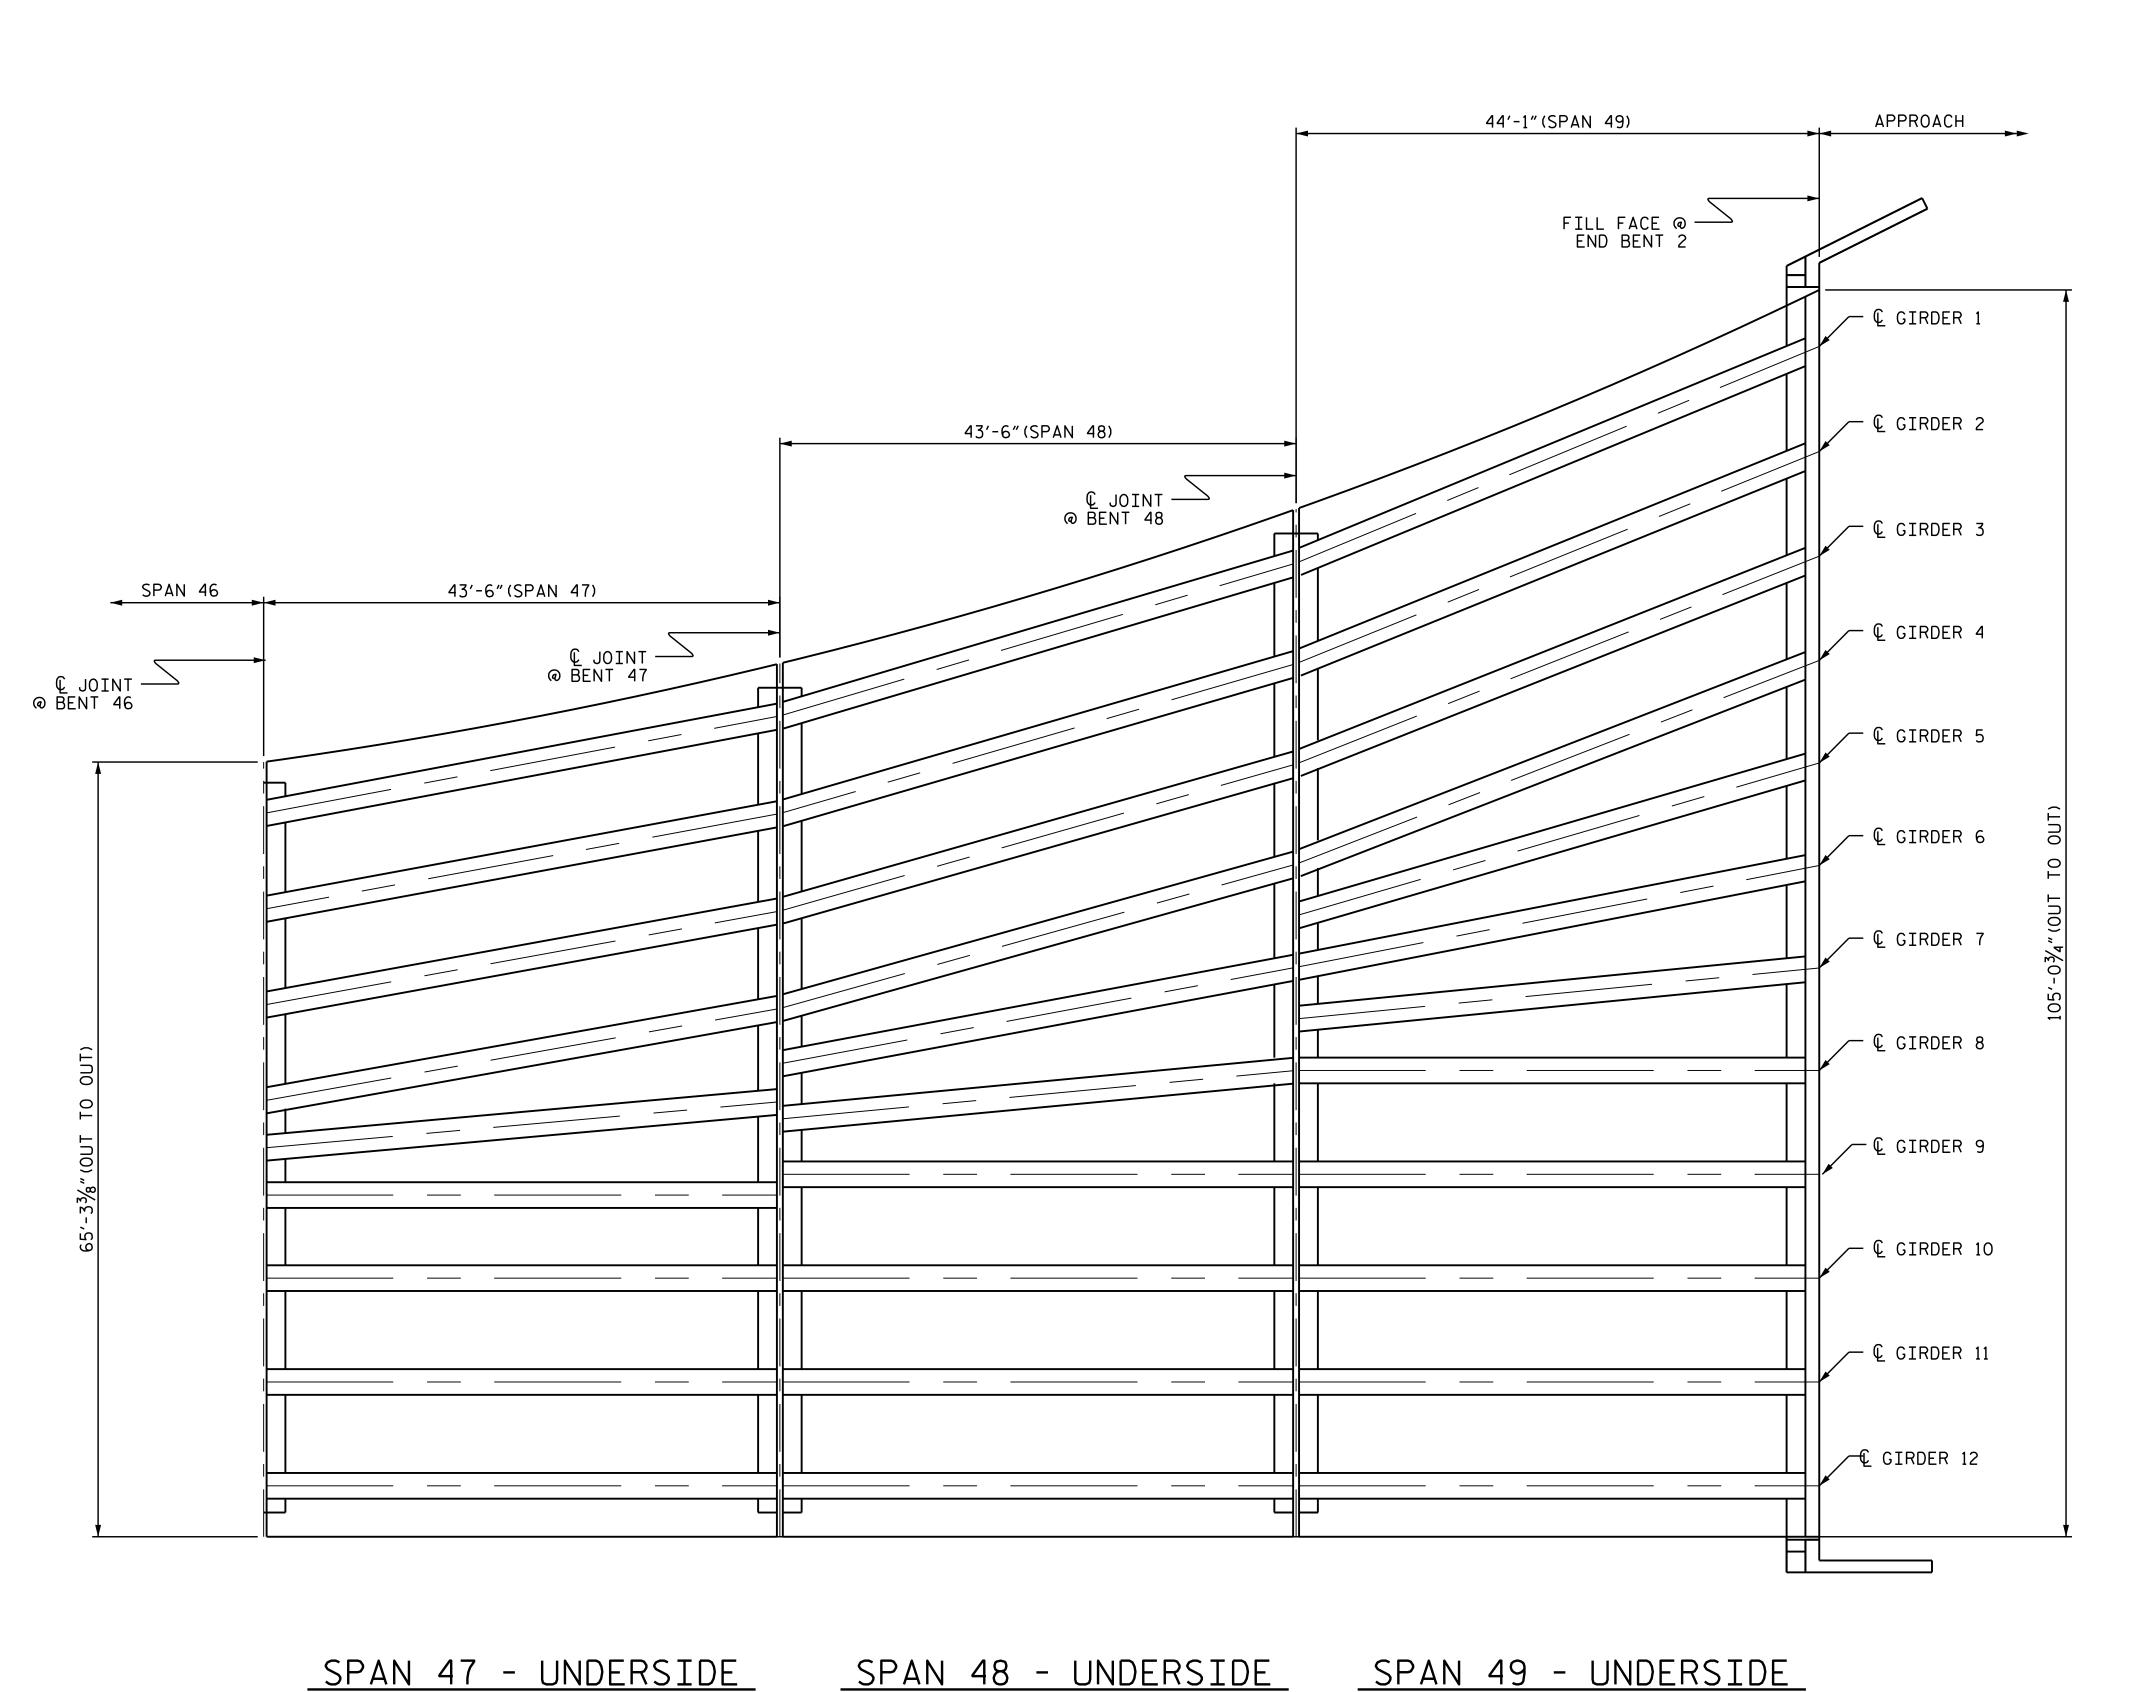
REVISIONS S1-38 DOCUMENT NOT CONSIDERED FINAL UNLESS ALL SIGNATURES COMPLETED

SPANS WILL RECEIVE FULL LENGTH TSA COATING, SEE "PRESTRESSED CONCRETE GIRDERS WITH THERMAL SPRAY ANODE" SPECIAL PROVISION AND SHEETS S1-40THRU S1-43.

FOR GIRDER & DIAPHRAGM AND UNDERDECK REPAIRS SEE "TYPICAL GIRDER, UNDERDECK AND DIAPHRAGM REPAIR DETAILS" SHEET.

VALUES IN CHART REPRESENT ESTIMATED REPAIR TOTALS AFTER REMOVAL OF UNSOUND CONCRETE TO REPAIR DEPTH AND MIN. 1"CL. TO SAW CUT. SEE REPAIR DETAILS.
