PROJECT NO. B-5939
CARTERET COUNTY
 BRIDGE NO. 6
 SHEET 25 OF 30

STATE OF NORTH CAROLINA
 DEPARTMENT OF TRANSPORTATION
 RALEIGH

FRAMING PLAN
 SPAN 48 & 49

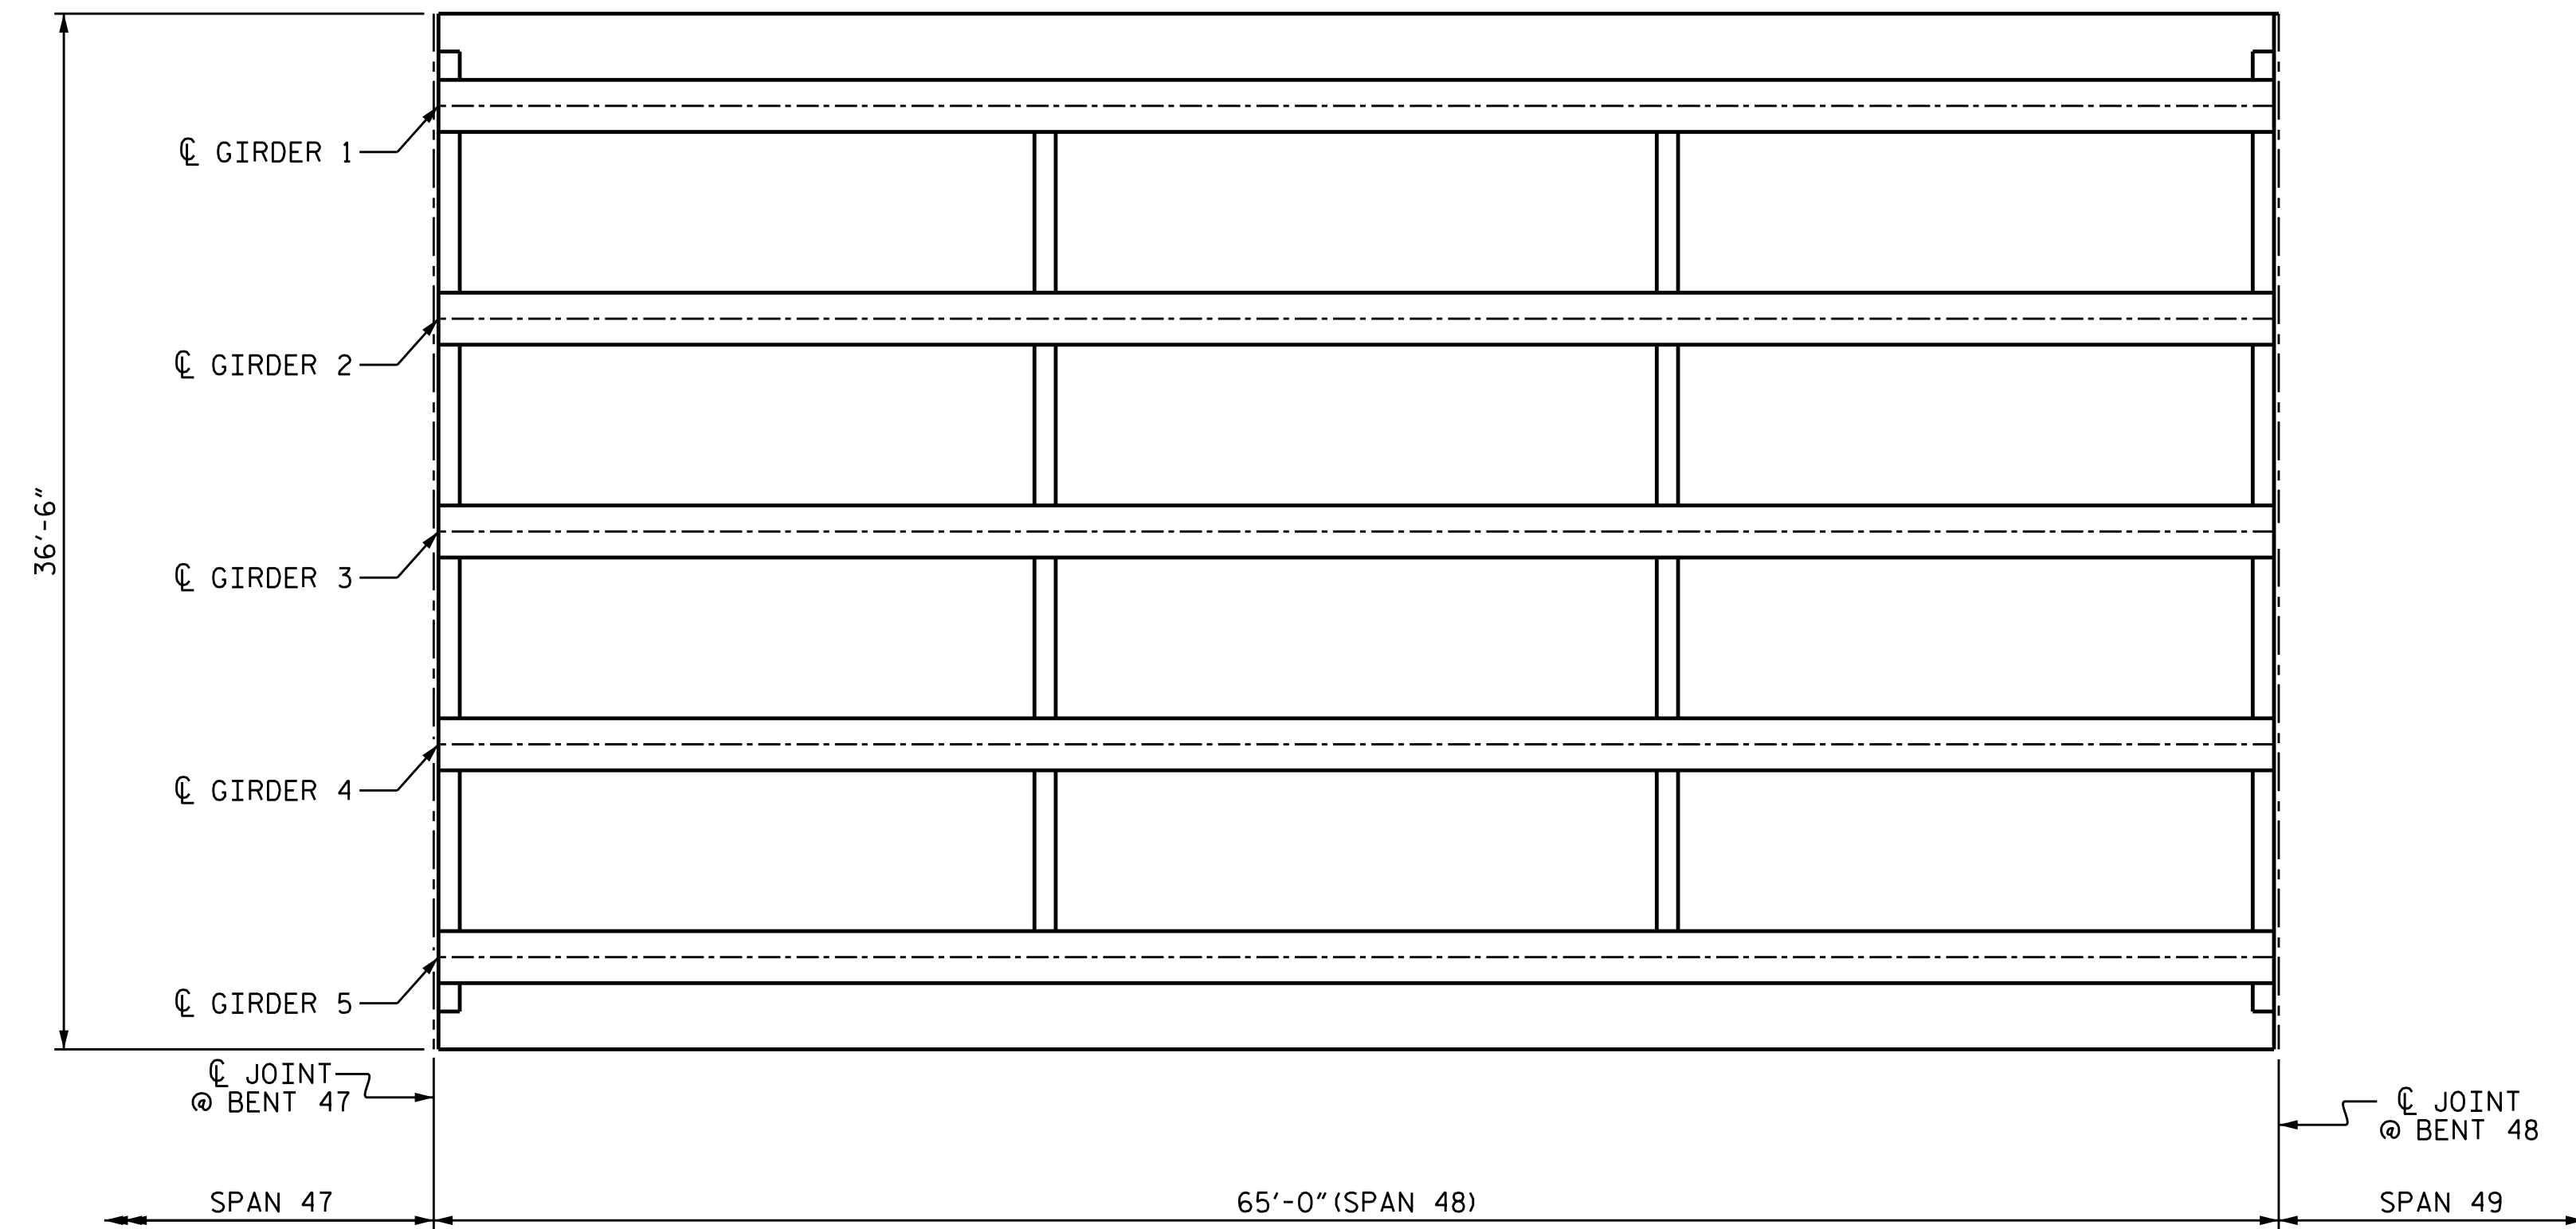
SPAN 48 - UNDERSIDE

NO REPAIRS NOTED DURING INSPECTION BY STRUCTURES MANAGEMENT UNIT. THE CONTRACTOR AND ENGINEER SHALL INSPECT THE GIRDERS AND DIAPHRAGMS PRIOR TO BEGINNING WORK.

SPANS WILL RECEIVE TSA COATING FOR THE FIRST 5' OF THE GIRDERS AT THE BENTS AND THEN THE TSA COATING IN PRESTRESSED CONCRETE GIRDER REPAIR LOCATIONS. SEE "PRESTRESSED CONCRETE GIRDERS WITH THERMAL SPRAY ANODE" SPECIAL PROVISION AND SHEETS S2-62 THRU S2-65.

FOR GIRDER & DIAPHRAGM AND UNDERDECK REPAIRS SEE "TYPICAL GIRDER, UNDERDECK AND DIAPHRAGM REPAIR DETAILS" SHEET.
