Preliminary Site Assessment Report

National Properties Corp. (Circle K/Shell Gas)

Parcel #37

Rocky Mounty -US 301 Bypass from NC 43-48 (Benvenue Rd.) to SR 1836

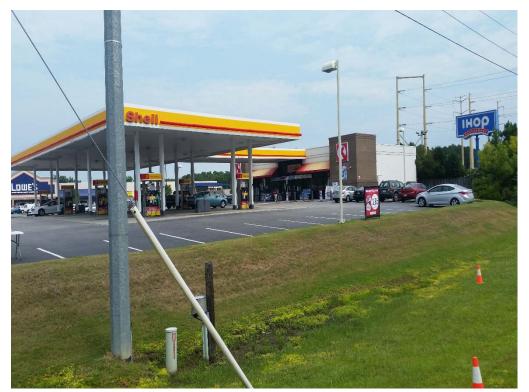
Photo 1

Viewing Parcel 37 Prior to Drilling Activities.

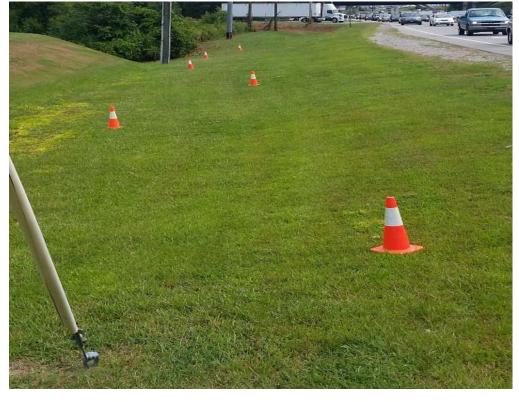
Photo 2

Viewing a portion of the investigation area. Cones are placed by the predetermined boring locations.

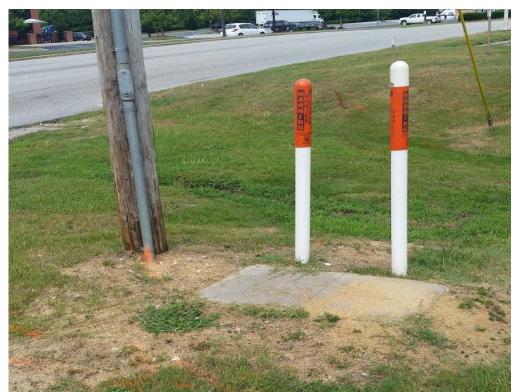
Photo 3

Viewing Parcel 37. Utilities are located in site investigation area.

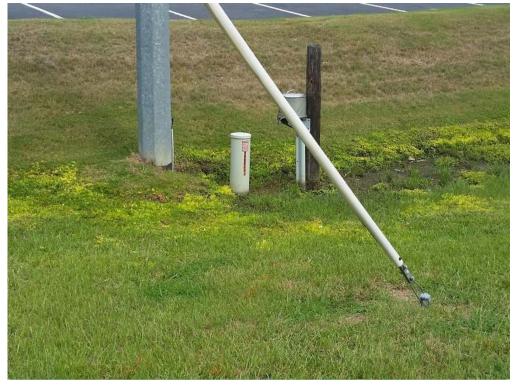
Photo 4

Viewing more utilities in the investigation area.

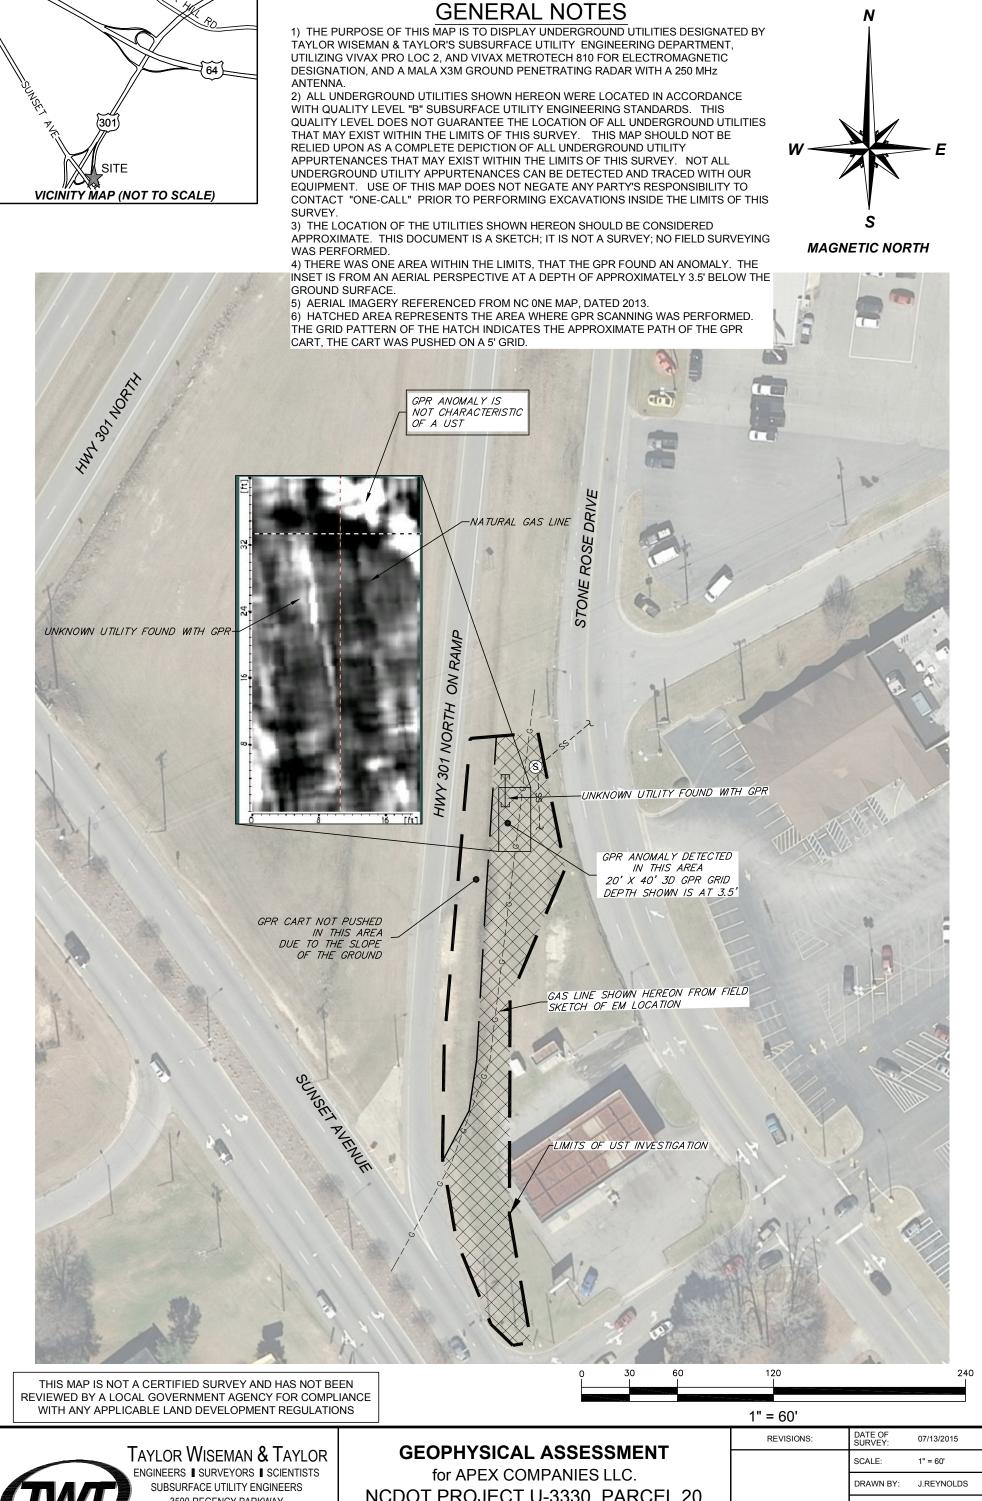
INE VISIONS.	SURVEY:	07/13/2013
	SCALE:	1" = 60'
	DRAWN BY:	J.REYNOLDS
	CHECKED BY:	C. HOWARD PLS
	PROJECT:	70668.5002.00
FIGURE #: 1	SHEET:	1/1

Parcel 20 (refer to Figure 1) is the only parcel where the GPR detected an anomaly. The anomaly was not characteristic of a UST and has been duly noted that way on the Figure.

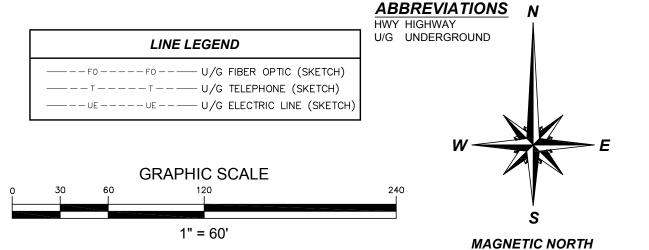
REVISIONS:	DATE OF SURVEY:	07/13/2015
	SCALE:	1" = 60'
	DRAWN BY:	J.REYNOLDS
	CHECKED BY:	C. HOWARD PLS
	PROJECT:	70668.5002.00
FIGURE #: 2	SHEET:	1/1

The geophysical survey of the site occurred the week of July 13th, 2015. TWT performed an electromagnetic (EM) survey followed by ground penetrating radar (GPR) survey. Their Geophysical Report is presented in **Appendix C**. No unknown EM features were identified.

Each Figure shows the underground utility lines that were detected by way of the electromagnetic designating. Each Figure shows any anomalies that were detected with the GPR.
