# STATE OF NORTH CAROLINA DEPARTMENT OF TRANSPORTATION

MEMORANDUM TO:	Name Project Development and Environmental Analysis Branch
ATTN:	Name Project Planning Engineer
FROM:	Njoroge W. Wainaina, P.E. State Geotechnical Engineer Geotechnical Engineering Unit
TIP NO: WBS: COUNTY: DESCRIPTION:	U-4751 & R-3300 401919.1.1 New Hanover & Pender New Route US 17 Hampstead Bypass / Military Cutoff Road Ext

## SUBJECT: Geotechnical Pre-Scoping Report

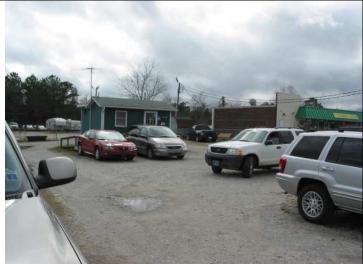
Site # 15: Jackson Motor Co

15)	Property Name	Property Owner:
,	Jackson Motor Co.	Betty J. Richardson
	6404 Market Street	Wilmington, NC
	Wilmington, NC 28405	
	Facility ID #: N/A	UST Owner: N/A
	Incident # 14505	
south any	side of Market Street approximately V UST system and no monitoring v	currently operates as a used car dealer. It is located on the 200 feet east of Green Meadows Drive. There is no evidence wells were noted at this site. The GWI database shows an & M motors. This site is anticipated to present low
	<b>vironmental impacts to the project</b>	· ·

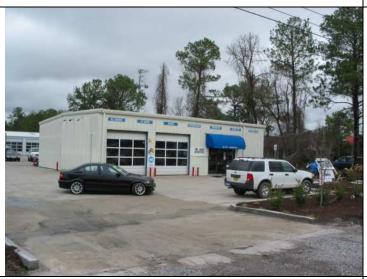
Site # 17: Kelly's Automotive

This facility (formerly Ed's Brake& Lube) presently operates as an automotive repair shop. It is located on the north side of Market Street approximately 950 feet east of Old Dairy Road. The UST facility ID # and GWI # are associated with the former business. According to the UST registry, one (1) UST (used waste oil) was closed in 1998. There are two (2) GWI # assigned to this facility. This facility has one (1) in-ground hydraulic lift currently in use. **This site is anticipated to present low geoenvironmental impacts to the project.**

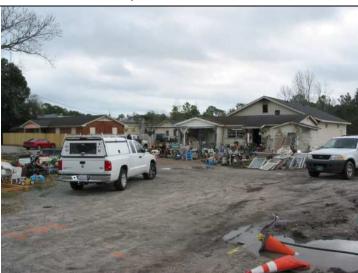
Site # 18: Thieves Market

This business currently operates as an antique shop. It is located on the south side of Market Street approximately 500 feet west of Station Road. There is no evidence of a UST system and no monitoring wells were noted at this facility. This site is anticipated to present low geoenvironmental impacts to the project.

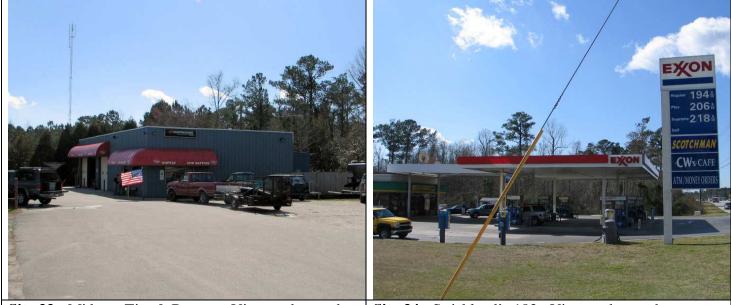
Site 33: Midway Tire & Battery. View to the south. Site 34: Strickland's 183. View to the southwest.

This facility operates as an auto repair shop. It is located 150 feet south of the US 17 median and approximately 650 feet east of Williams Love Grove Church Road. There are no USTs in use at this facility and no monitoring wells were noted. This site is anticipated to present low geoenvironmental impacts to the project.

Exxon 130 feet This facility currently operates as a convenience store and Exxon gas station. It is located in the south quadrant of the US 17 and Country Club Drive intersection. The tank bed is located 130 feet south from the US 17 centerline. The UST registry shows two (2) tanks currently in use at this facility. Four (4) USTs were removed in 1997. Monitoring wells were noted on site and incident # 16267 has been assigned to the facility. **This site is anticipated to present low geoenvironmental impacts to the project.**

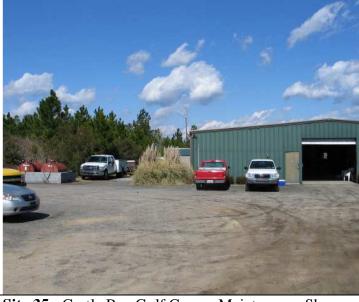
**Site 35:** Castle Bay Golf Course Maintenance Shop. View to the north.

This facility operates as the maintenance and landscaping shop for the golf course. It is located 115 feet east of Hoover Road and 0.3 mile north of Highlands Drive. Two (2) ASTs were located between Hoover Road and the shop. The shop area itself stores landscaping equipment, fertilizer, herbicides, and pesticides. This site is anticipated to present low geoenvironmental impacts to the project.
