SCOPE OF WORK
 - STRUCTURAL STEEL REPAIRS
 - SUBSTRUCTURE REPAIRS TO END BENTS AND BENT CAPS
 - ZONE PAINTING

PROJECT NO. I-5889A
BUNCOMBE COUNTY
 BRIDGE NO. 334

STATE OF NORTH CAROLINA
 DEPARTMENT OF TRANSPORTATION
 RALEIGH
 GENERAL DRAWING
 BRIDGE #334 ON I-40 EBL
 OVER HOMINY CREEK

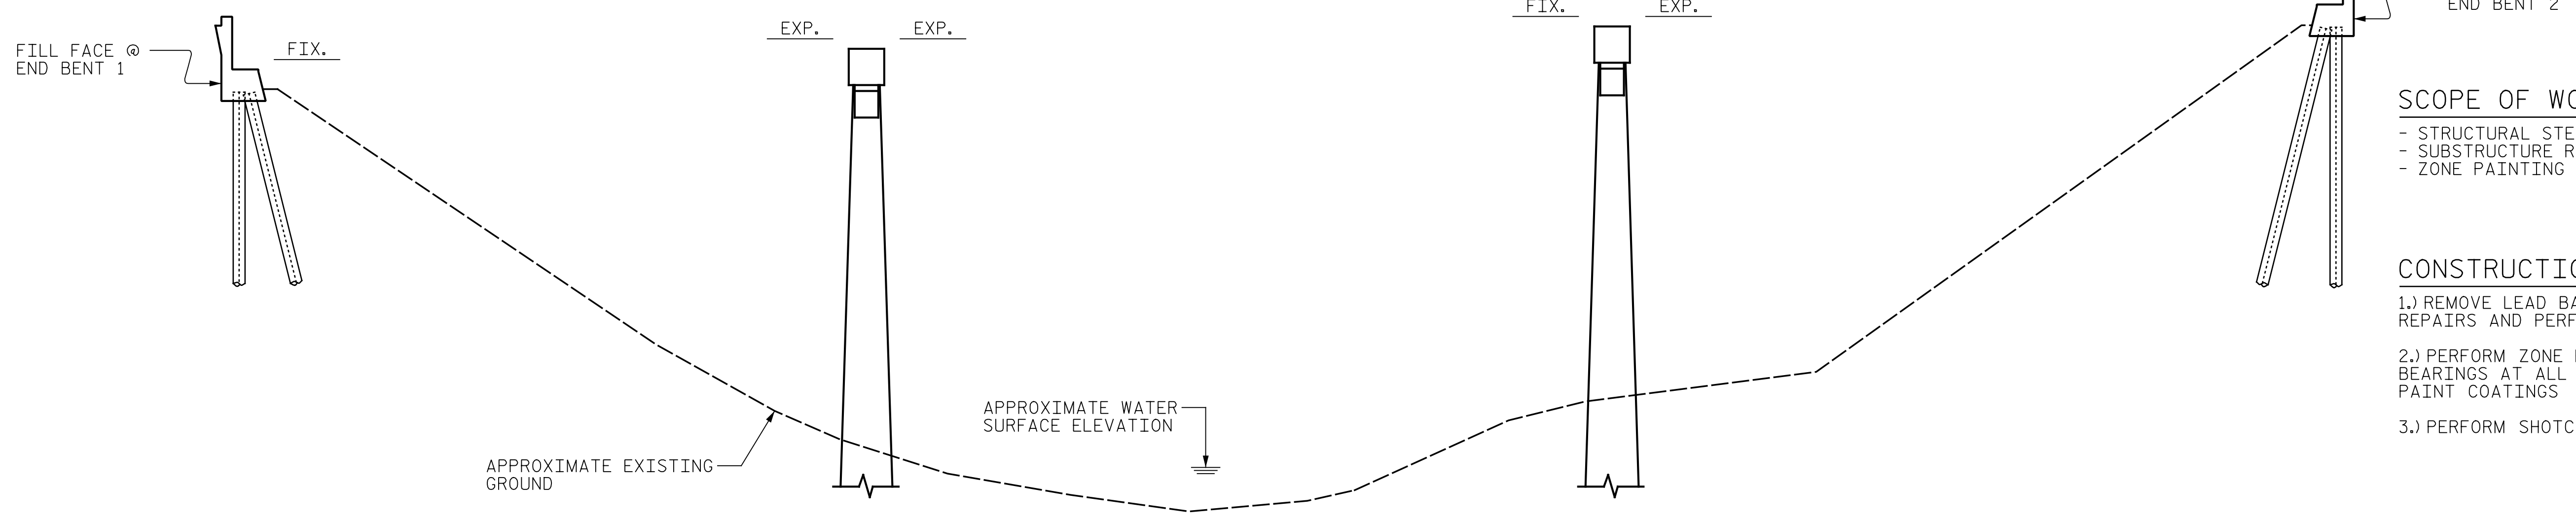
SECTION ALONG ϕ BRIDGE

NOTE:
 PROFILE INFORMATION IS TAKEN FROM THE ORIGINAL PLANS AND THE ROUTINE INSPECTION REPORT DATED 10/22/2015.
 BRIDGE ORIENTATION CONFORMS TO EXISTING BRIDGE PLANS.

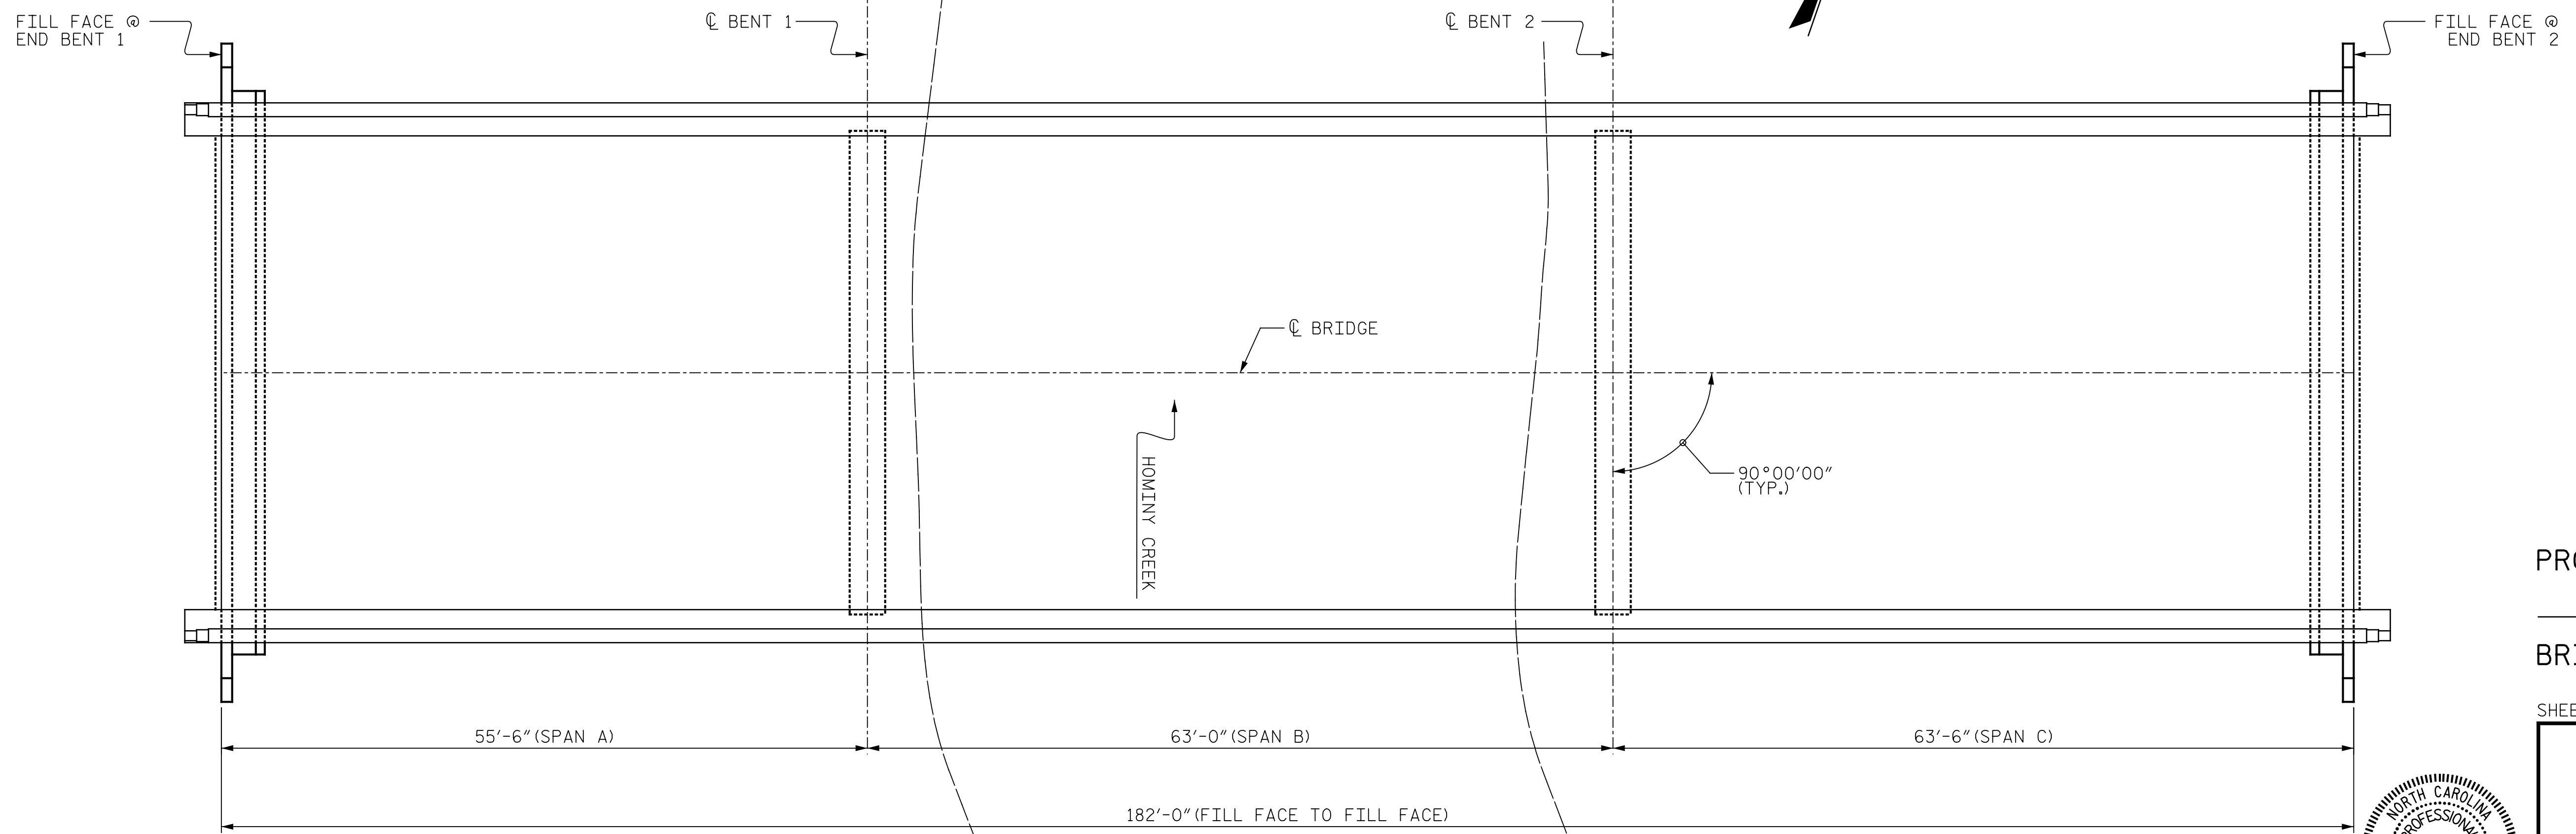
PLAN

(PILES NOT SHOWN FOR CLARITY)
