AS-BUILT REPAIR QUANTITY TABLE

PROJECT NO. I-5889A

BRIDGE NO. 334

BENT 2 SPAN B SIDE

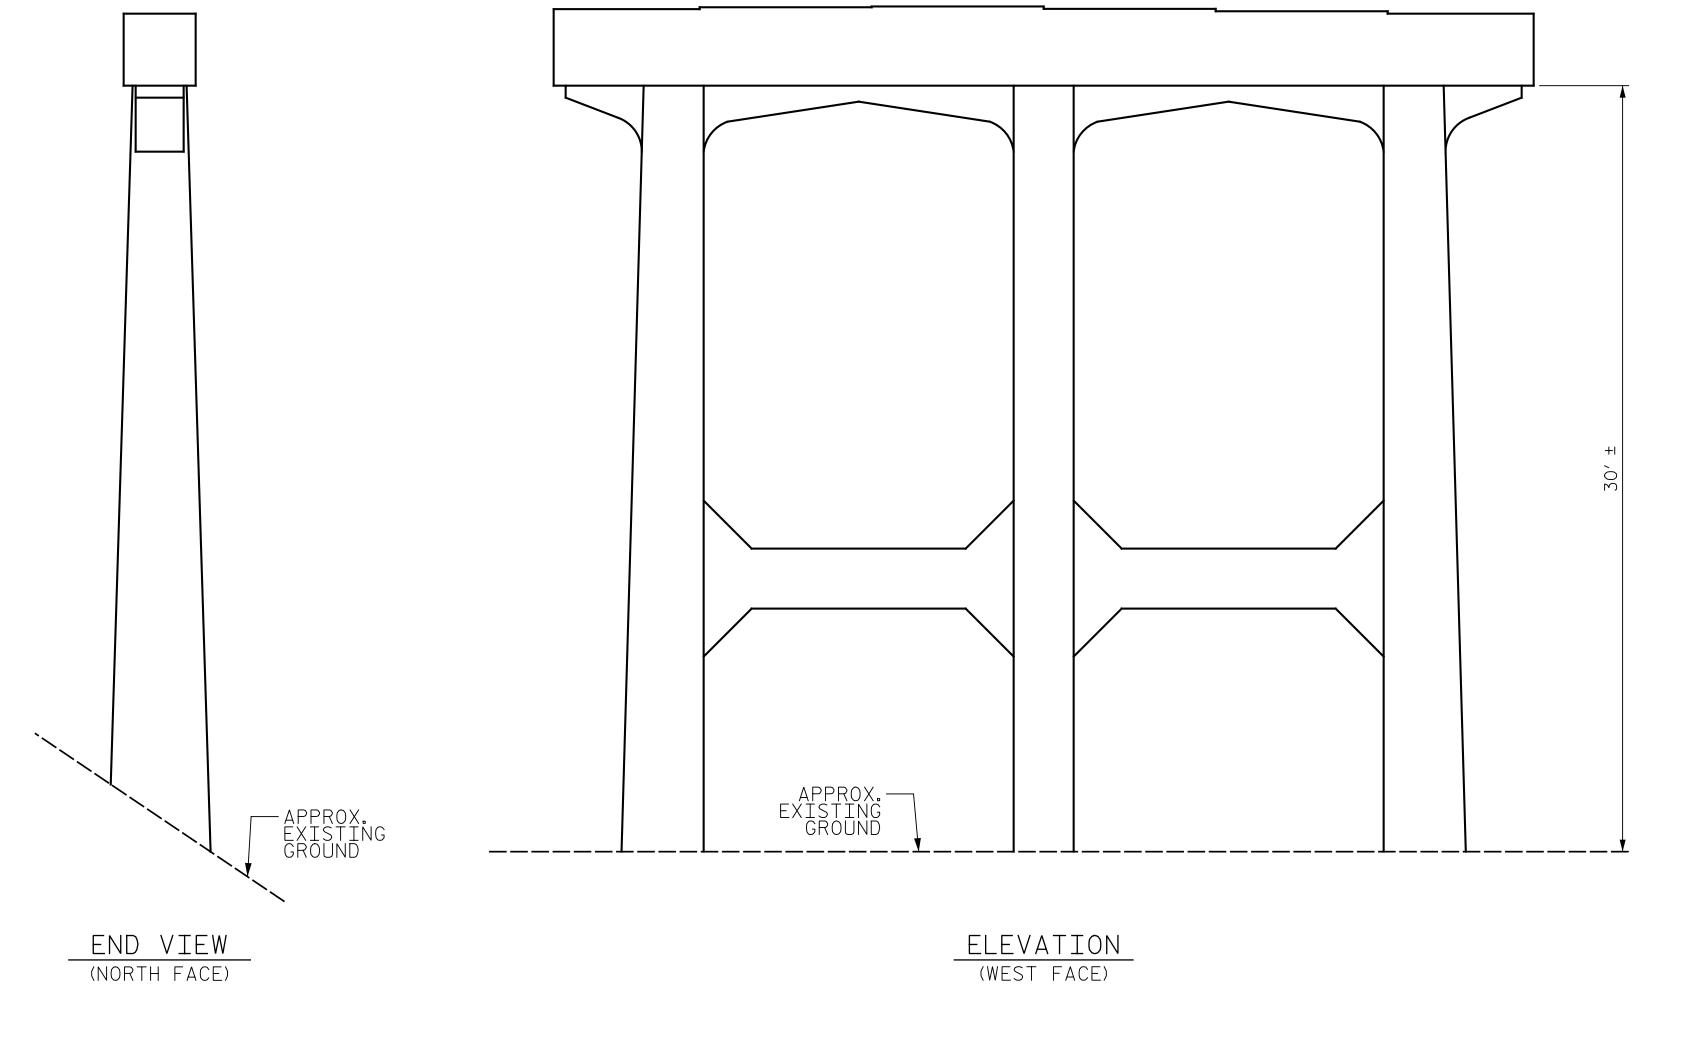
BENT 2 (SPAN B SIDE)

BENT 2 REPAIRS	QUANTITIES					
		ESTI	ACTUAL				
	SHOTCRETE REPAIRS	AREA SF	VOLUME CF	AREA SF	DEPTH FT	VOLUME CF	
	CAP (VERTICAL FACE)	12.0	6.0				
	CAP (HORIZONTAL, CORNER)	0	0				
	COLUMN	0	0

VALUES IN CHART REPRESENT ESTIMATED REPAIR TOTALS AFTER REMOVAL OF UNSOUND CONCRETE, MIN. OF 1"BEHIND REBAR AND MIN. 2"CL TO SAWCUT. SEE REPAIR DETAILS.

SHOTCRETE REPAIRS MAY BE REPLACED WITH CONCRETE REPAIRS WITH THE APPROVAL OF THE ENGINEER.

FOR SHOTCRETE REPAIRS, SEE SPECIAL PROVISIONS.

FOR CONCRETE REPAIR DETAILS, SEE "TYPICAL CAP & COLUMN REPAIR DETAILS" SHEET.
