PROJECT NO. I-5889A
BUNCOMBE COUNTY
 BRIDGE NO. 334

STATE OF NORTH CAROLINA
 DEPARTMENT OF TRANSPORTATION
 RALEIGH

BENT 2
SPAN C SIDE

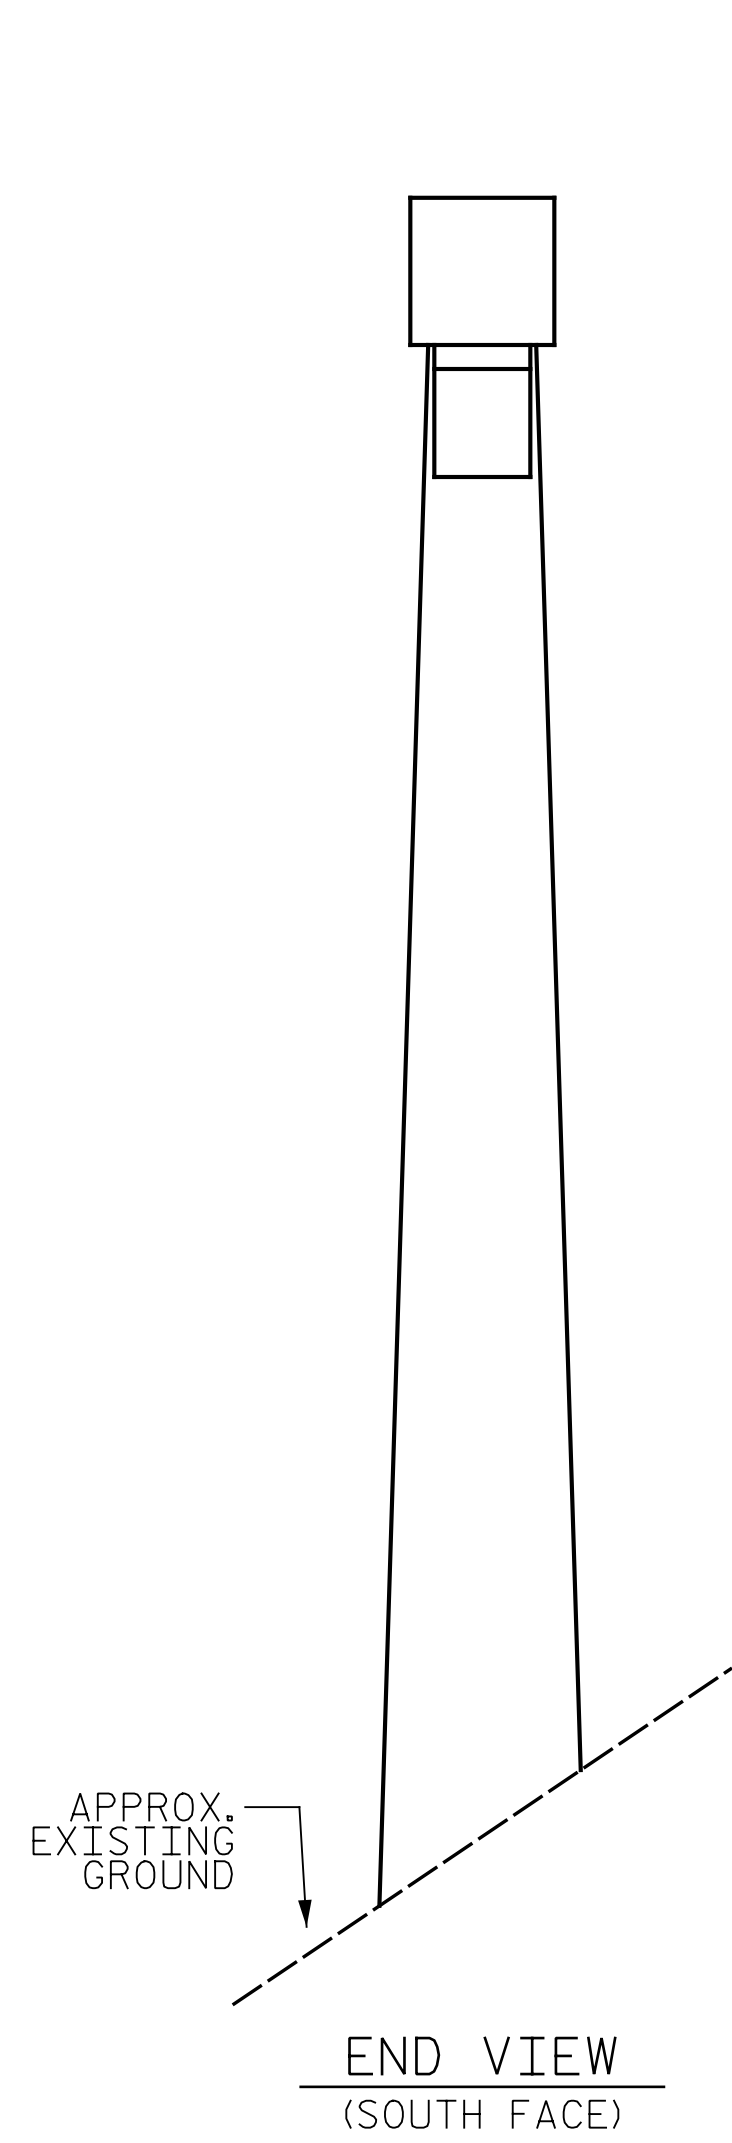
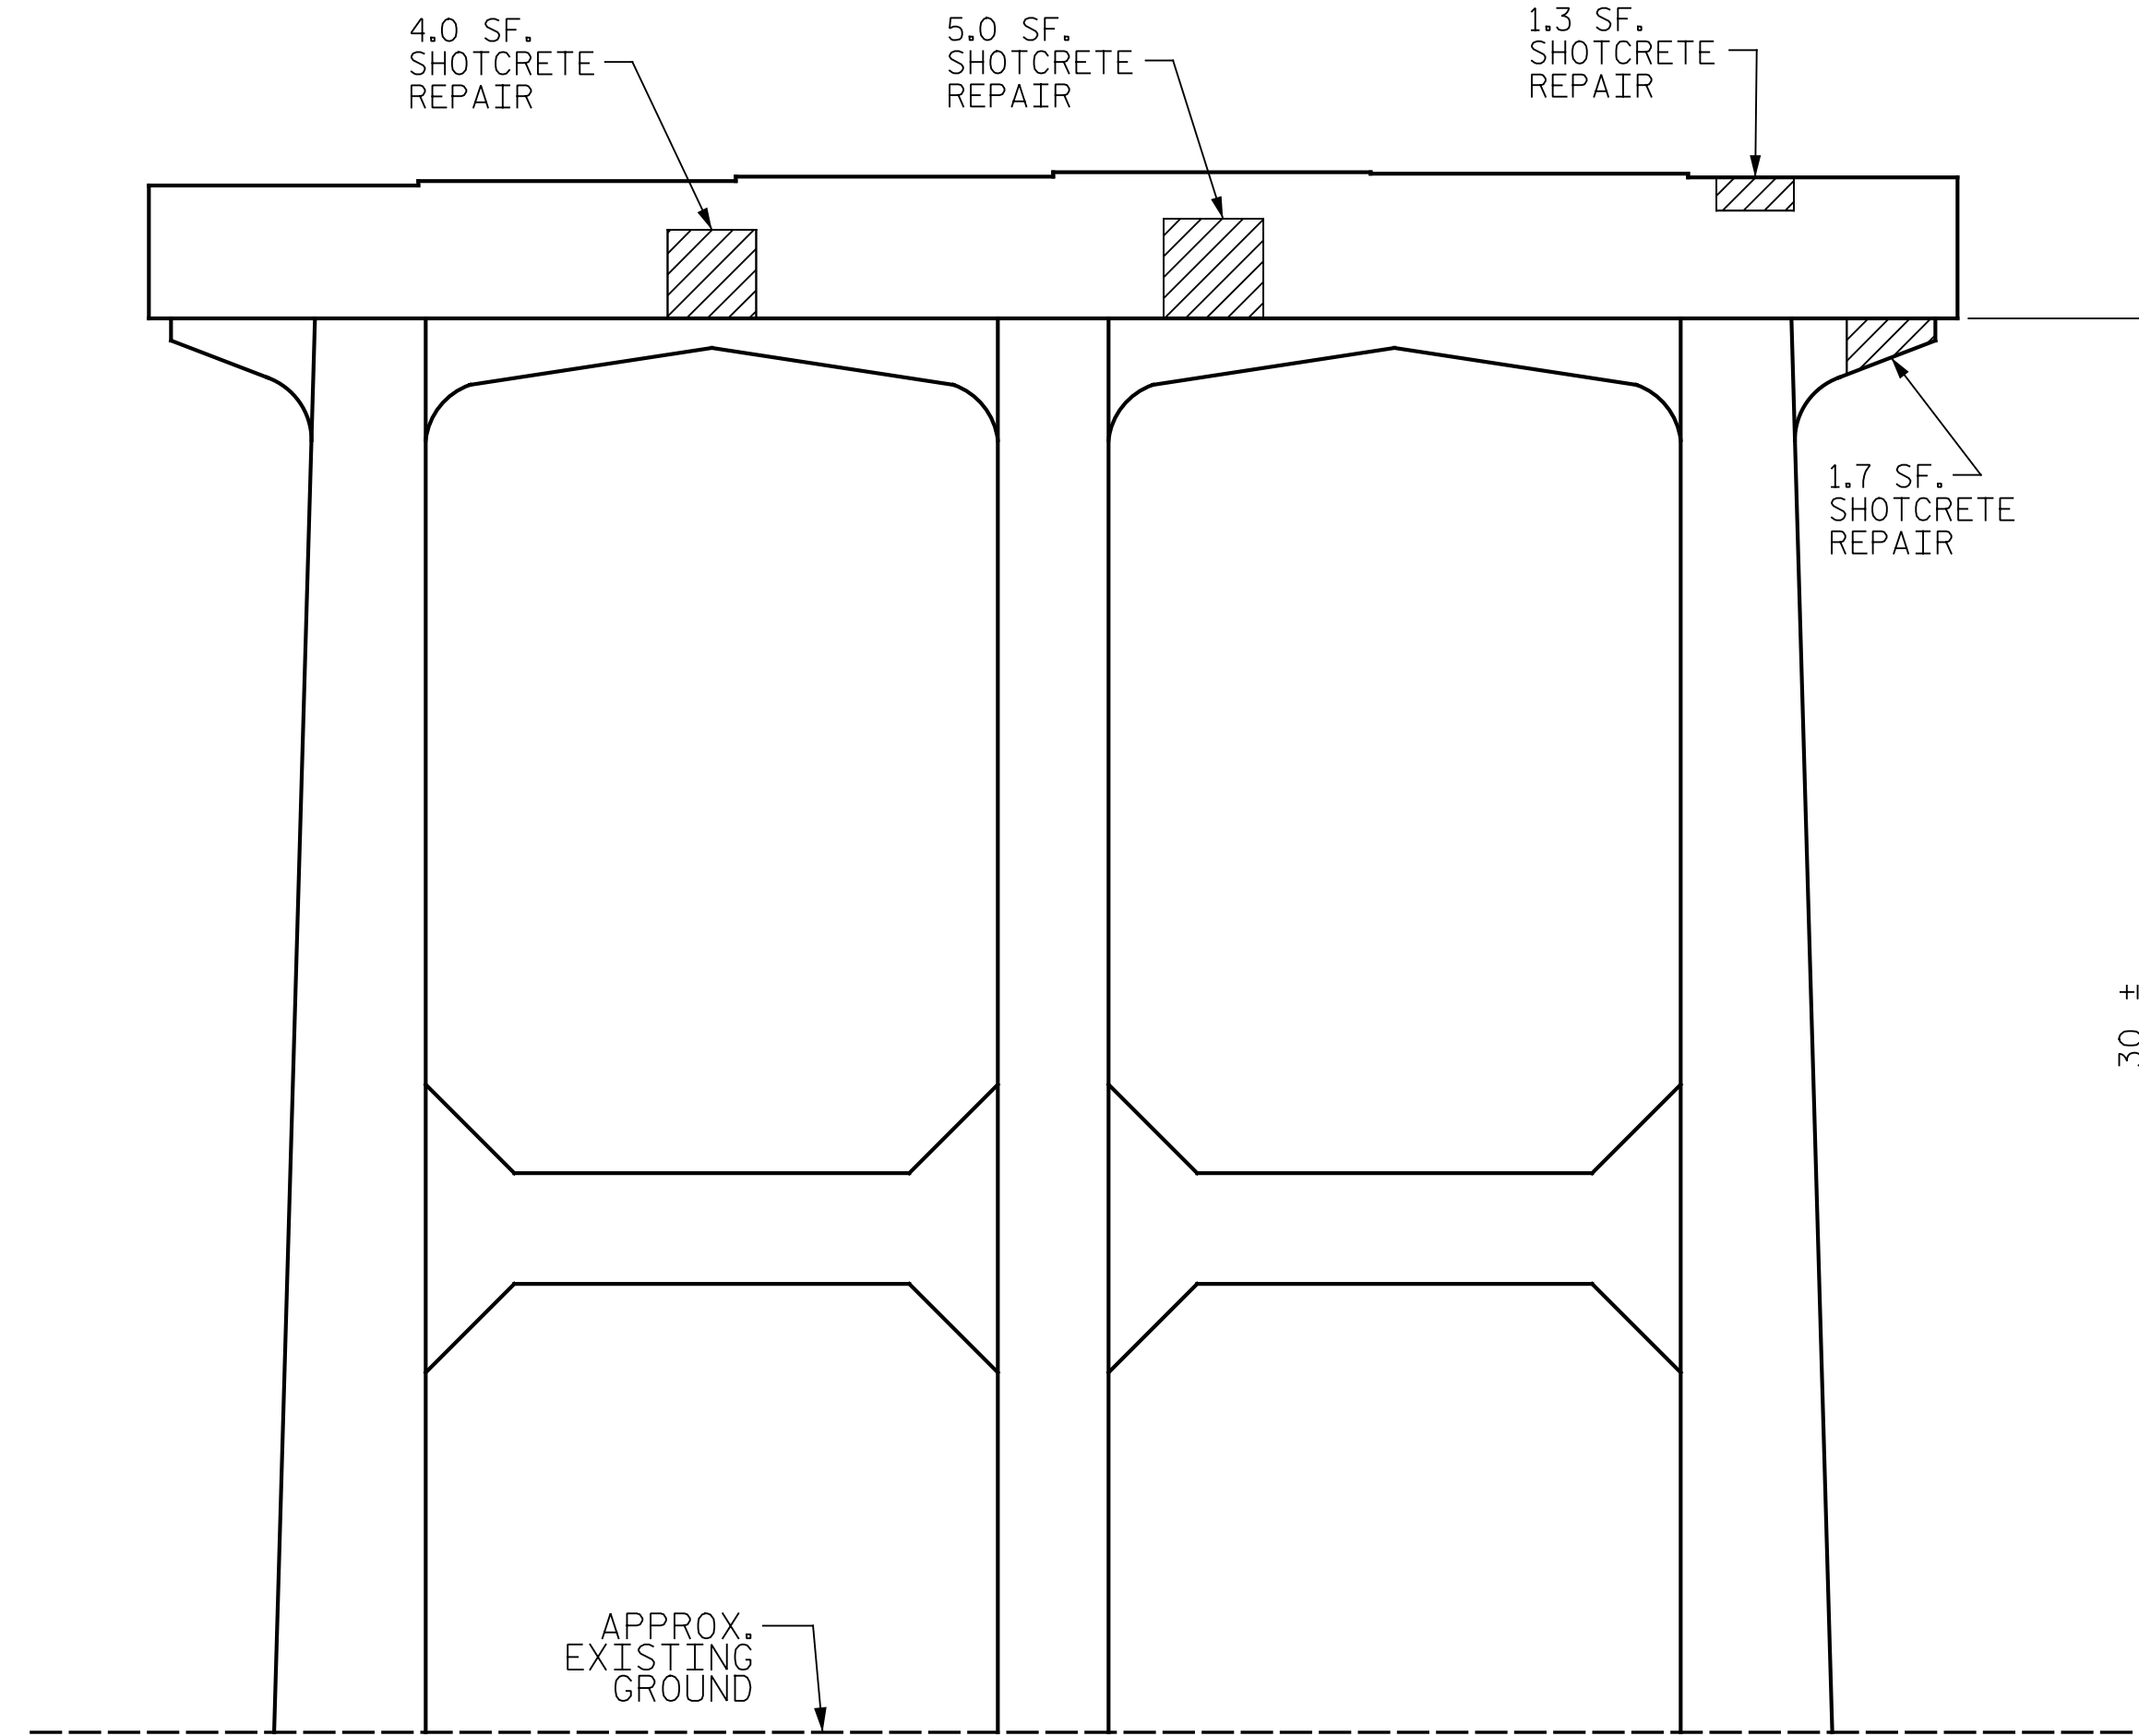
BENT 2
(SPAN C SIDE)

SPAN B

SPAN C

BOTTOM OF CAP

- SHOTCRETE REPAIR
- CONCRETE REPAIR

SHOTCRETE REPAIRS MAY BE REPLACED WITH CONCRETE REPAIRS WITH THE APPROVAL OF THE ENGINEER.

FOR SHOTCRETE REPAIRS, SEE SPECIAL PROVISIONS.

FOR CONCRETE REPAIR DETAILS, SEE "TYPICAL CAP & COLUMN REPAIR DETAILS" SHEET.
