PROJECT NO. I-5889A
BUNCOMBE COUNTY
 BRIDGE NO. 339

STATE OF NORTH CAROLINA
 DEPARTMENT OF TRANSPORTATION
 RALEIGH

BEAM REPAIR LOCATIONS

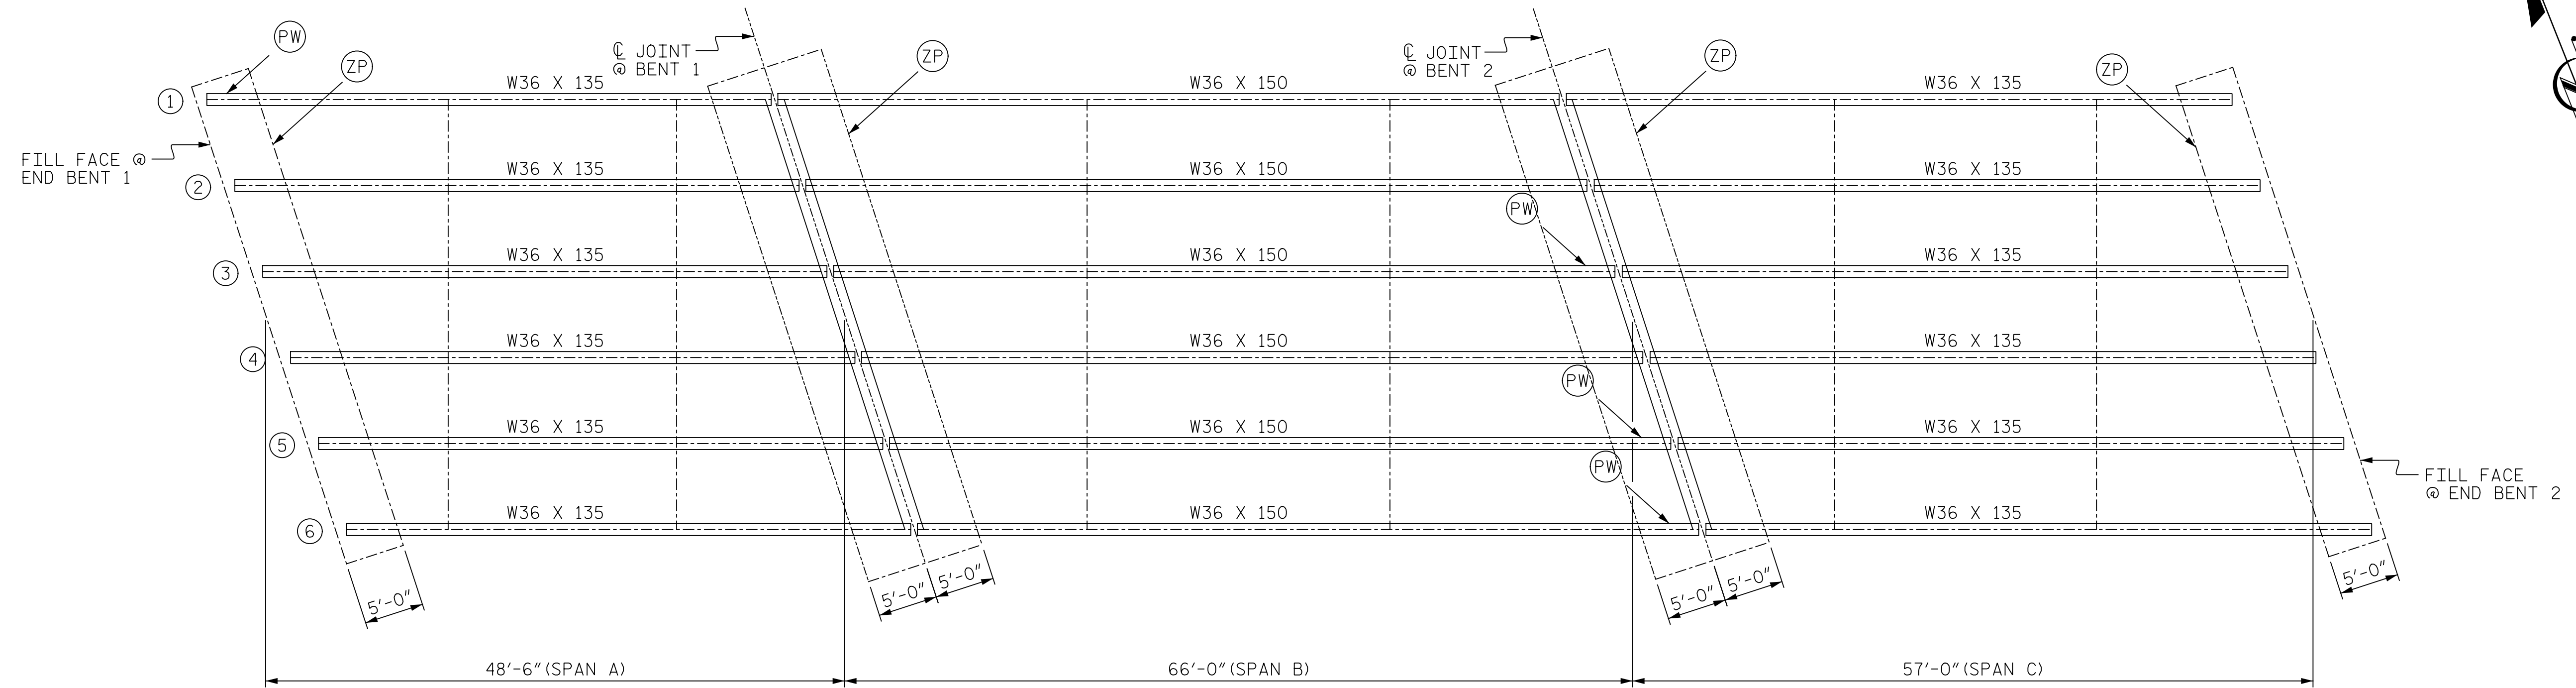
FRAMING PLAN

SEE SHEET NO. S-16 FOR BEAM PLATING REPAIR DETAILS.
 THE LOCATIONS AND DIMENSIONS OF THE AREAS FOR REPAIR ARE BASED ON THE BEST INFORMATION AVAILABLE. THE CONTRACTOR, IN CONJUNCTION WITH THE ENGINEER, SHALL VERIFY THE LOCATION AND EXTENT OF REPAIR AREAS PRIOR TO PERFORMING REPAIRS.
 CONTRACTOR SHALL ENSURE THAT EXISTING UTILITIES ADJACENT TO THE BRIDGE ARE NOT DAMAGED DURING THE REPAIR OPERATIONS.

ANTICIPATED BEAM REPAIR LOCATIONS							
SPAN	BEAM	LOCATION	REPAIR TYPE	DIM "A"	DIM "B"	DIM "C"	DIM "D"
A	1	END BENT 1	PW	2'-8"	6"	-	-
B	5	BENT 2	PW	4"	2'-6"	-	-
B	6	BENT 2	PW	5"	3'-0"	-	-
