PROJECT NO. I-5889A  
BUNCOMBE COUNTY  
 BRIDGE NO. 344

STATE OF NORTH CAROLINA  
 DEPARTMENT OF TRANSPORTATION  
 RALEIGH

BENT 1  
 SPAN B SIDE

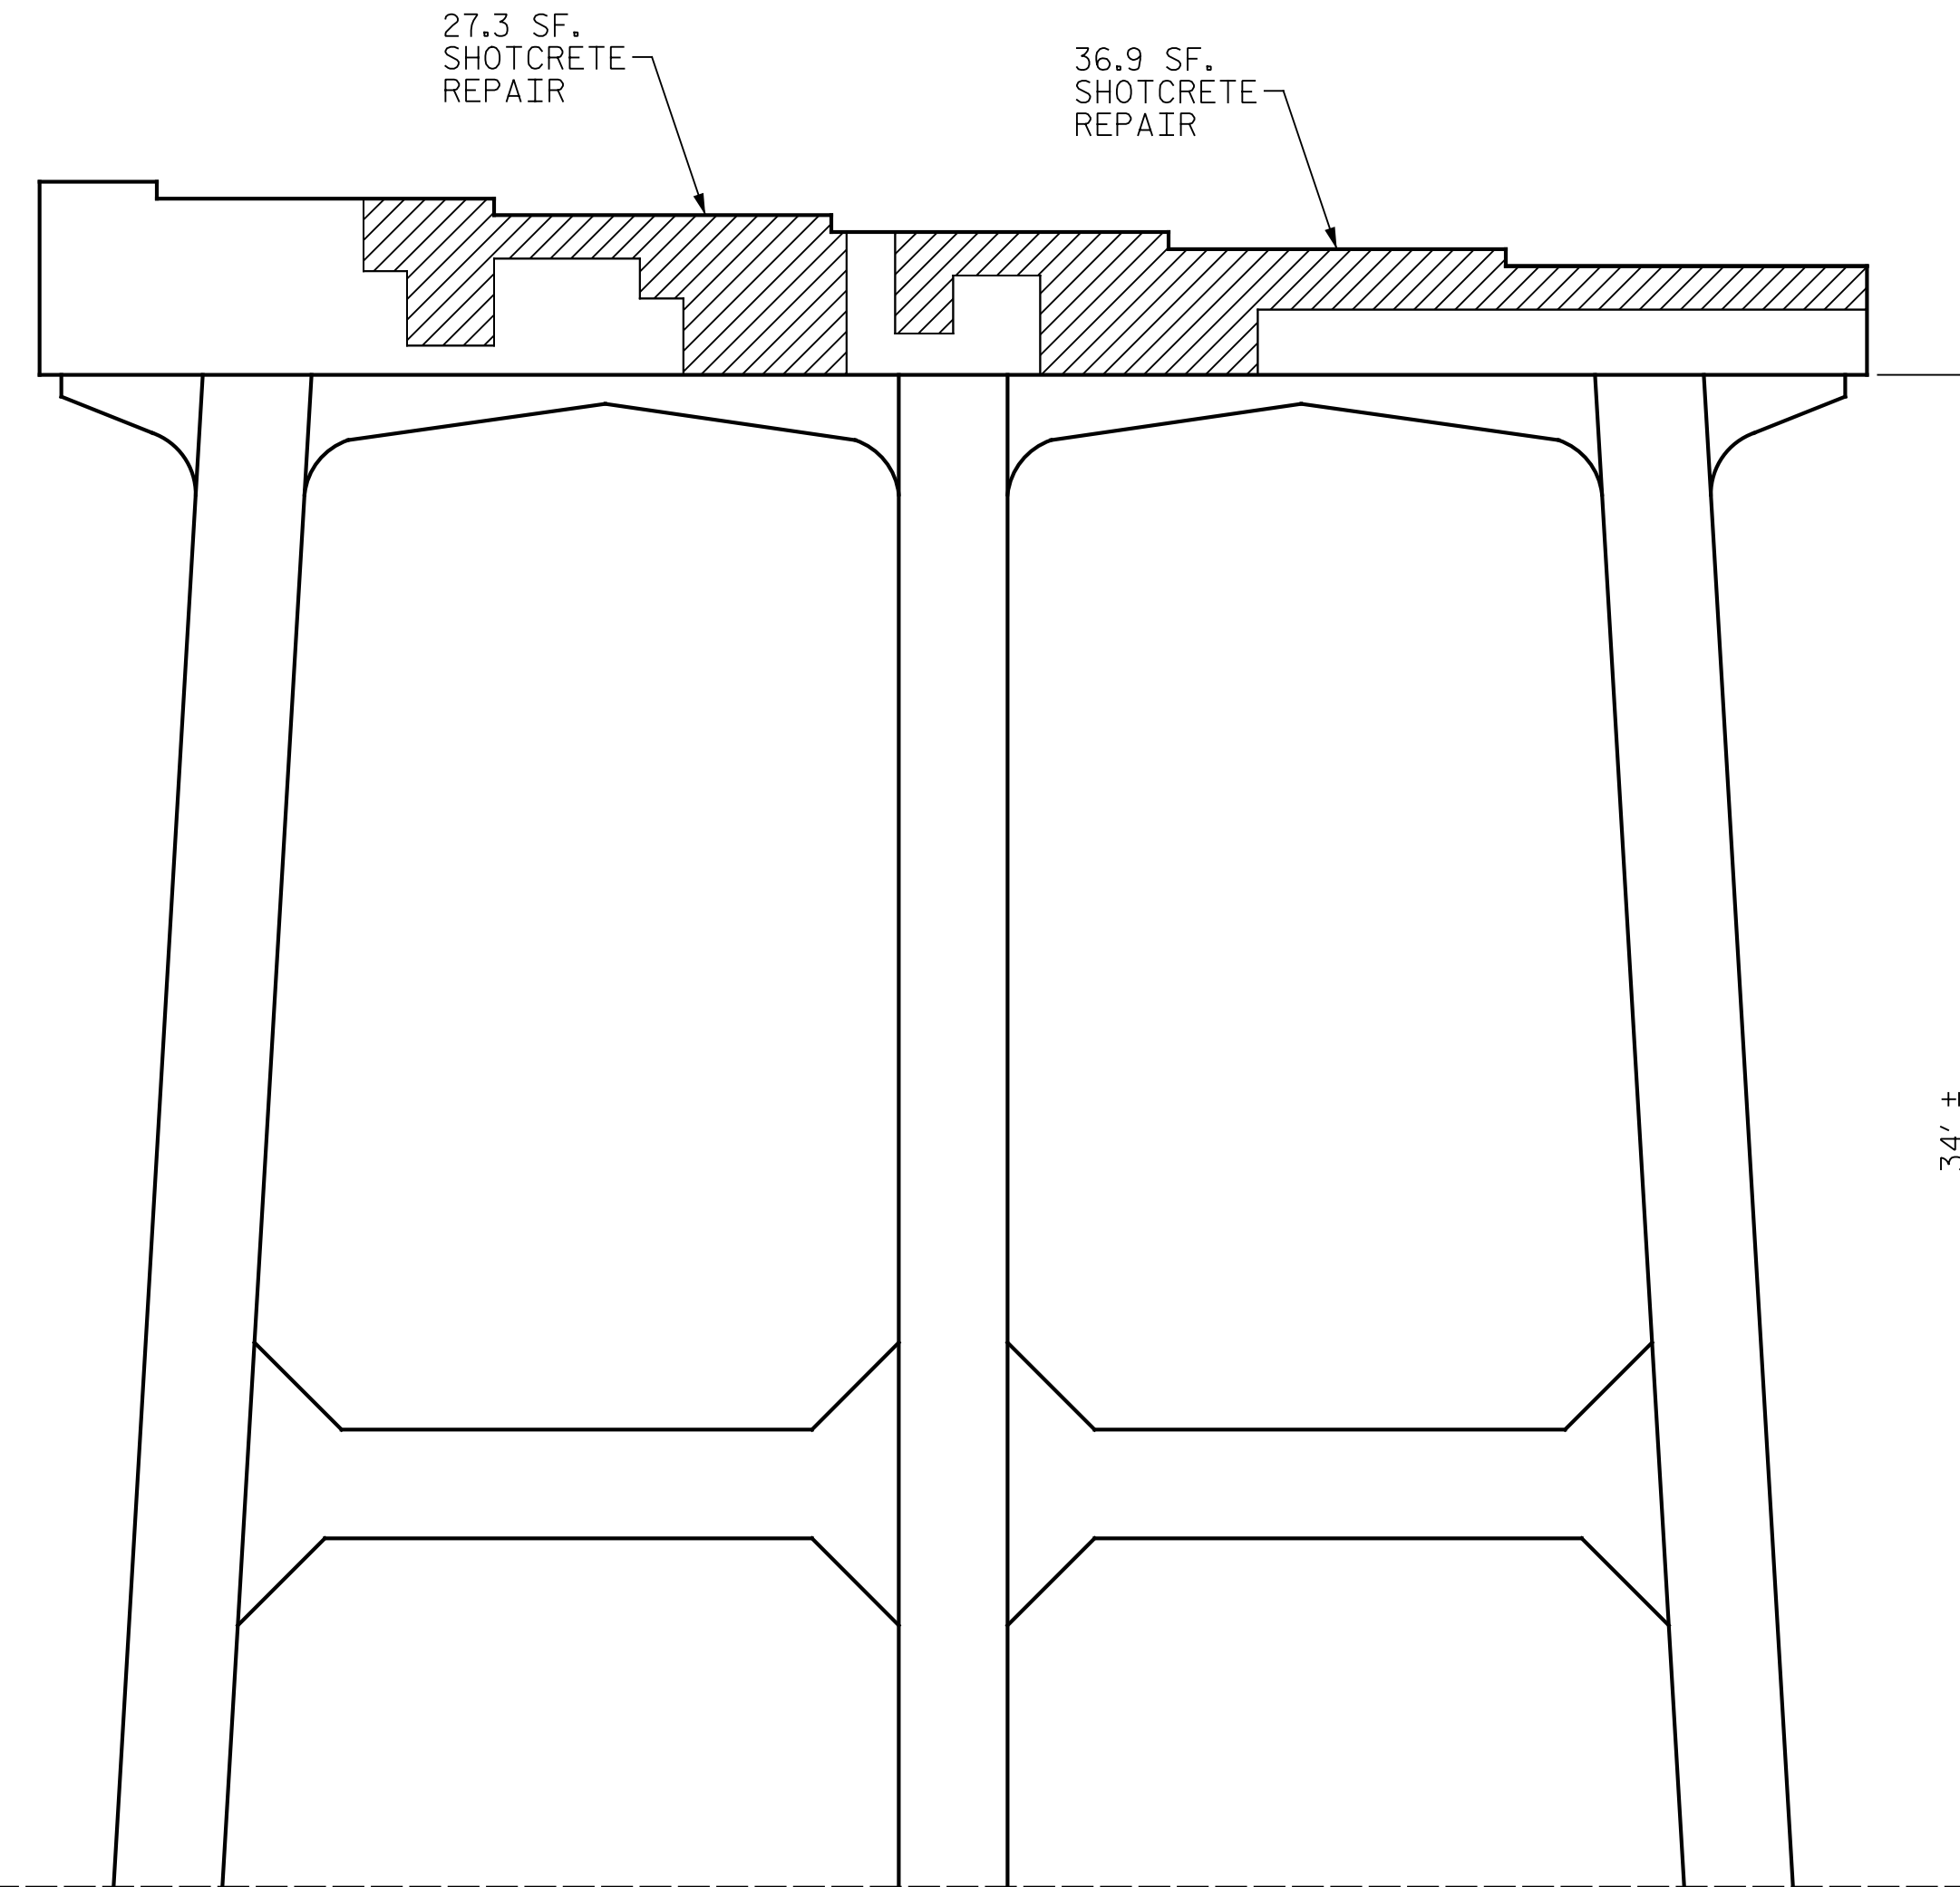
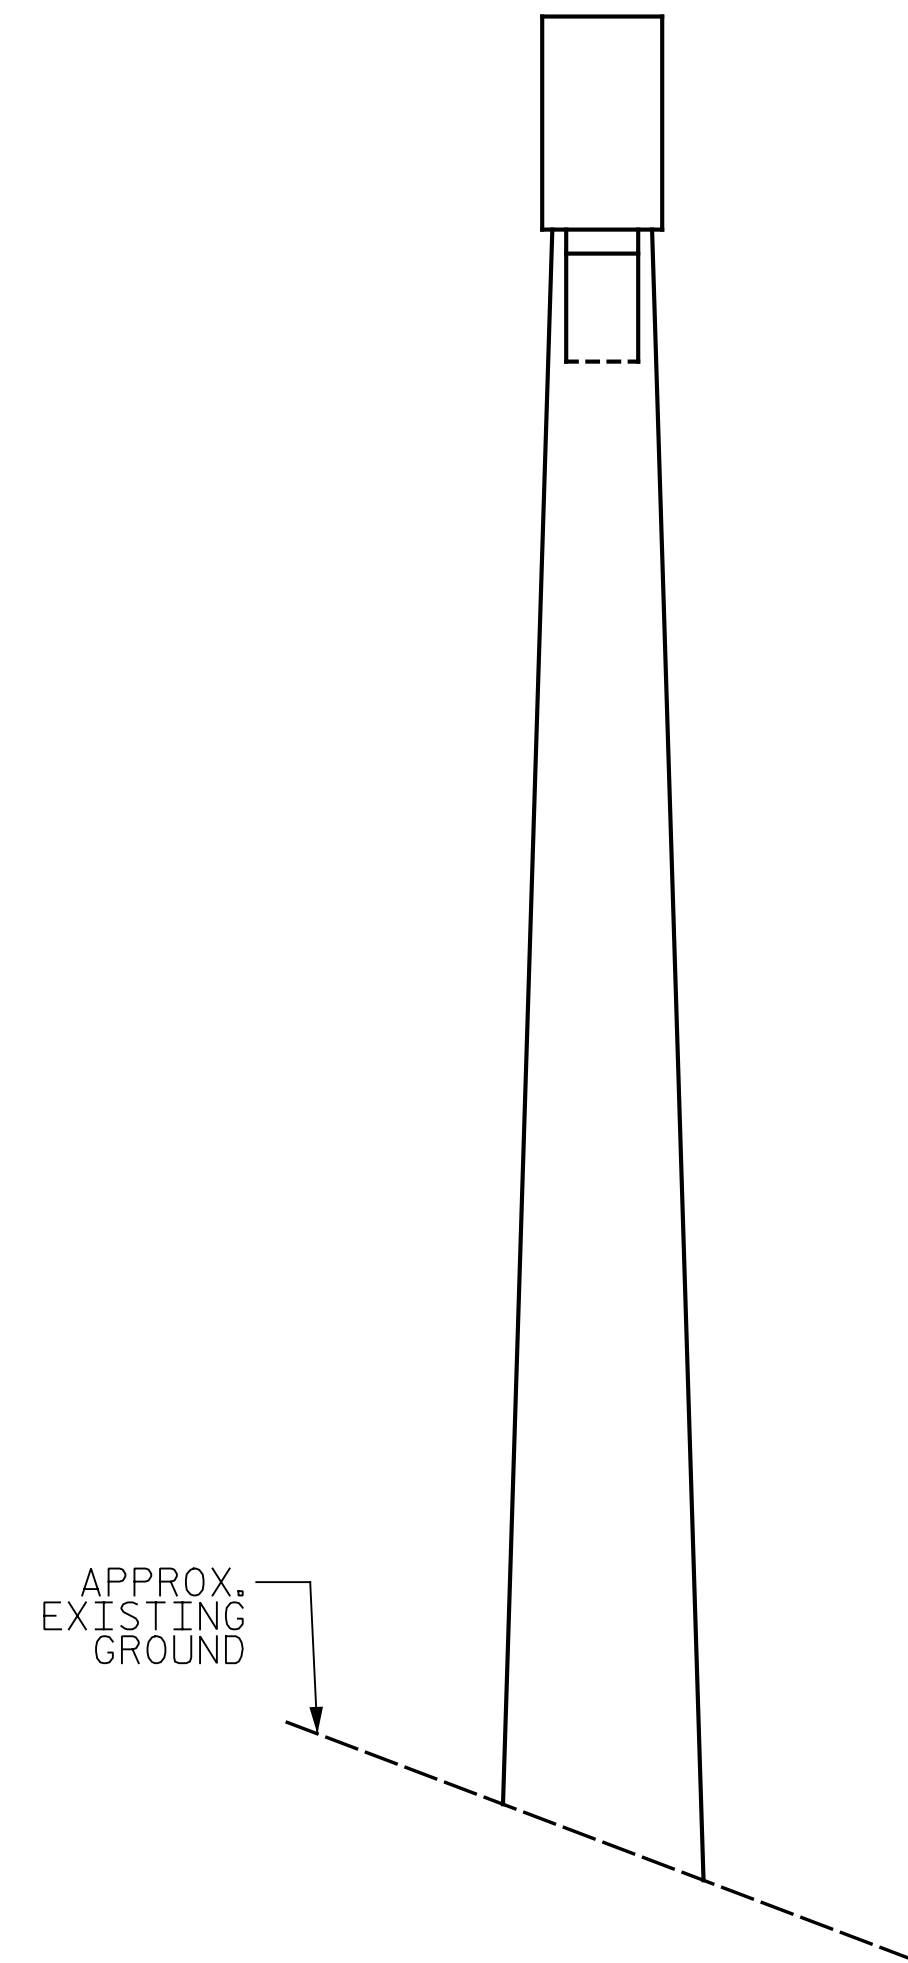
BENT 1  
(SPAN B SIDE)

- SHOTCRETE REPAIR
-

- CONCRETE REPAIR

BOTTOM OF CAP

END VIEW  
(SOUTH FACE)

ELEVATION  
(EAST FACE)

SHOTCRETE REPAIRS MAY BE REPLACED WITH CONCRETE REPAIRS WITH THE APPROVAL OF THE ENGINEER.

FOR SHOTCRETE REPAIRS, SEE SPECIAL PROVISIONS.

FOR CONCRETE REPAIR DETAILS, SEE "TYPICAL CAP & COLUMN REPAIR DETAILS" SHEET.
