PROJECT NO. I-5889A
BUNCOMBE COUNTY
BRIDGE NO. 344

STATE OF NORTH CAROLINA
DEPARTMENT OF TRANSPORTATION
RALEIGH

BENT 2
SPAN B SIDE

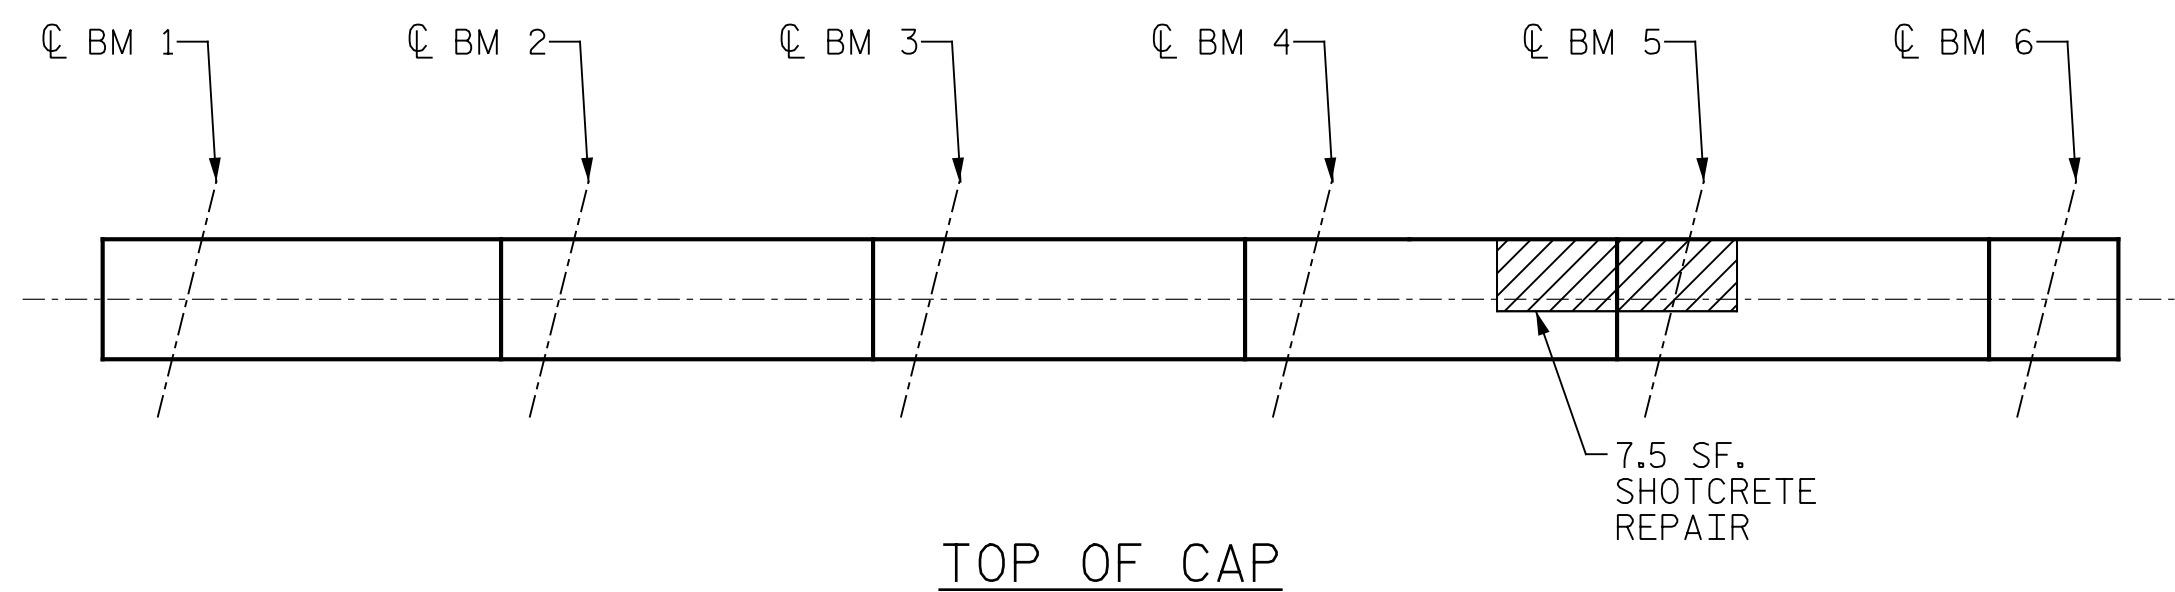
BENT 2
(SPAN B SIDE)

BENT 2 REPAIRS	QUANTITIES				
	ESTIMATE		ACTUAL		
SHOTCRETE REPAIRS	AREA SF	VOLUME CF	AREA SF	DEPTH FT	VOLUME CF
CAP (VERTICAL FACE)	12.6	6.3			
CAP (HORIZONTAL, CORNER)	7.5	3.7			
COLUMN	0	0

- SHOTCRETE REPAIR
- CONCRETE REPAIR

VALUES IN CHART REPRESENT ESTIMATED REPAIR TOTALS AFTER REMOVAL OF UNSOUND CONCRETE, MIN. OF 1" BEHIND REBAR AND MIN. 2" CL TO SAWCUT. SEE REPAIR DETAILS.

FOR CONCRETE REPAIR DETAILS, SEE "TYPICAL CAP & COLUMN REPAIR DETAILS" SHEET.
