PROJECT NO. I-5889A
BUNCOMBE COUNTY
 BRIDGE NO. 347

STATE OF NORTH CAROLINA
 DEPARTMENT OF TRANSPORTATION
 RALEIGH

BEAM REPAIR LOCATIONS

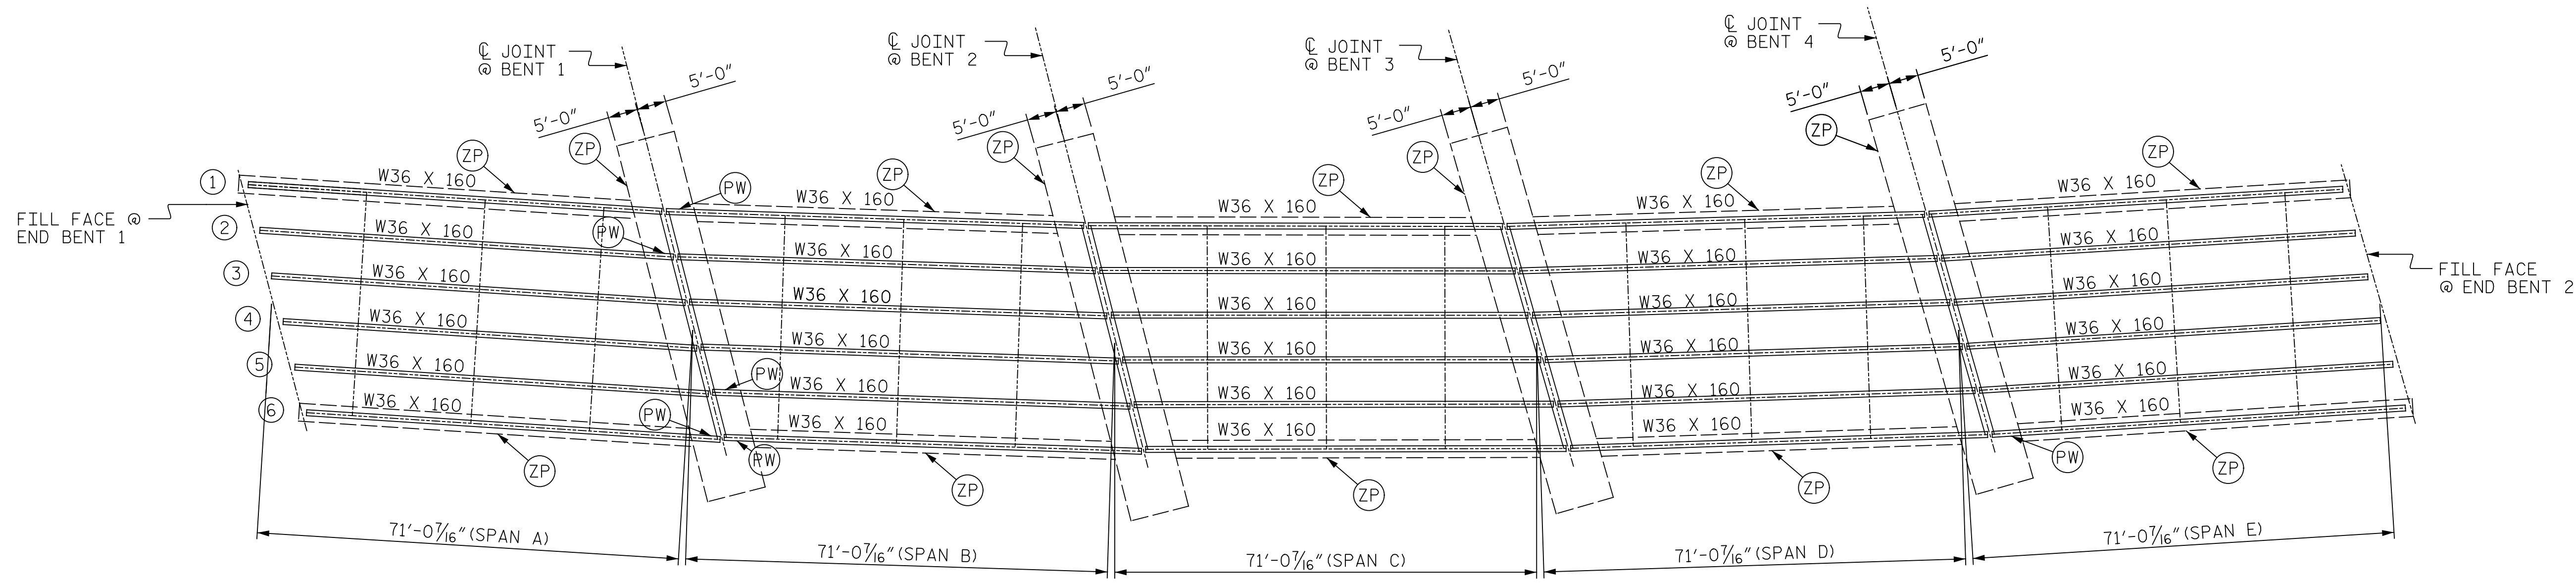
FRAMING PLAN

- ① - BEAM NUMBER
- (PW) - PLATING WEB REPAIR
- (PF) - PLATING FLANGE REPAIR
- (ZP) - ZONE PAINTING

NOTES:
 SEE SHEET NO. S-40 FOR BEAM PLATING REPAIR DETAILS.
 THE LOCATIONS AND DIMENSIONS OF THE AREAS FOR REPAIR ARE BASED ON THE BEST INFORMATION AVAILABLE. THE CONTRACTOR, IN CONJUNCTION WITH THE ENGINEER, SHALL VERIFY THE LOCATION AND EXTENT OF REPAIR AREAS PRIOR TO PERFORMING REPAIRS.
 CONTRACTOR SHALL ENSURE THAT EXISTING UTILITIES ADJACENT TO THE BRIDGE ARE NOT DAMAGED DURING THE REPAIR OPERATIONS.

ANTICIPATED BEAM REPAIR LOCATIONS							
SPAN	BEAM	LOCATION	REPAIR TYPE	DIM "A"	DIM "B"	DIM "C"	DIM "D"
A	2	BENT 1	PW	6"	2'-0"	-	-
A	6	BENT 1	PW	2'-8"	1'-0"	-	-
B	1	BENT 1	PW	6"	1'-0"	-	-
B	5	BENT 1	PW	4"	1'-0"	-	-
B	6	BENT 1	PW	6"	3'-0"	-	-
E	6	BENT 4	PW	5"	6'-0"	-	-
