PROJECT NO. I-5889A  
BUNCOMBE COUNTY  
 BRIDGE NO. 347

STATE OF NORTH CAROLINA  
 DEPARTMENT OF TRANSPORTATION  
 RALEIGH

BENT 3  
 SPAN D SIDE

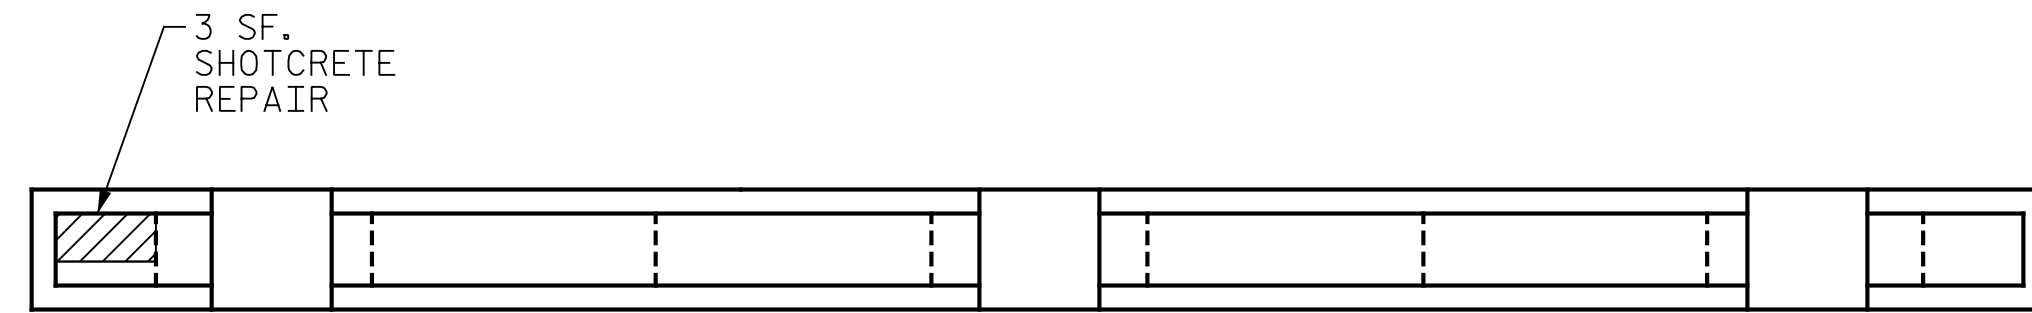
BOTTOM OF CAP

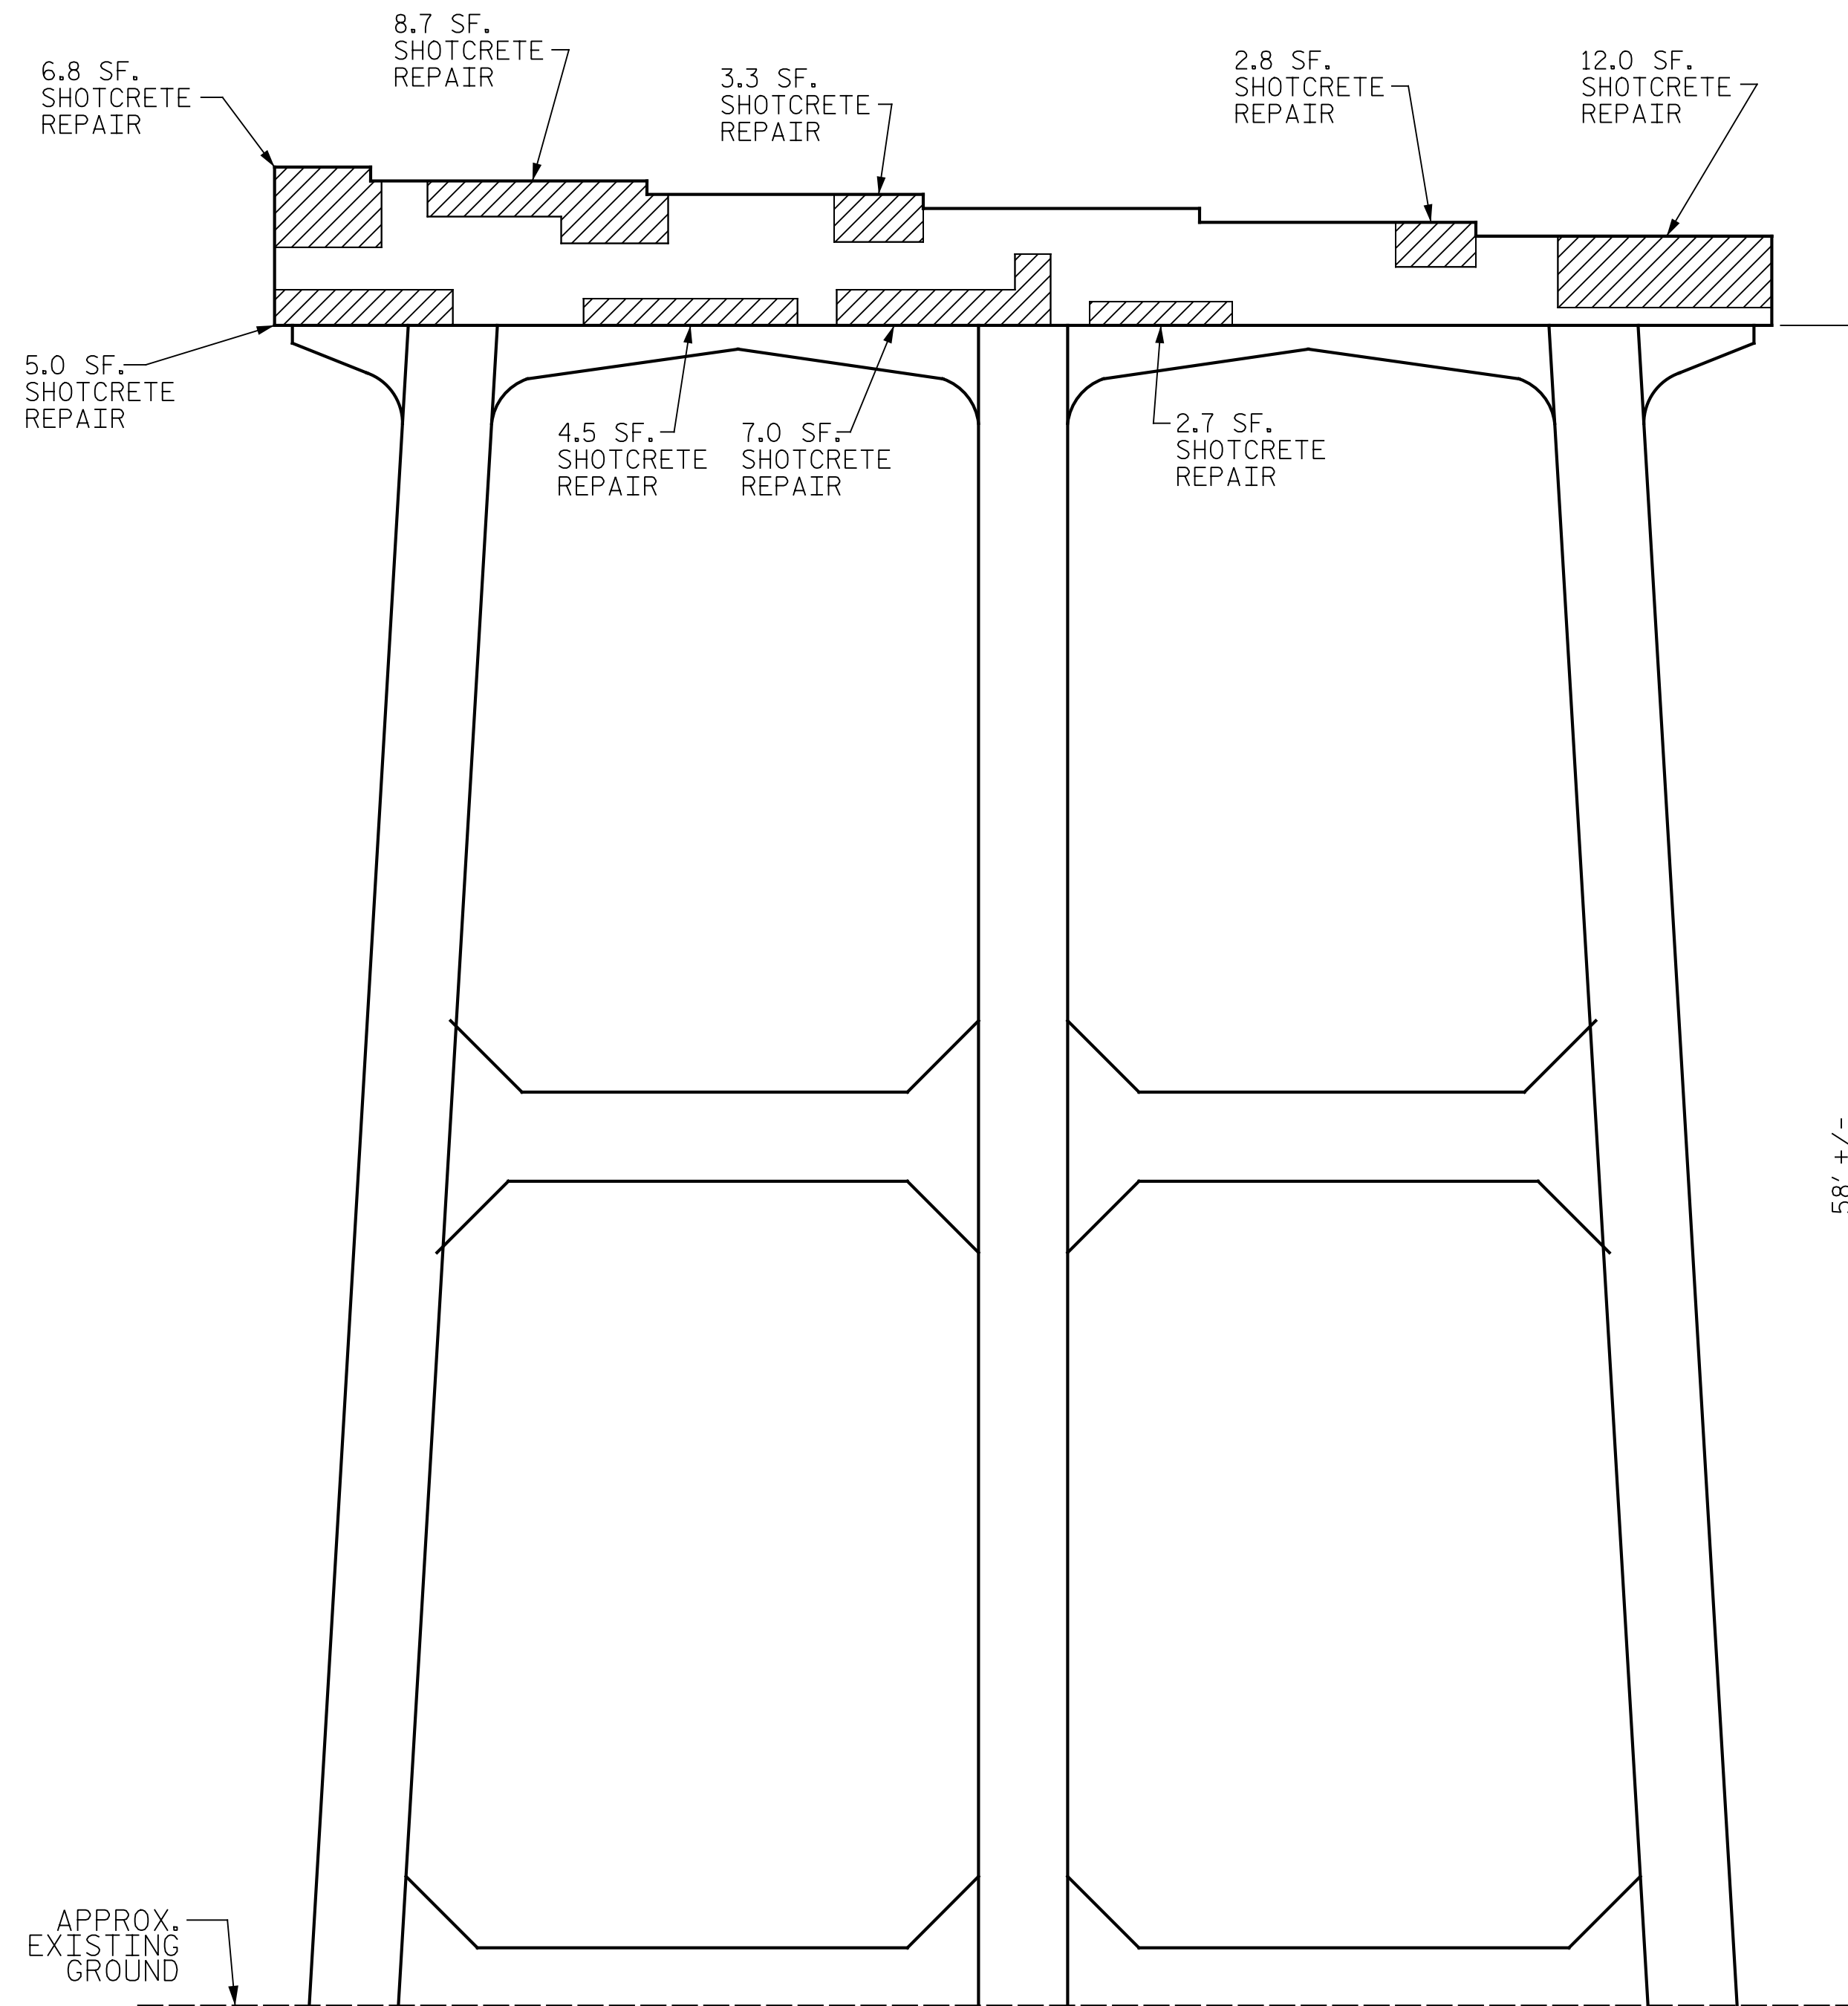
BENT 3  
(SPAN D SIDE)

- SHOTCRETE REPAIR
- CONCRETE REPAIR

ELEVATION  
(EAST FACE)

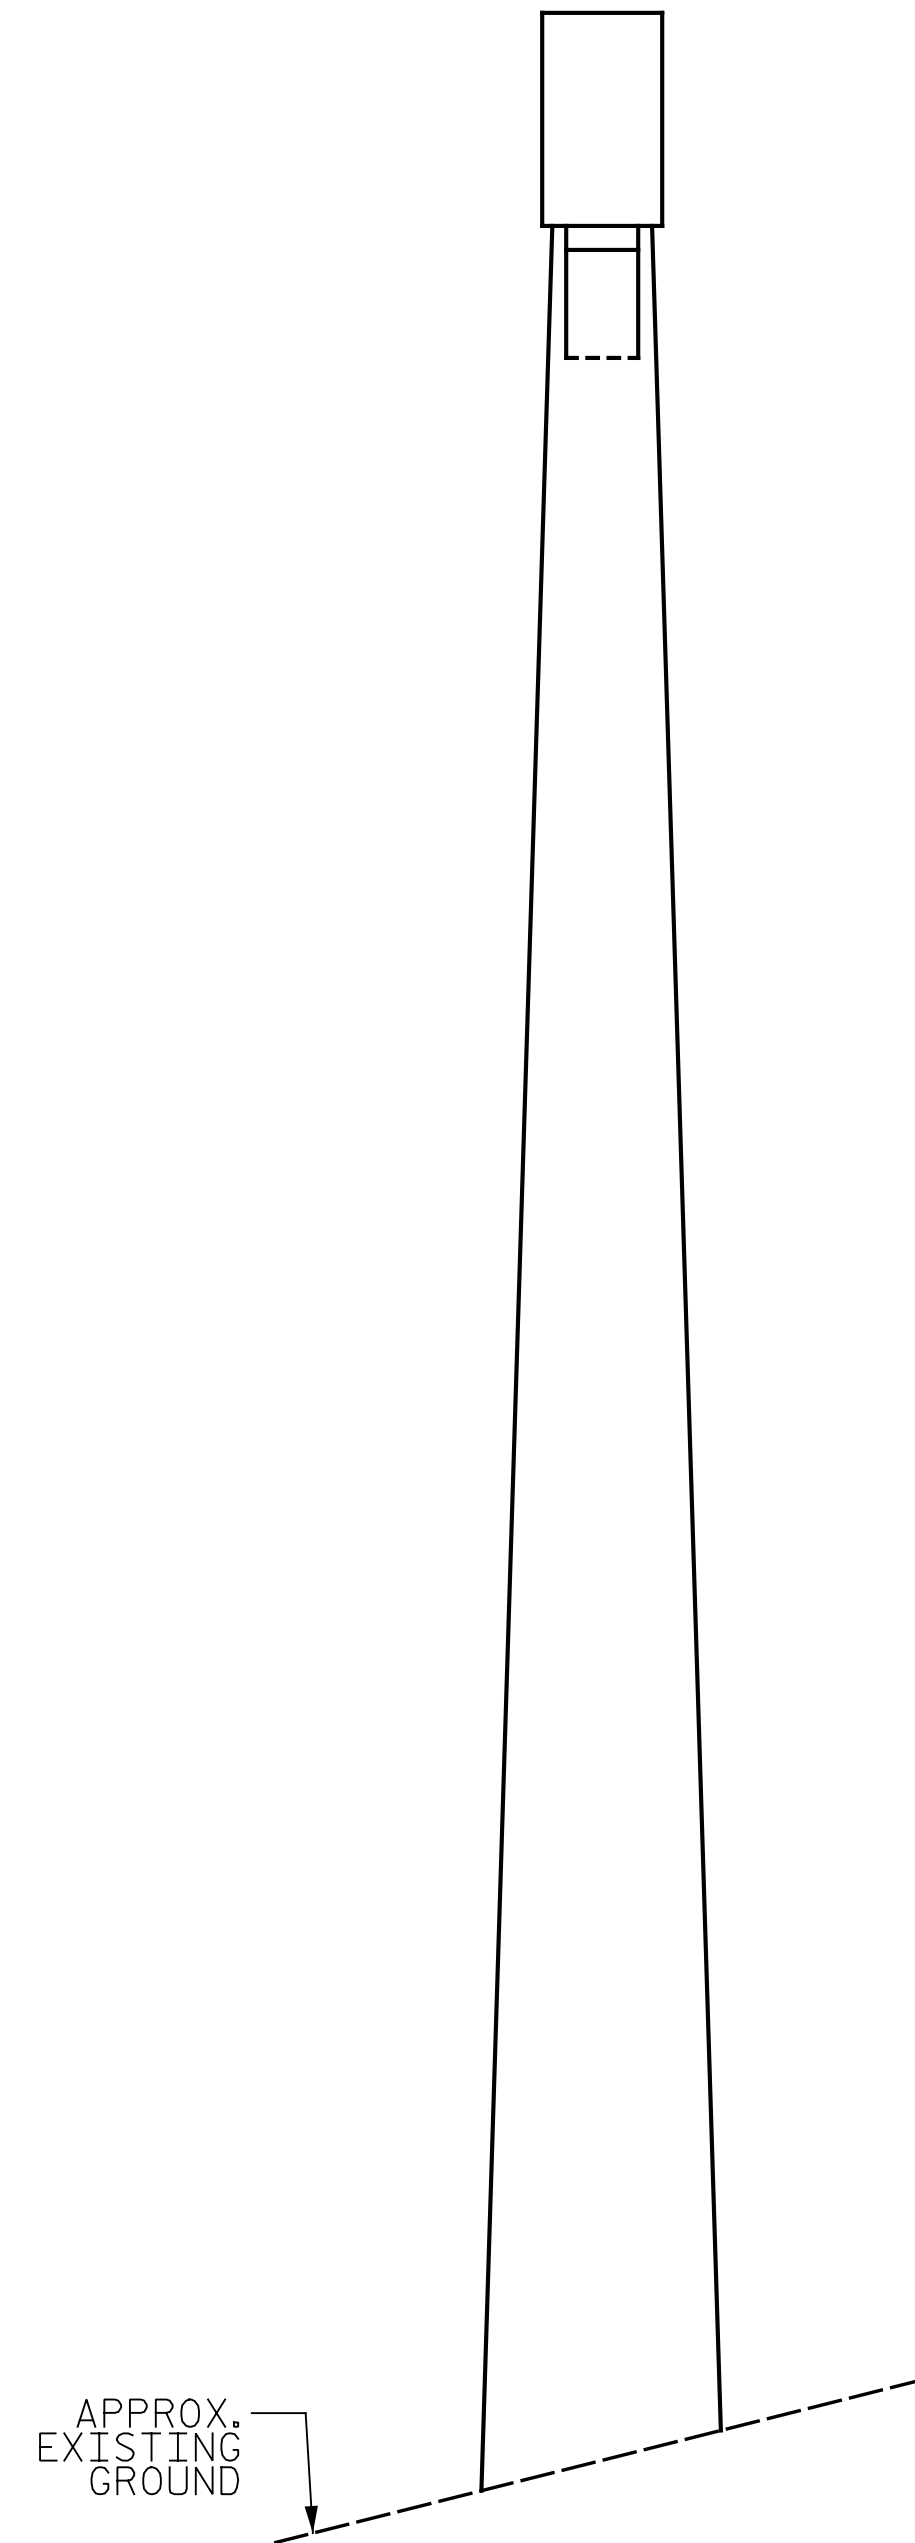
END VIEW  
(SOUTH FACE)
