## AS-BUILT REPAIR QUANTITY TABLE BENT 1 REPAIRS QUANTITIES

PROJECT NO. I-5889A

BRIDGE NO. 352

BENT 1 SPAN A SIDE

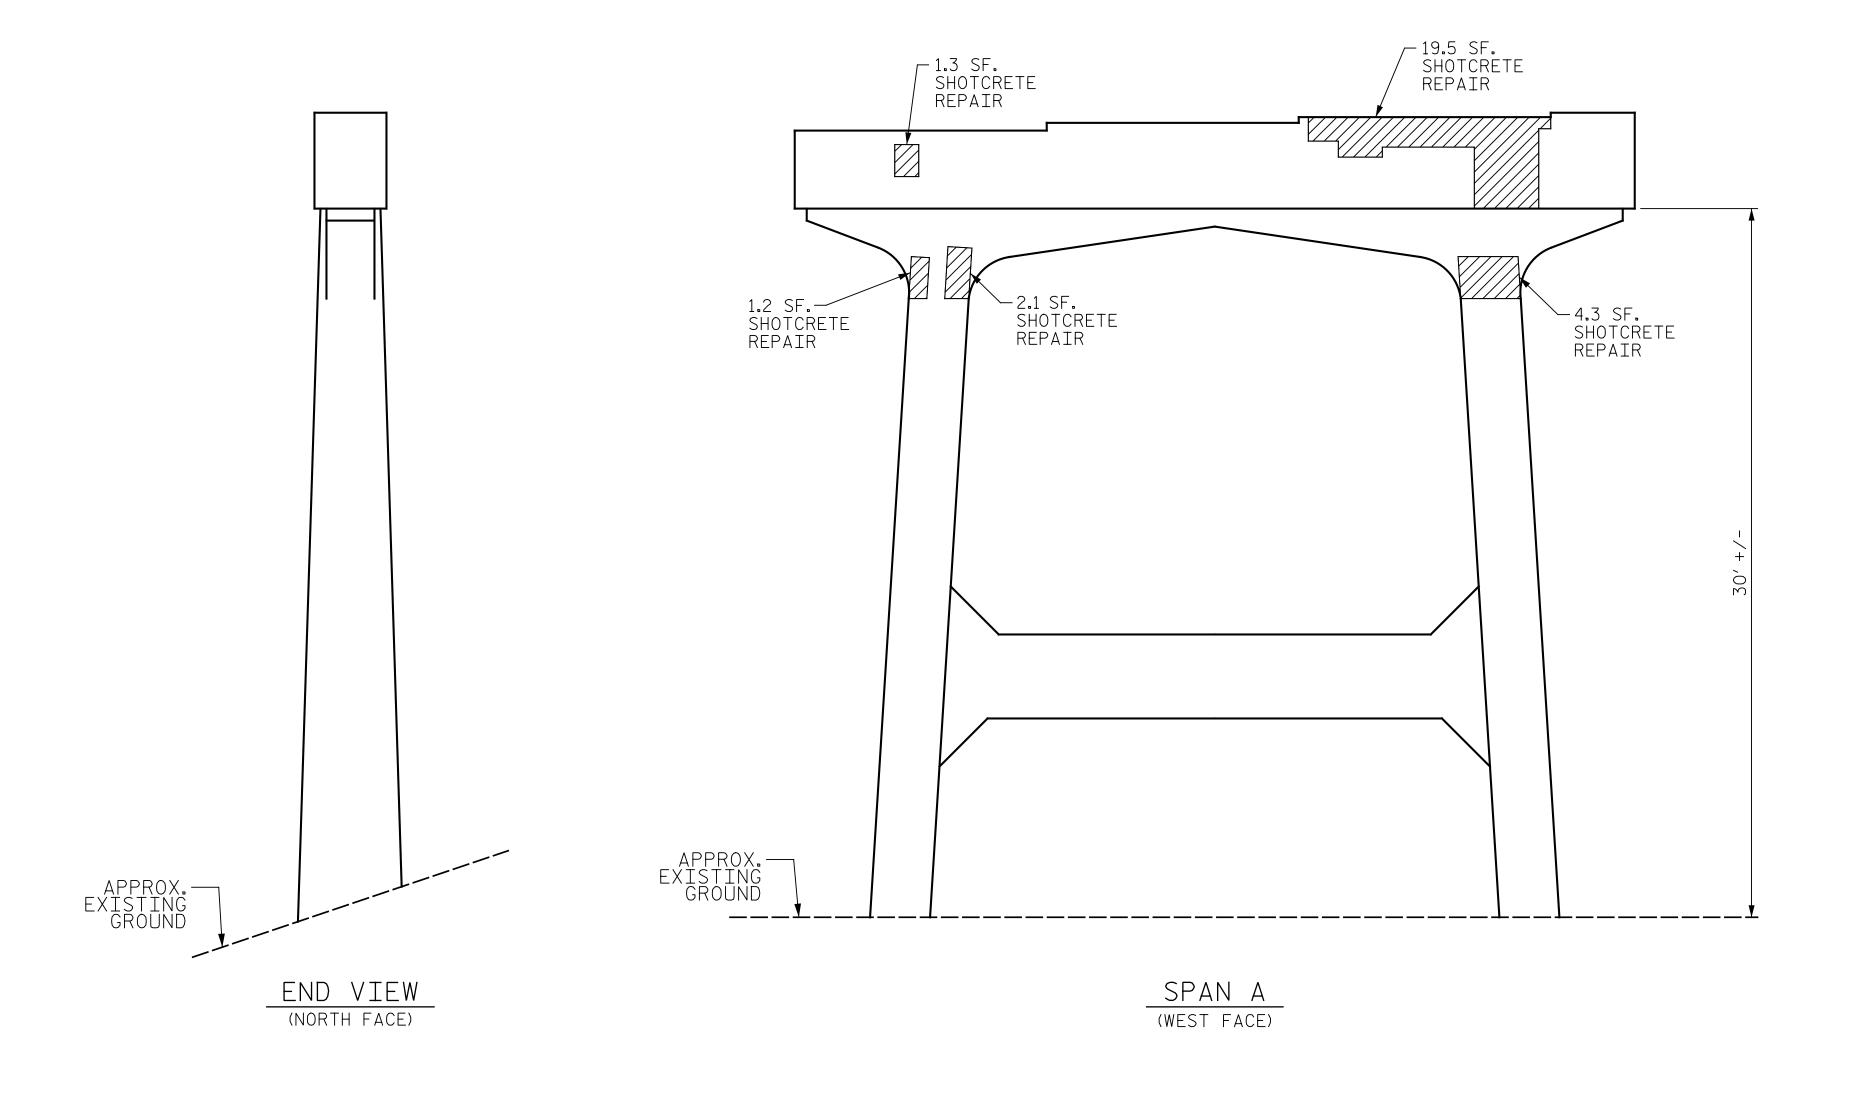
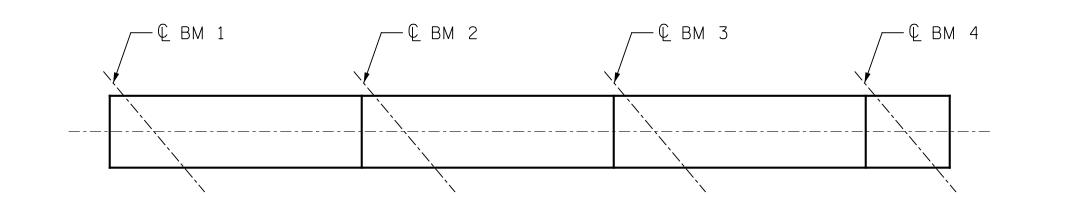
BENT 1
(SPAN A SIDE)

BENT 1 REPAIRS	QUANTITIES					
		ESTI	ACTUAL				
	SHOTCRETE REPAIRS	AREA SF	VOLUME CF	AREA SF	DEPTH FT	VOLUME CF	
	CAP (VERTICAL FACE)	57.1	28.6				
	CAP (HORIZONTAL, CORNER)	0	0				
	COLUMN	0	0

VALUES IN CHART REPRESENT ESTIMATED REPAIR TOTALS AFTER REMOVAL OF UNSOUND CONCRETE, MIN. OF 1"BEHIND REBAR AND MIN. 2"CL TO SAWCUT. SEE REPAIR DETAILS.
